# INGATORP

## A CORNER TIMBERED TITHE BARN FROM THE 13<sup>TH</sup> CENTURY

Ingatorp church, in the province of Småland in the south of Sweden, is recognized as a high standard art deco church. In the outskirts of the churchyard stands a corner timbered shed that has been dated by dendrochronological analysis and C-14 to between 1219 and 1239. This shed is one of the oldest wooden buildings in Sweden. This poster presents the discovering of a medieval religious building tradition in wood.

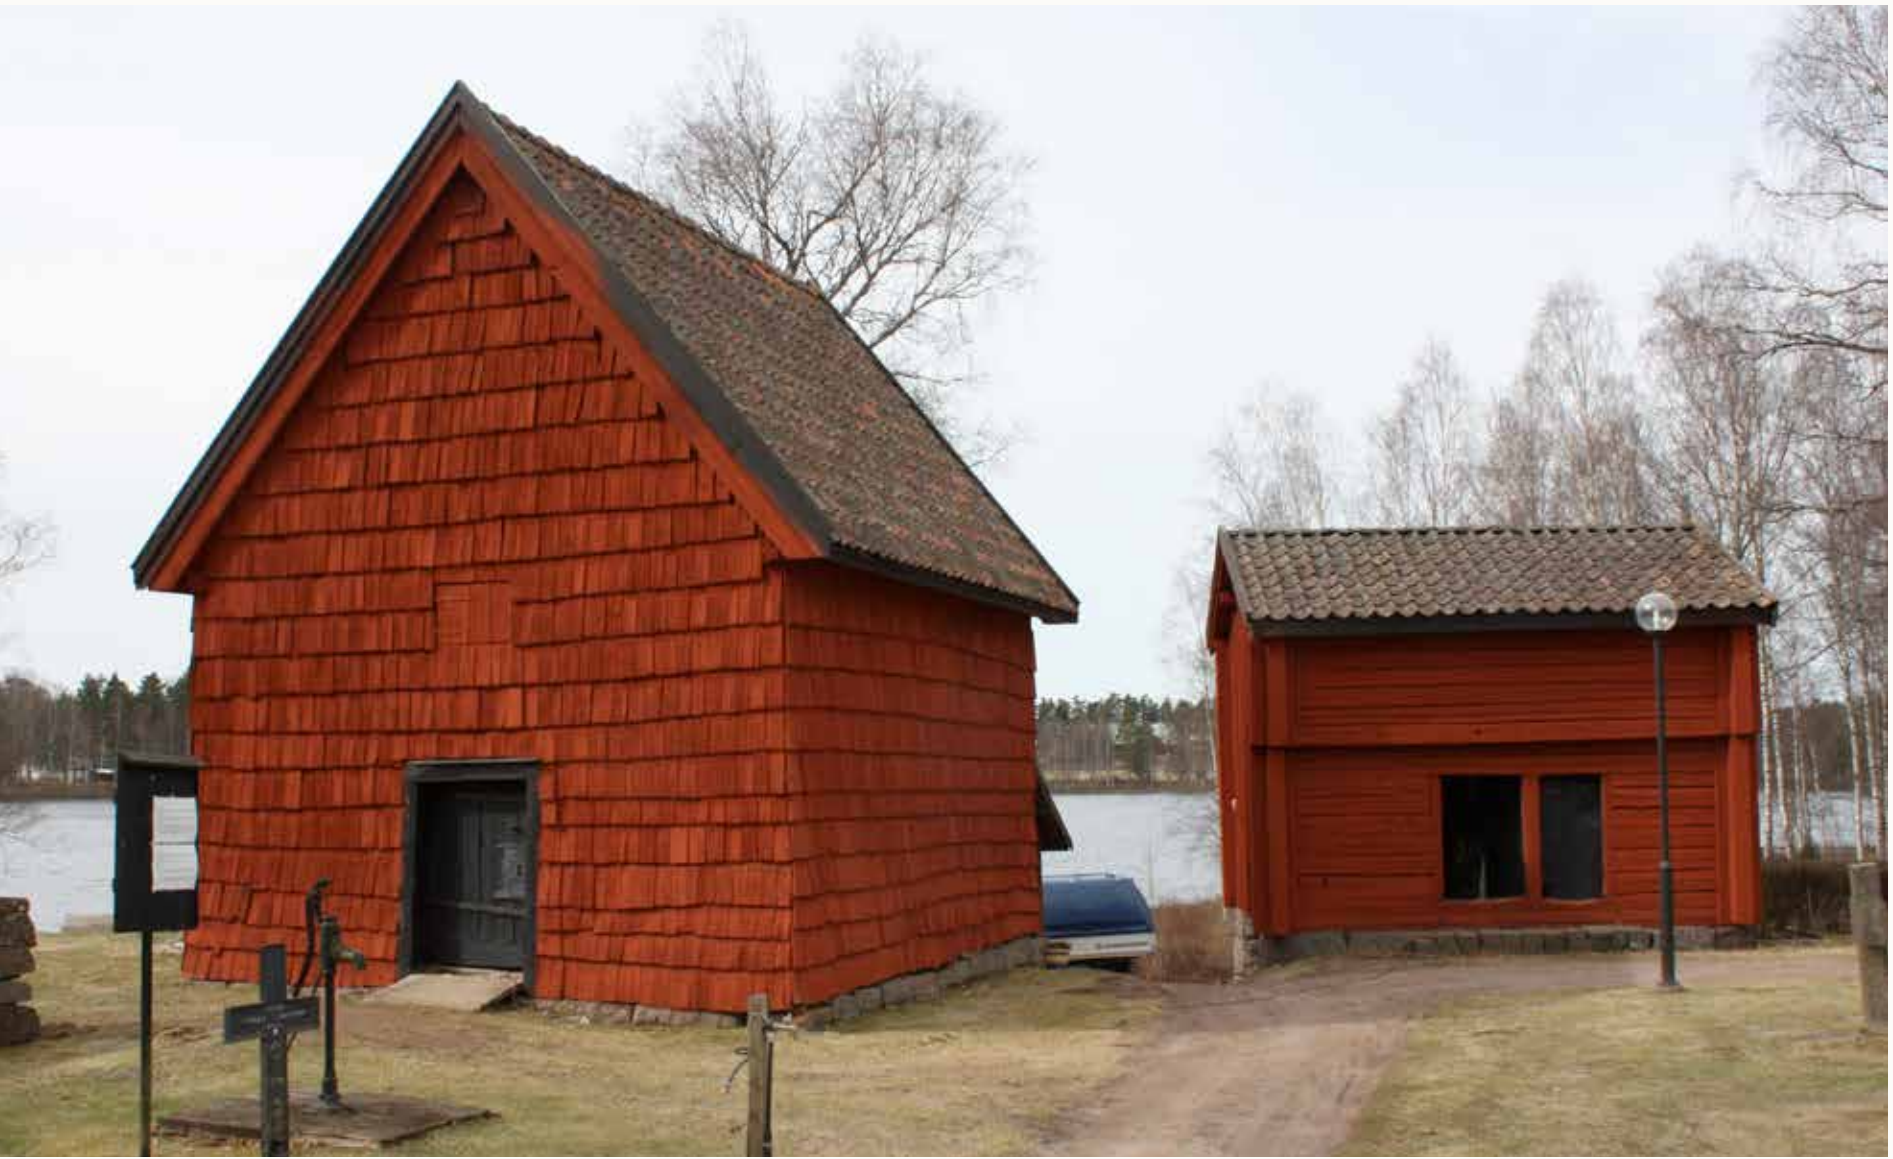
**Ingatorp tithe barn.** Ingatorp belongs to the Diocese of Linköping, located in the province of Småland and reads the administrative region of Jönköping and the Municipality of Eksjö.

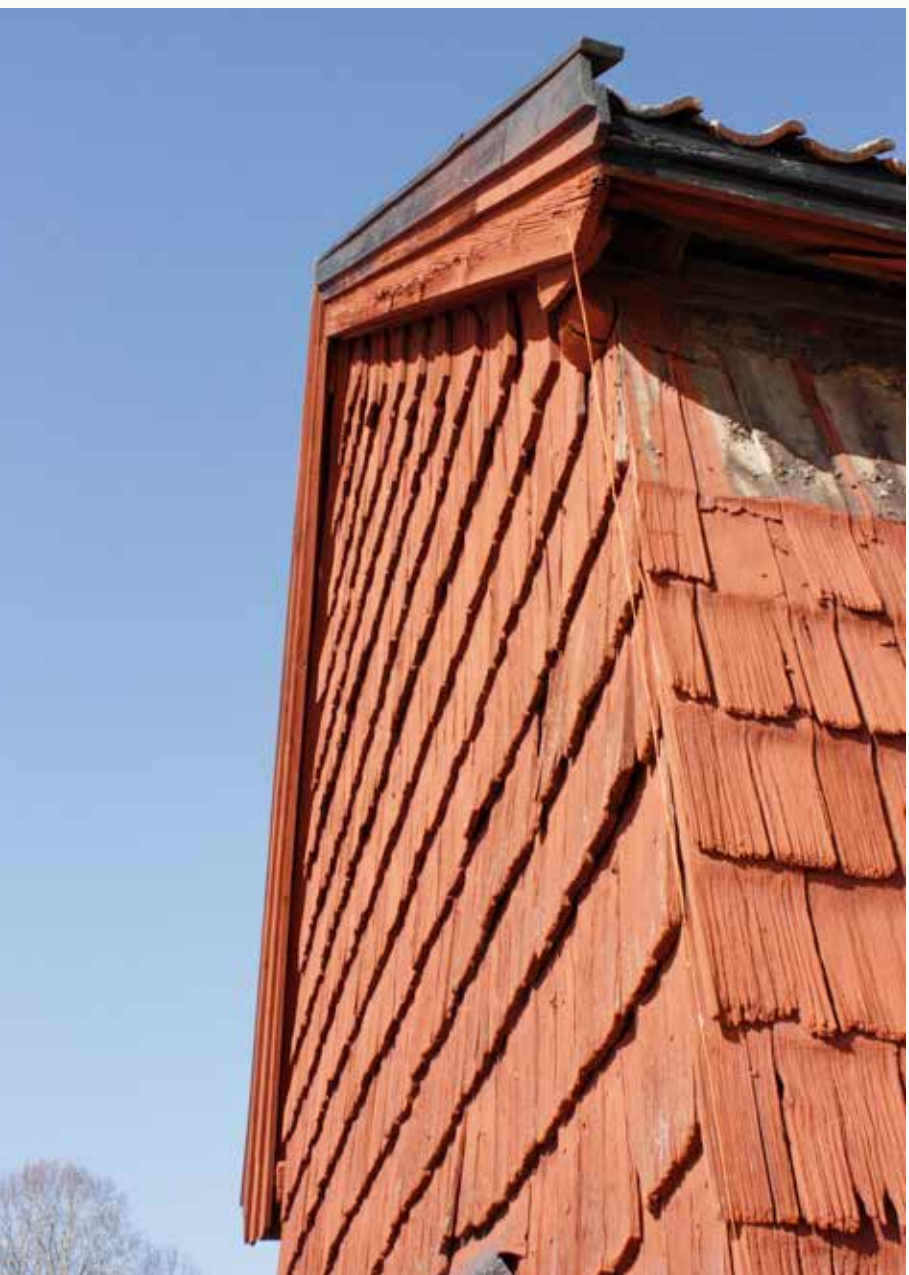
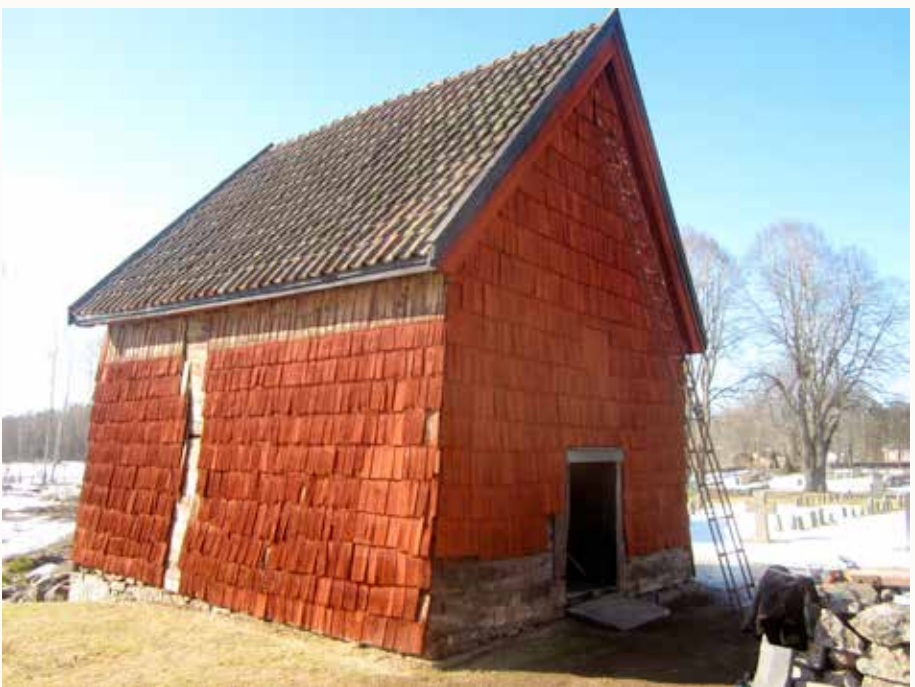
**Leaning walls** (left and right above) The plumb expose the leaning of the timbered walls. **“Church shingle”** (left below) Originally the exterior logs were weathered and tarred. The first generation shingles has been dated by dendrochronology to 1555-1580. **Trapezoid sill** (right below) Traces of the original form of the sill with a trapezoid cross section can be recognized by the shaped ending of the longitudinal timber that was formed to merge with the gable sill.

The measures of the tithe barn are “church-like” with a high and compact building with a steep pitched roof. The ground plan is almost square. Standing in front of the building gives a tall and fortified impression. This is also enhanced by manipulation, as the walls are leaned inwards about 10 cm from the sill to the eave. The gables are in reverse leaned outwards from the eave to the rooftop to magnify the impression. The frame to the reinforced entrance door also leans inwards, making it about 10 cm wider to the ground. The craft performance to achieve this architectural image is very calculated.

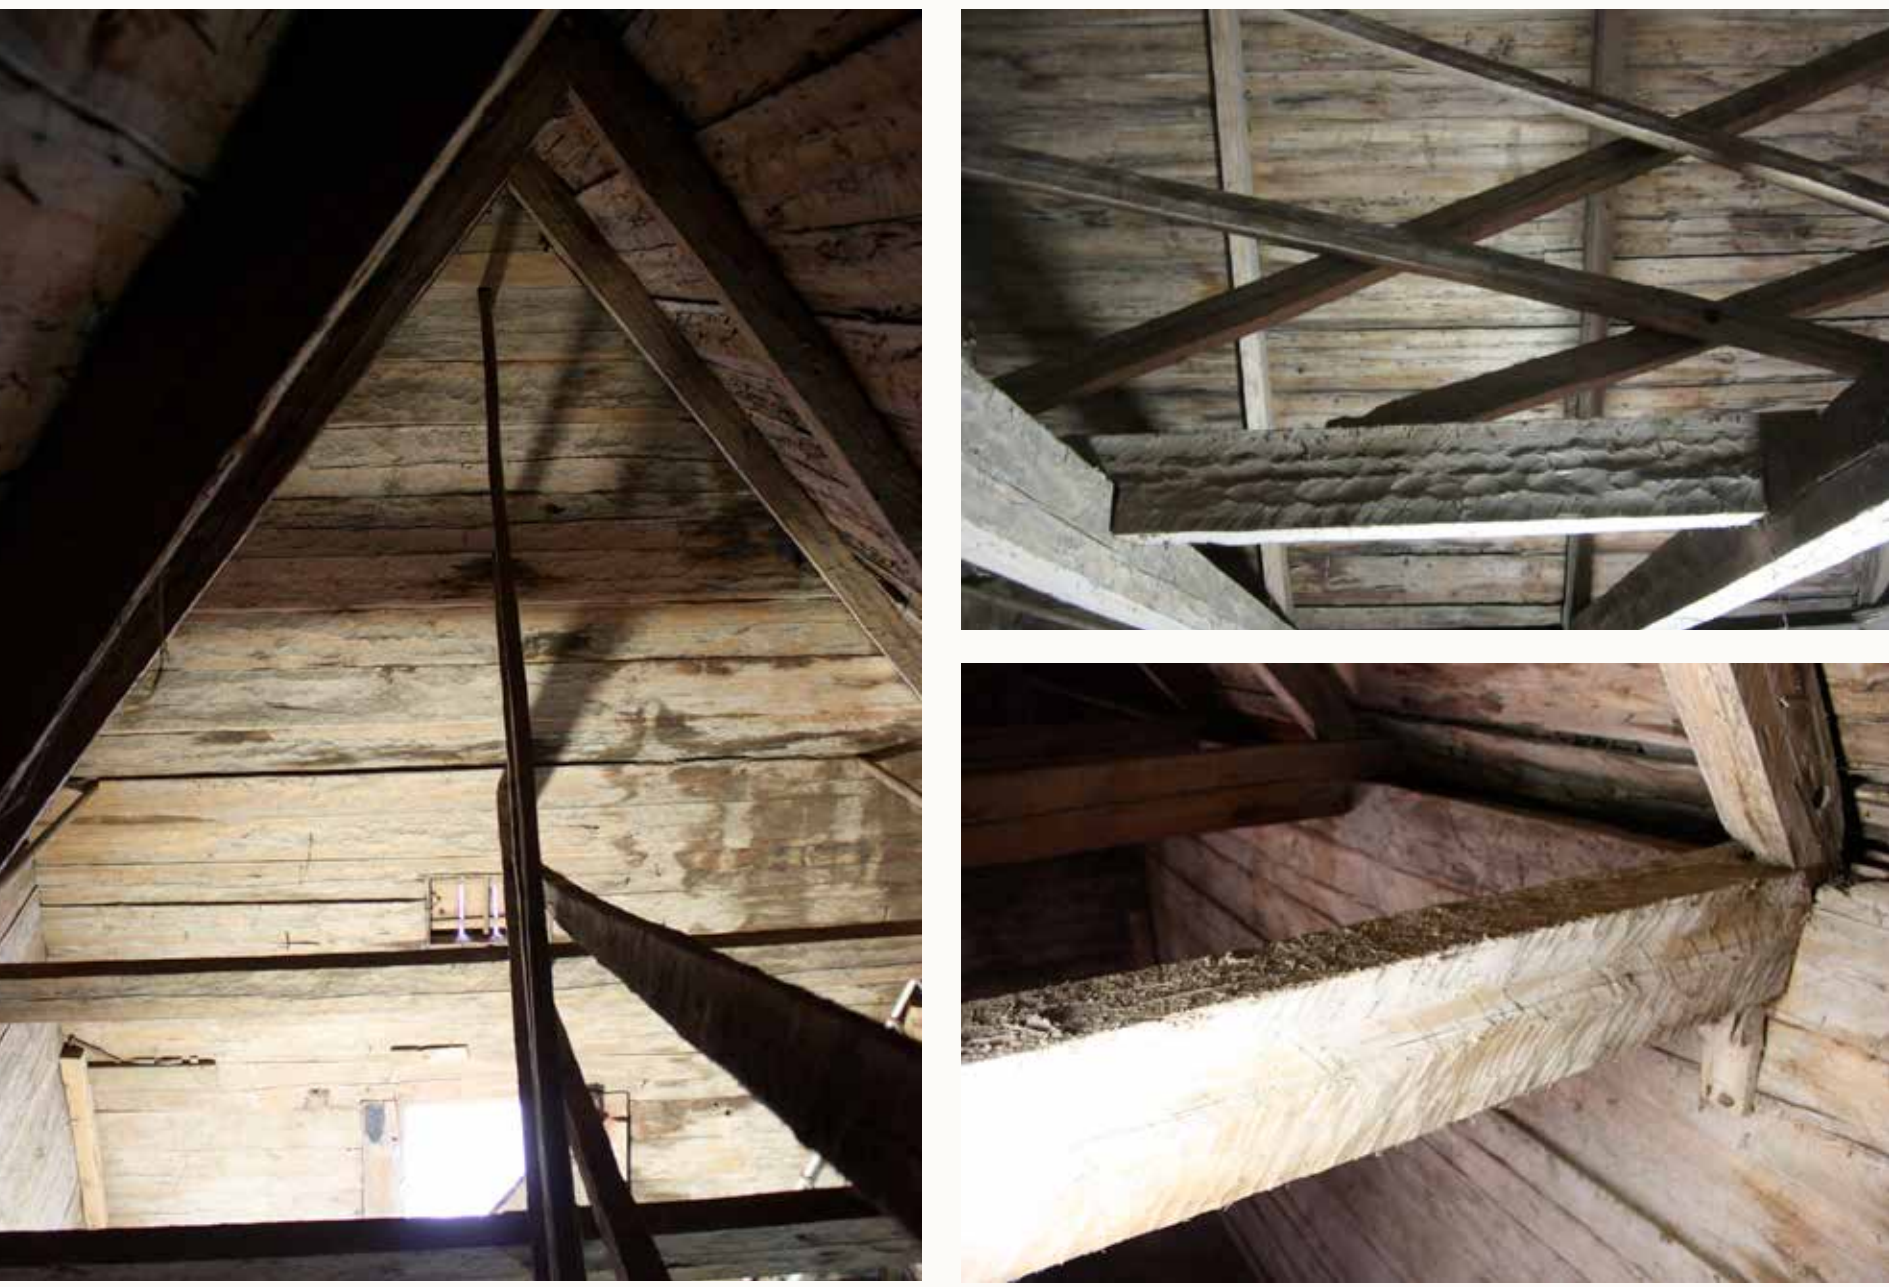
**A peculiar longitude consolidating roof construction.** Ingatorp combines timbered gables with roof trusses standing on tie beams. The trusses do not have struts or collarbeams which tells us the construction was made for light wooden shingles. On the tie beams rests a longitudinal timber, called *styrbjälke* in Swedish. At a first glimpse this ‘styrbjälke’ seems to support the gables but it is not connected to these at all. Instead it works as a support for four crossed raking struts that are nailed to the styrbjälke and recessed and fastened into the gables.

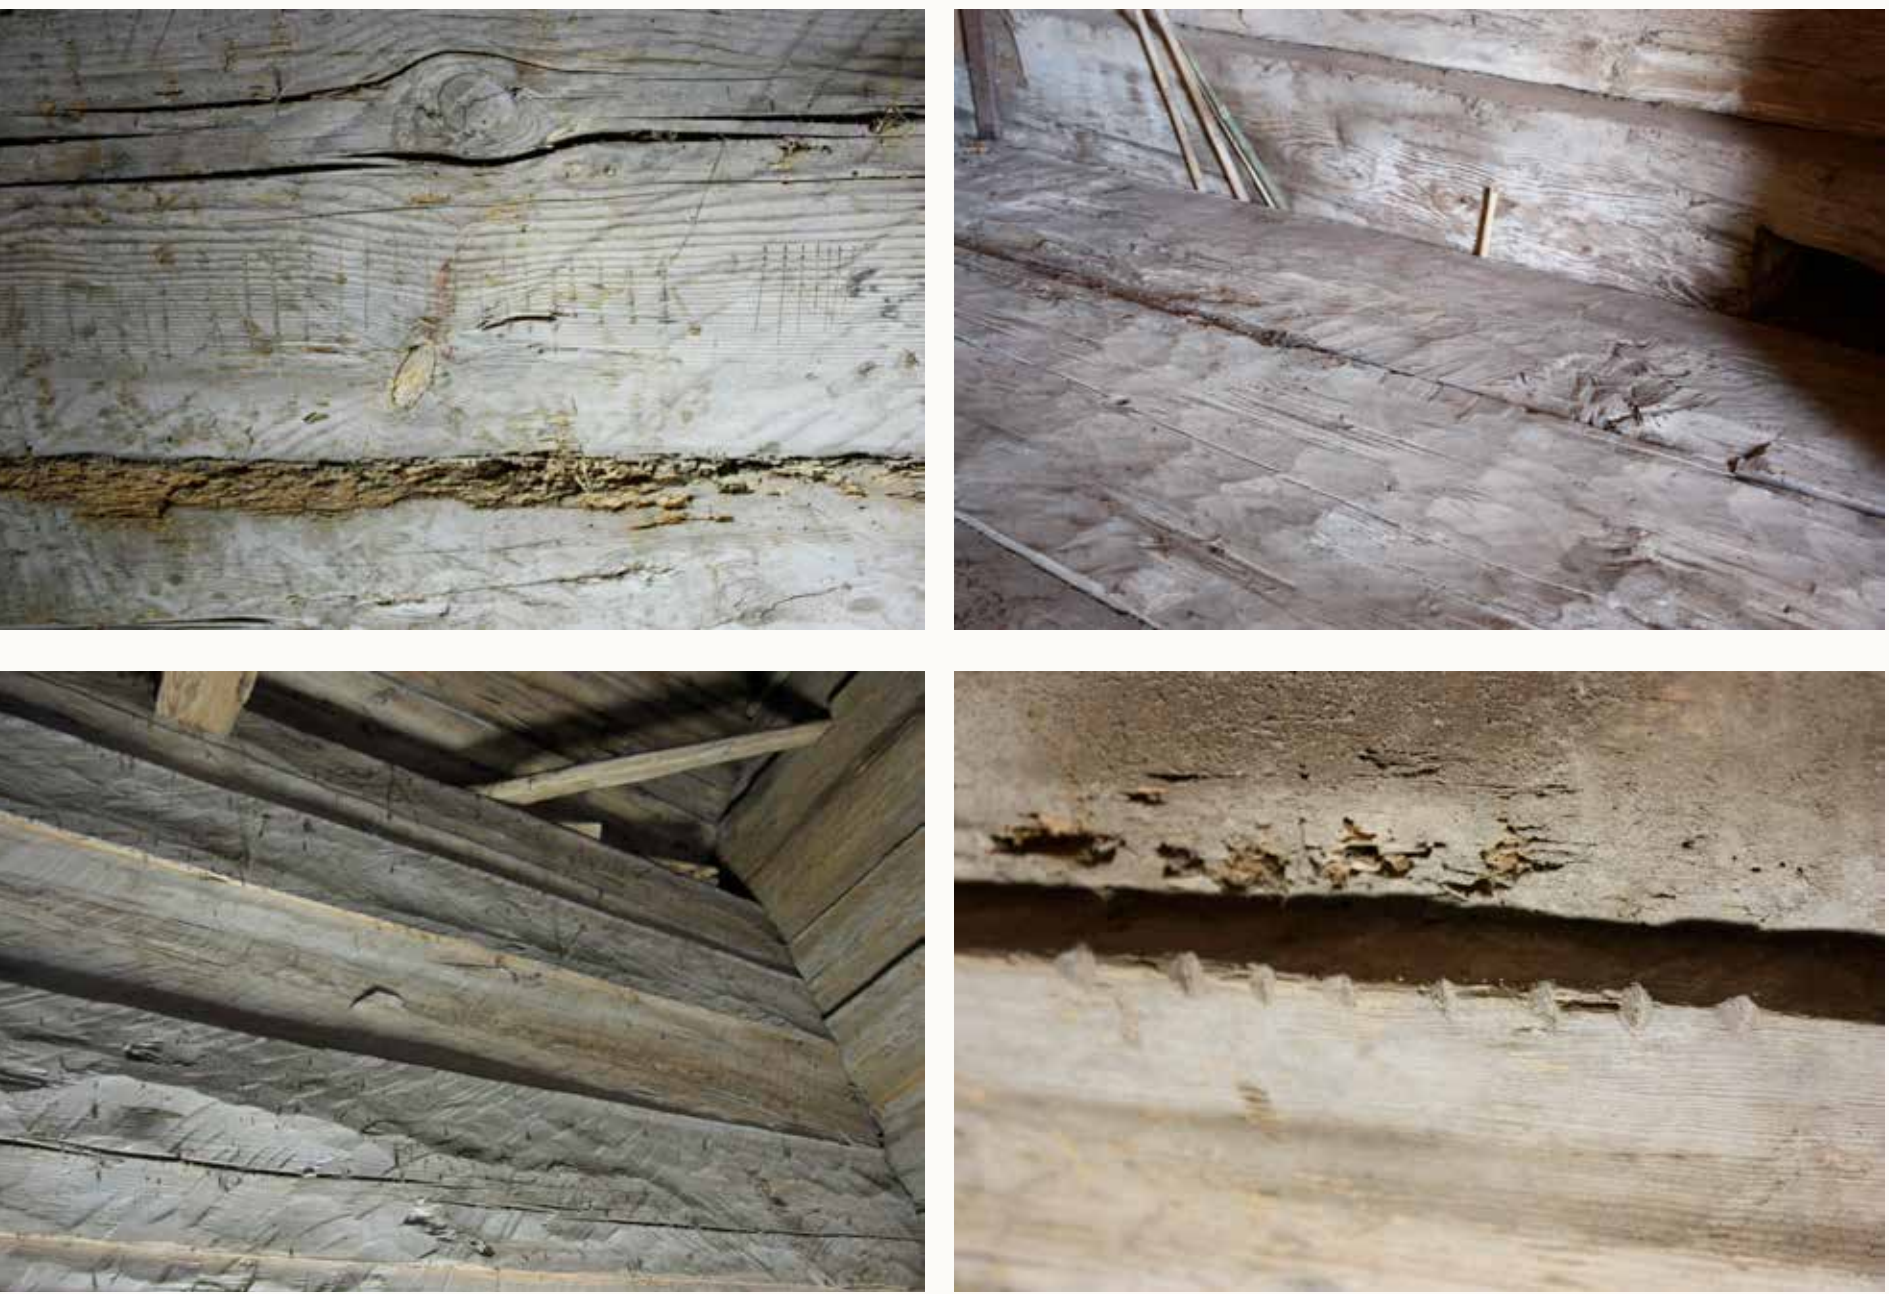
**Counting marks on the wall** (left above) **Interior** (right above) The floor tiles are cleaved and planed with axe. The inner walls was at some time painted white. **The timbered walls** (left below) The logs are boxed with sharp corners giving a plane wall. As they are not doweled the logs have shifted out. **Traces of numbering** (right below). The eighth log was numbered seemingly during the work process.

Ingatorp and the medieval corner timbered churches are bound together in a building tradition using an extensive cutting of the logs. The timber is boxed with sharp corners, and when fitted together they make plane wall surfaces. In Ingatorp dovetail joints were used in the corners. This is also different from the known medieval profane building craft, using overhanging logs in the corner joints.

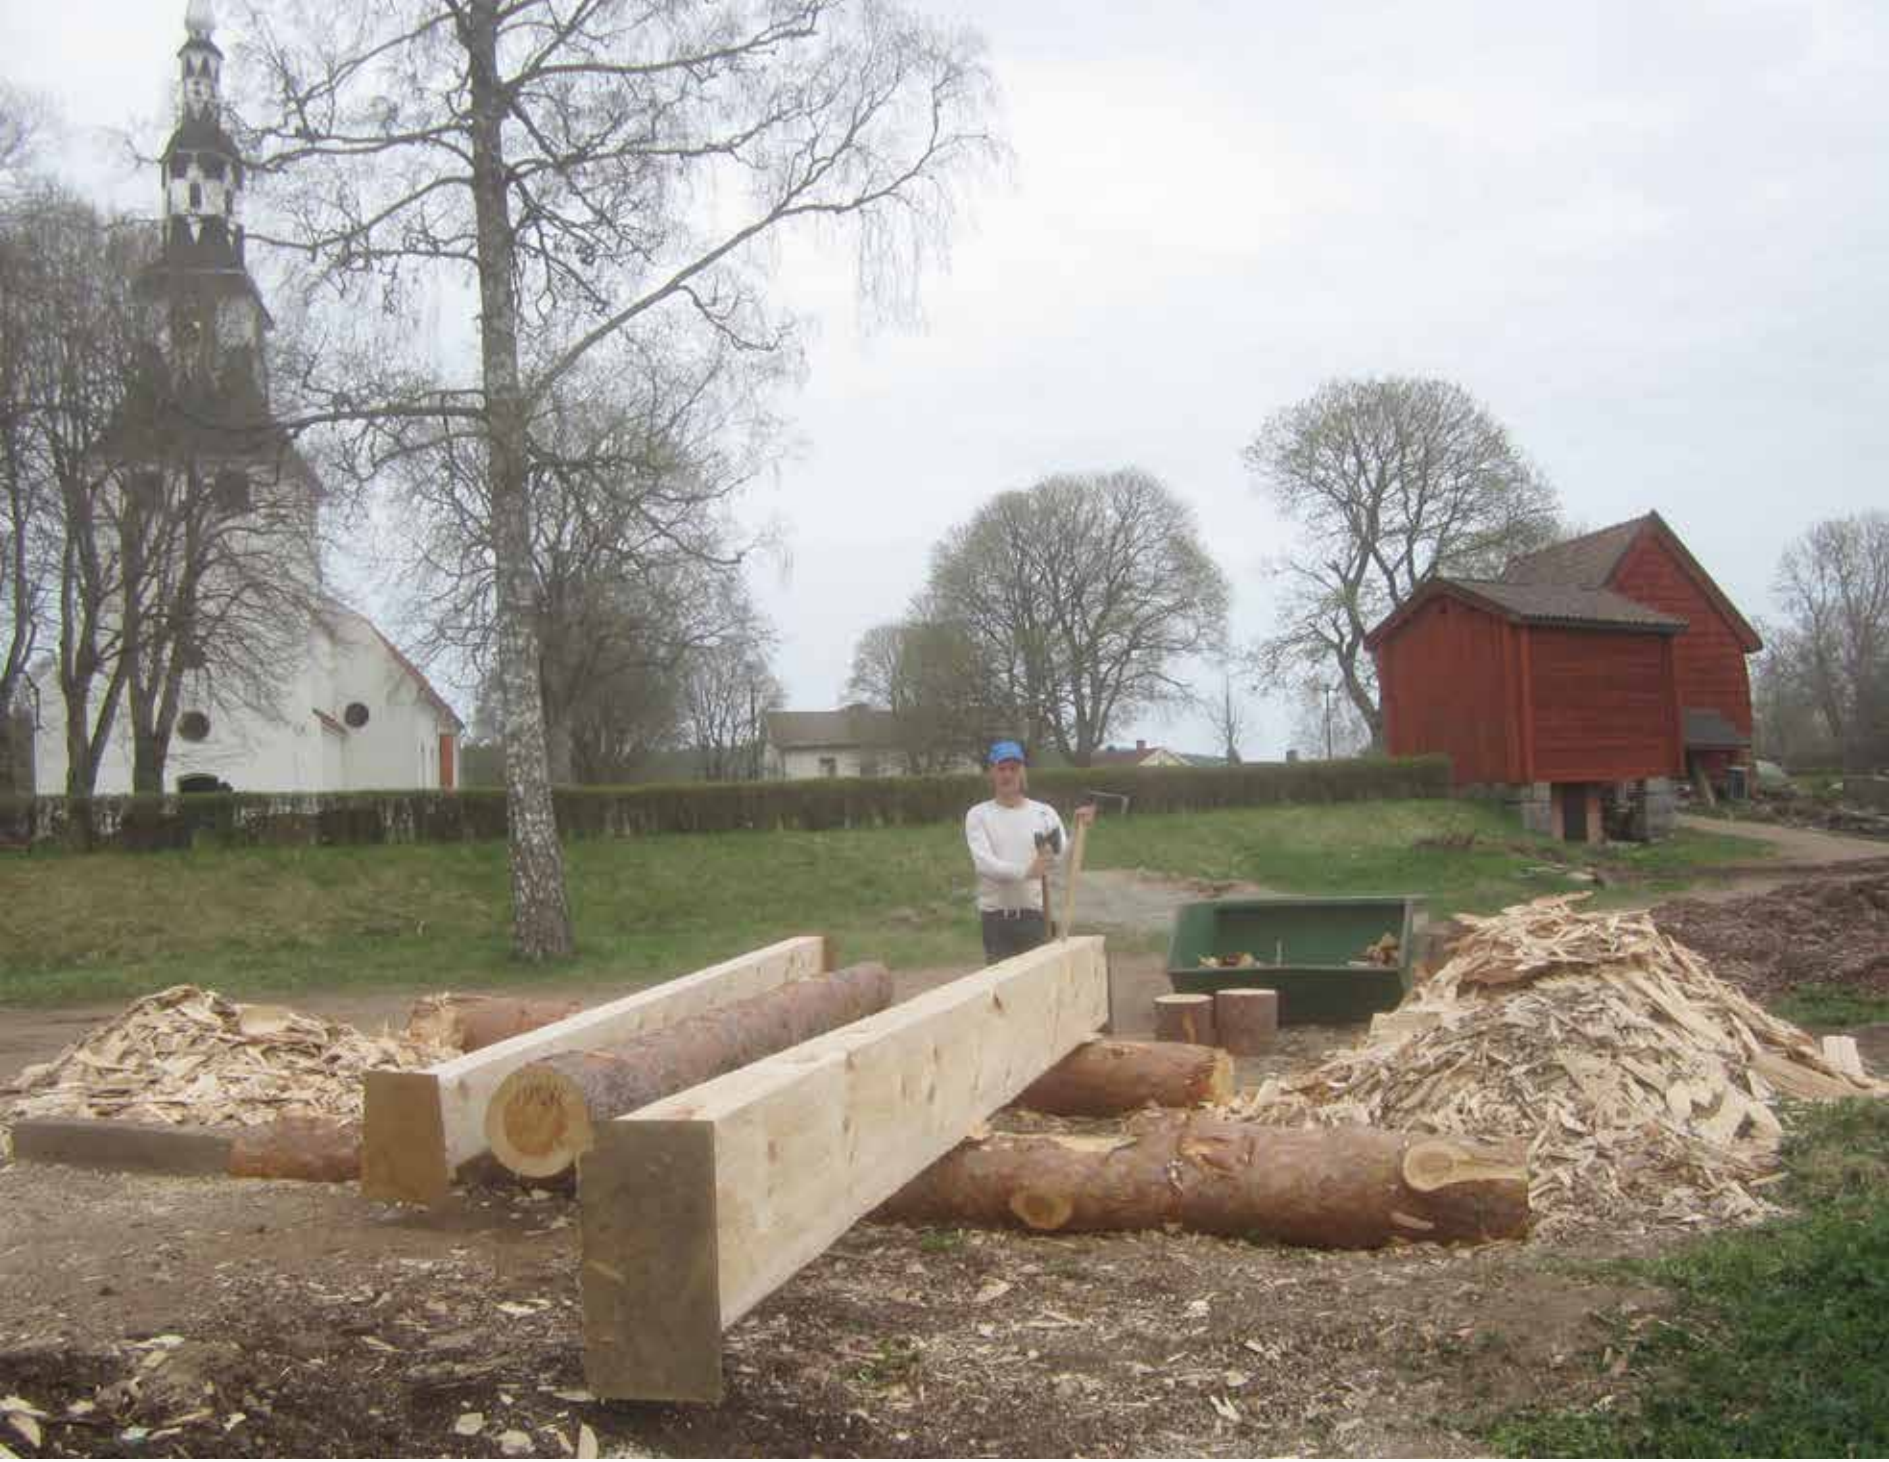
**Restoration.** Karl-Magnus Melin prepares a log for repair. The timber is cut in the parish forest, the trees selected to match the quality and hewed with historic axes and techniques.
