The Craftsmanship in Construction and Transformation of Historic Tower Campaniles

Mattias Hallgren and Gunnar Almevik

The Tower Campanile in Grevbäck

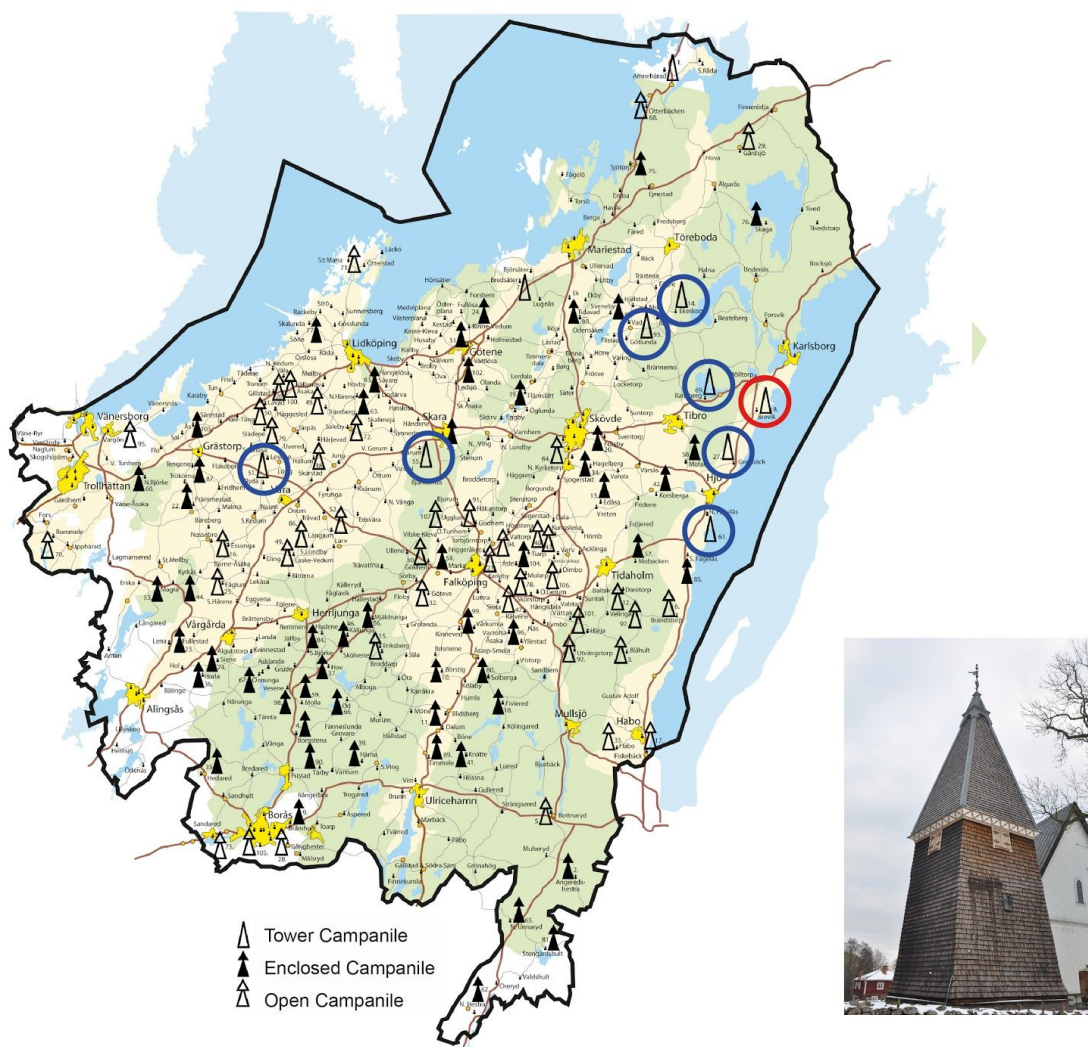
Fig 1. Mapping of campaniles in the diocese of Skara. Grevbäck is marked with a red ring. A preliminary date is set to 1303 but further dendrochronological analysis is in progress. Dated by dendrochronology are also: Brevik 1321-1336, Norra Fågelås 1360, and Ransberg 1383-1407. St. Levene, Marum, Vad and Ekeskog are considered to be medieval constructions. Illustration by Elisabeth Orebär Krantz.

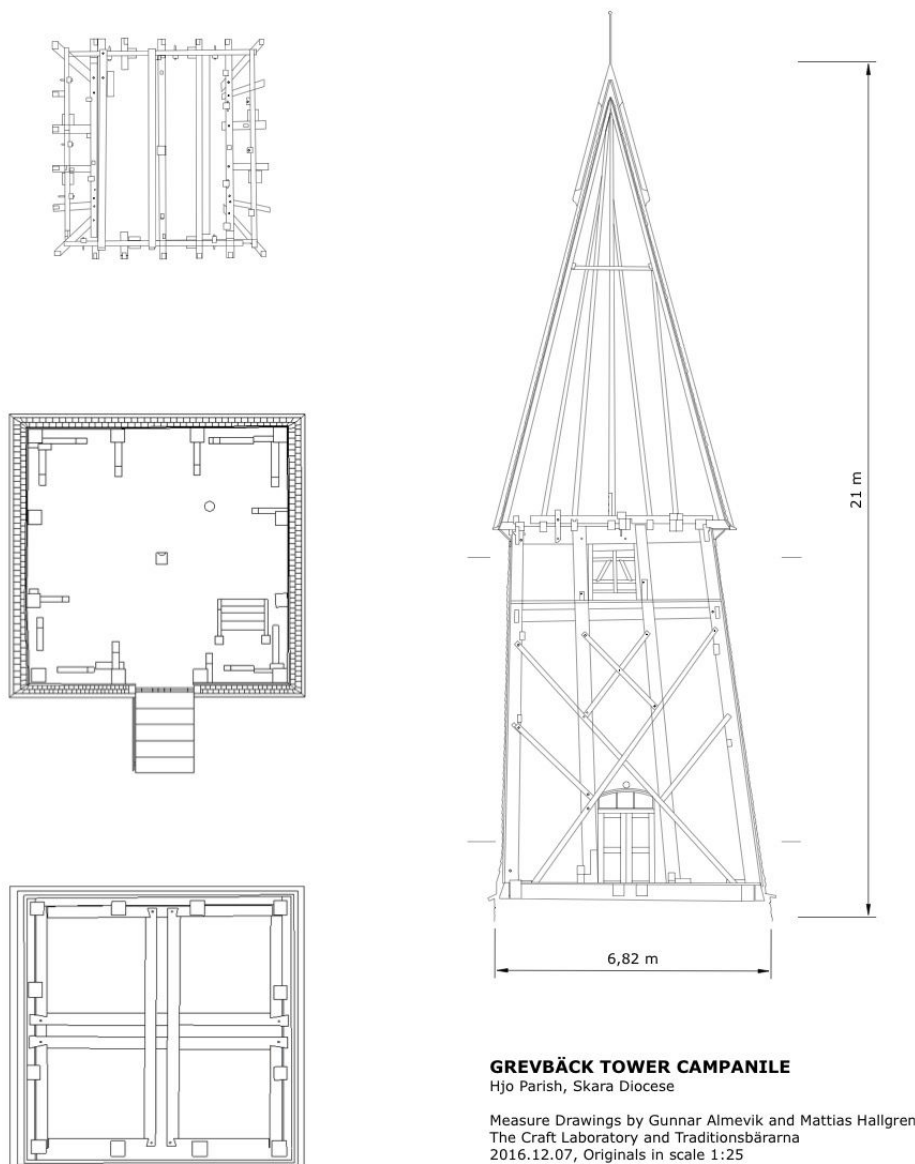
Fig. 3. Documentation drawings by Gunnar Almevik and Mattias Hallgren. Original scale 1:25.

The campanile is located north east of the church not more than four meters from the church walls. The location is the highest on the churchyard, and the campanile raises further 21 meters above the ground. The walls of the tower are leaning inwards and just slightly breaking the angle in the transition to a steep pyramid roof. The building is square with sides 6,3 meter on the ground and 5 meters by the eave. The walls as well as the roof are now covered with wooden shingles.

The construction is built of slowly grown pine and spruce. Pine is used in the timber frame construction and spruce in the truss. The dowels are both oak and pine. The constructive material is hewn into rectangular or square shapes with sharp edges. Beams, braces and the upper plates are cleaved in pairs of larger logs and hewn with sharp edges. The roof-carrying timber frame construction consists of 12 wall posts, 10.5 meters long and about 14x13” in cross-section. Each wall frame facing cardinal directions, consists of four posts connected with crossed diagonal beams and braces.

The wall posts are mounted in a sill and continue to the top plate. The sill is constructed with an inner and an outer ground plate clamping the pillars. In the middle of the campanile is a central post continuing with a mast to the rooftop. The post is 10,5x10,5” neatly hewn and shaped with climb steps and hand grips. This post was evidently the stair to the bell floor. The same type of mid post is found in the campaniles in Vad and Ekeskog.

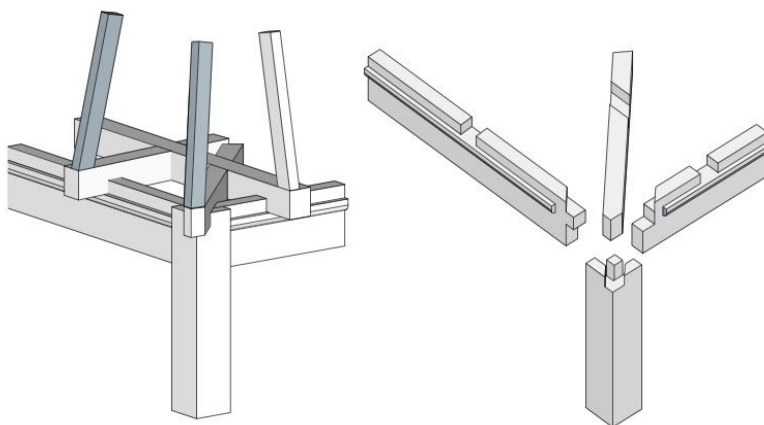
Top Plate Corner Joint

Fig. 4. Detail of the eave with top plate, bressumer and clamped soffit joists.

The bell floor system of joists are fit in a 3,5"x11" end up plate penetrating the wall posts. The plates are cleaved in pairs from a block and carry the four joists 6x5" in the bell floor. The pyramid roof spire rests on a bressumer connected to a top plate. Also the top plate 3,5x18" end up plate penetrates the wall posts. The system of joists to the roof are 6x8,5" and placed in the north and south upper plate. The joists make a 15" eave in north and south. To the east and west short soffit joists, clamped between the top plate plank and an outer bressumer, construct the eave.

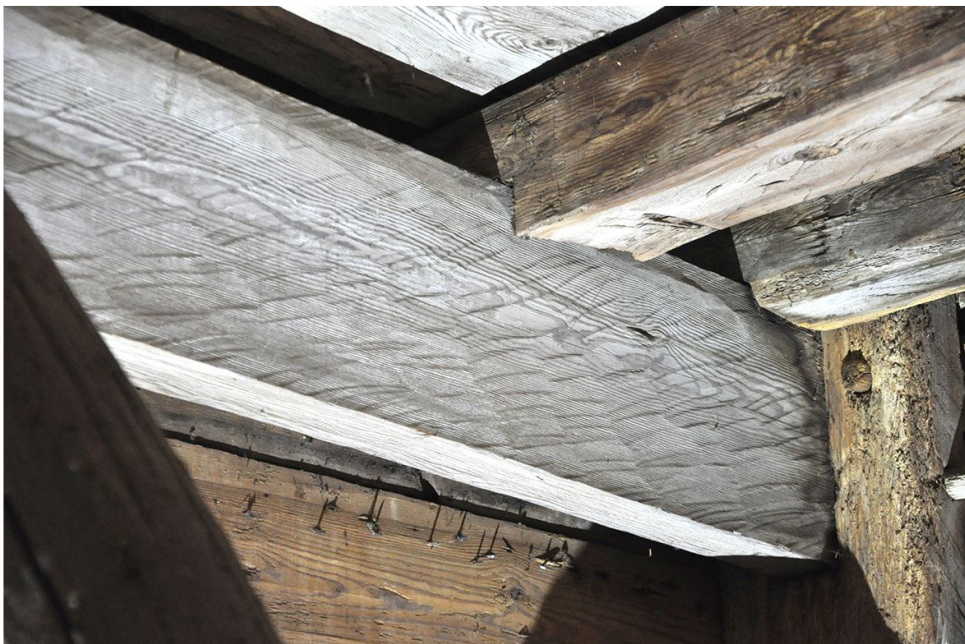
Fig. 6. Toolmarks from the particular hewing technique *sprättäljning*.

All material that is considered original is hewn in a particular technique, so called *sprättäljning*. The work process of hewing in parallel or diagonal bands along the wooden fibres is significant in mainland Sweden before the Black Death in late fourteenth century.[14] The clamped sill that is considered secondary, has marks from a broad axe cutting the fibres in perpendicular angle. Another significant quality of the original construction material is the boxed shape and the sharp edges. This quality is consequent and must have been a norm in the historic building process. The dimensions however vary from root end to top and within the same type of construction material. The edges are always sharp but the shape may be rhombus and the surfaces concave.

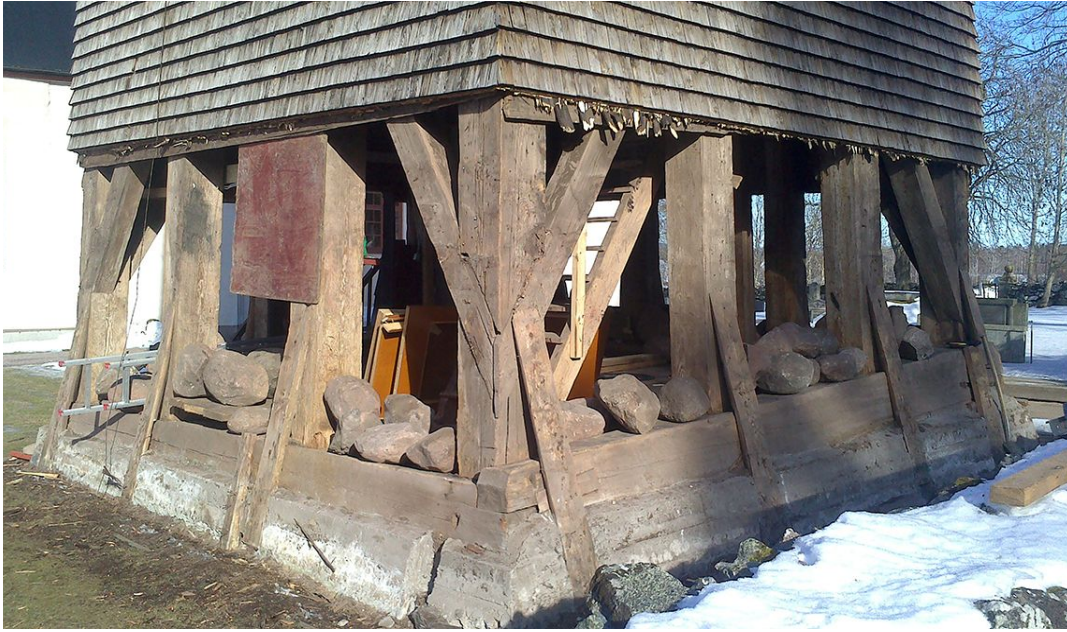
Fig 7. Ransbergs tower campanile. The secondary clamped sill with inner and outer plates.

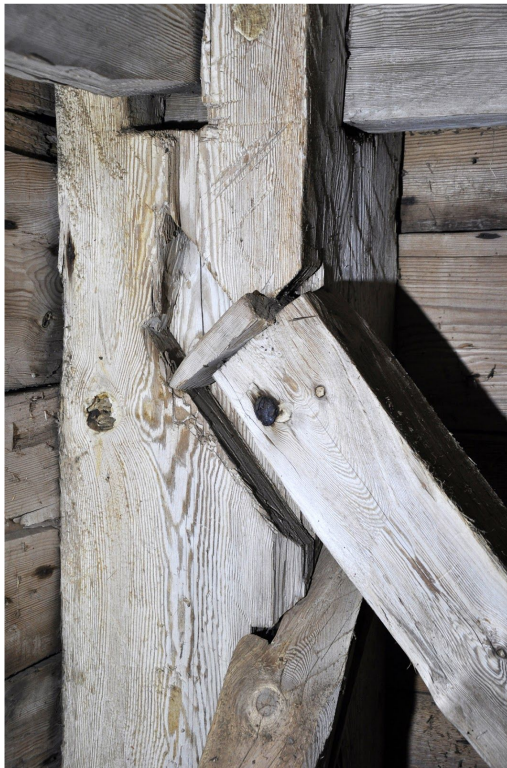
Fig 8. The north east corner post.

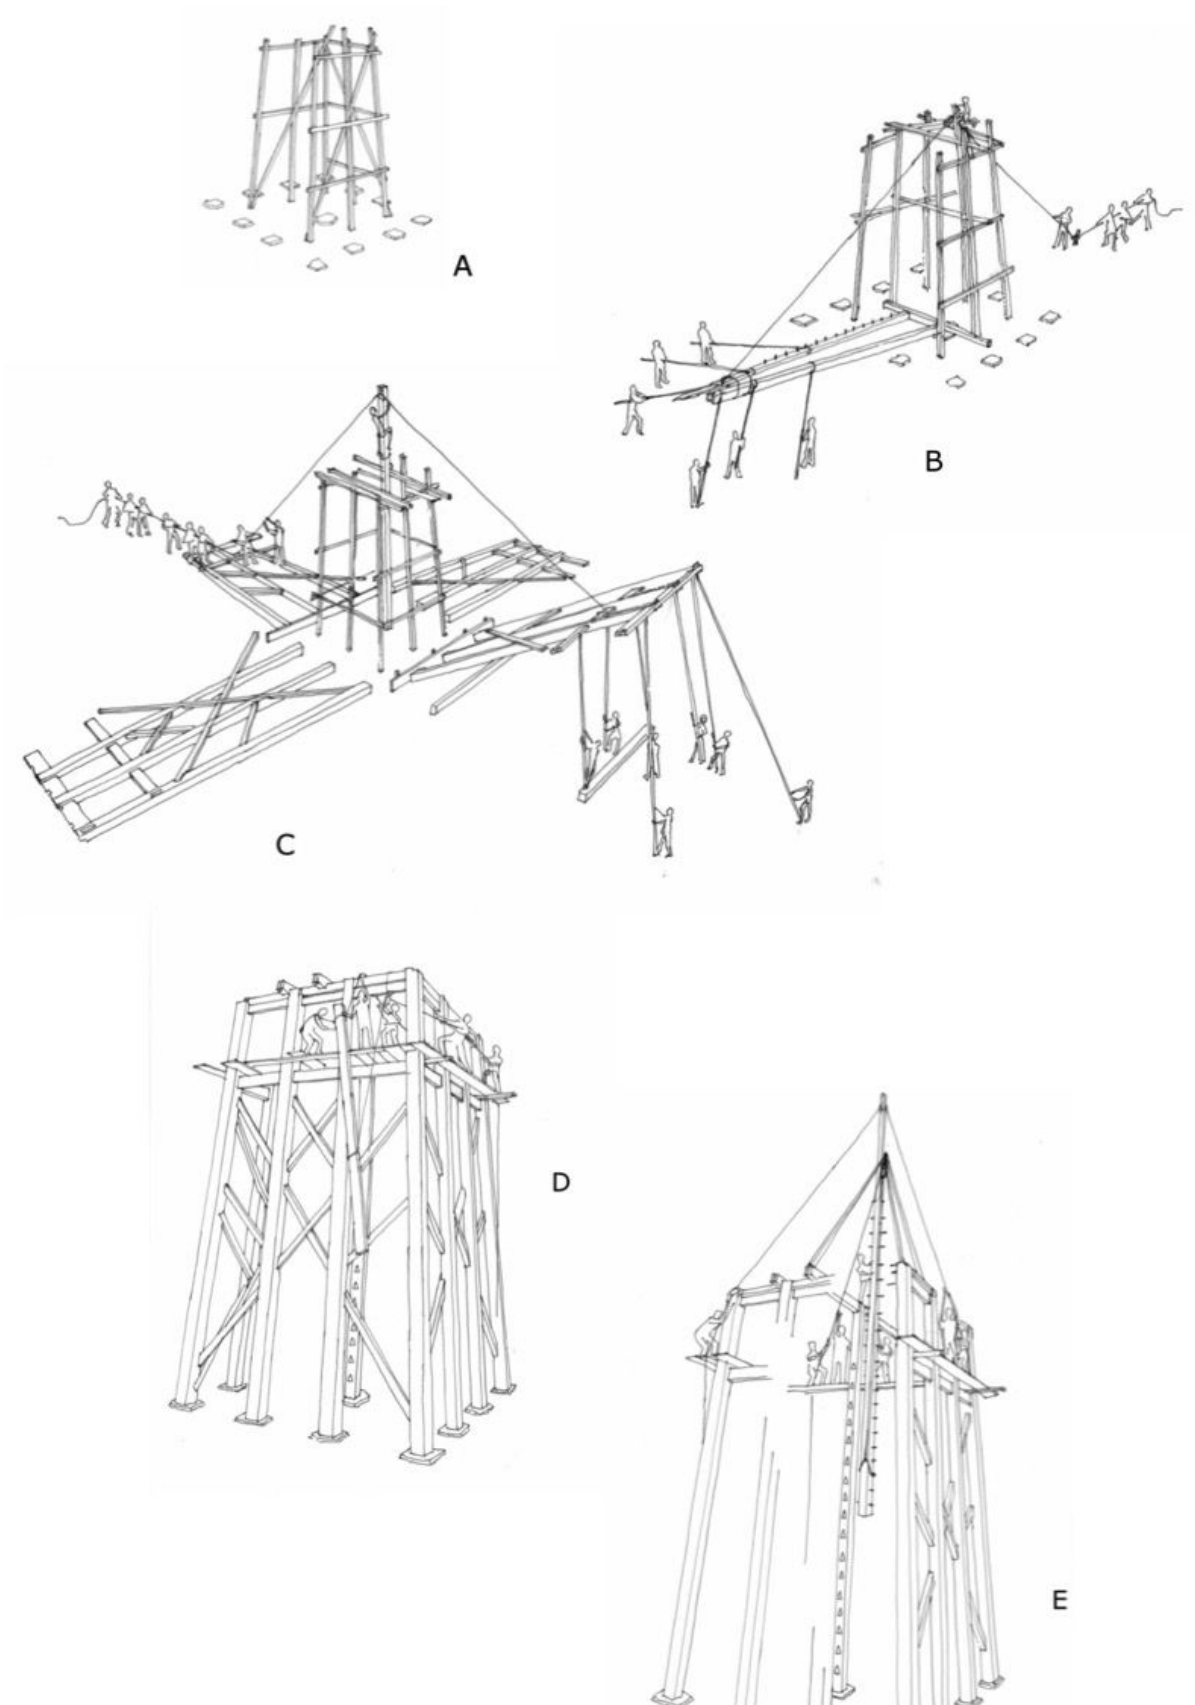
Fig 9. Illustration of the erection process step by step. Illustrations by Gunnar Almevik and Mattias Hallgren.

The wall frames were erected clockwise. Each frame had one corner post and the mid posts fixed with crossed diagonal beams and braces and the upper plates in place. They started with the east wall frame, continuing with the south, to the west and finally the north.

Already when the craftsmen had raised the western wall frame they realized the problems coming, whereat they had to do adjustments. Pre cut joints that were never used are revealing the mistake. When the last north wall frame was erected, the precut joint did not fit and a new joint have been cut at the spot. The rough character and the use of nails also indicate that this is what happened.

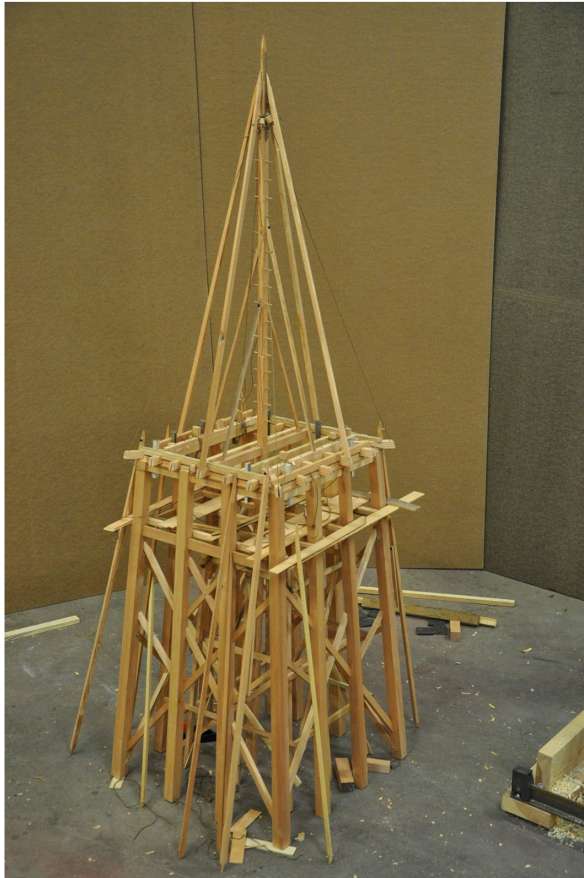
Fig. 10 The model in scale 1:10.
