Carpentry art, excursion to England

The search for comparison of Scandinavian craftsmanship in medieval English carpentry art

This PM is the result of a carpentry art excursion made by Karl-Magnus Melin and Mattias Hallgren in april 2017. Karl-Magnus works as a carpenter and craft researcher at Knadriks Kulturbbygg, is project leader for the diocese project Historic carpentry art in the diocese of Lund and is a doctoral student at the University of Gothenburg.

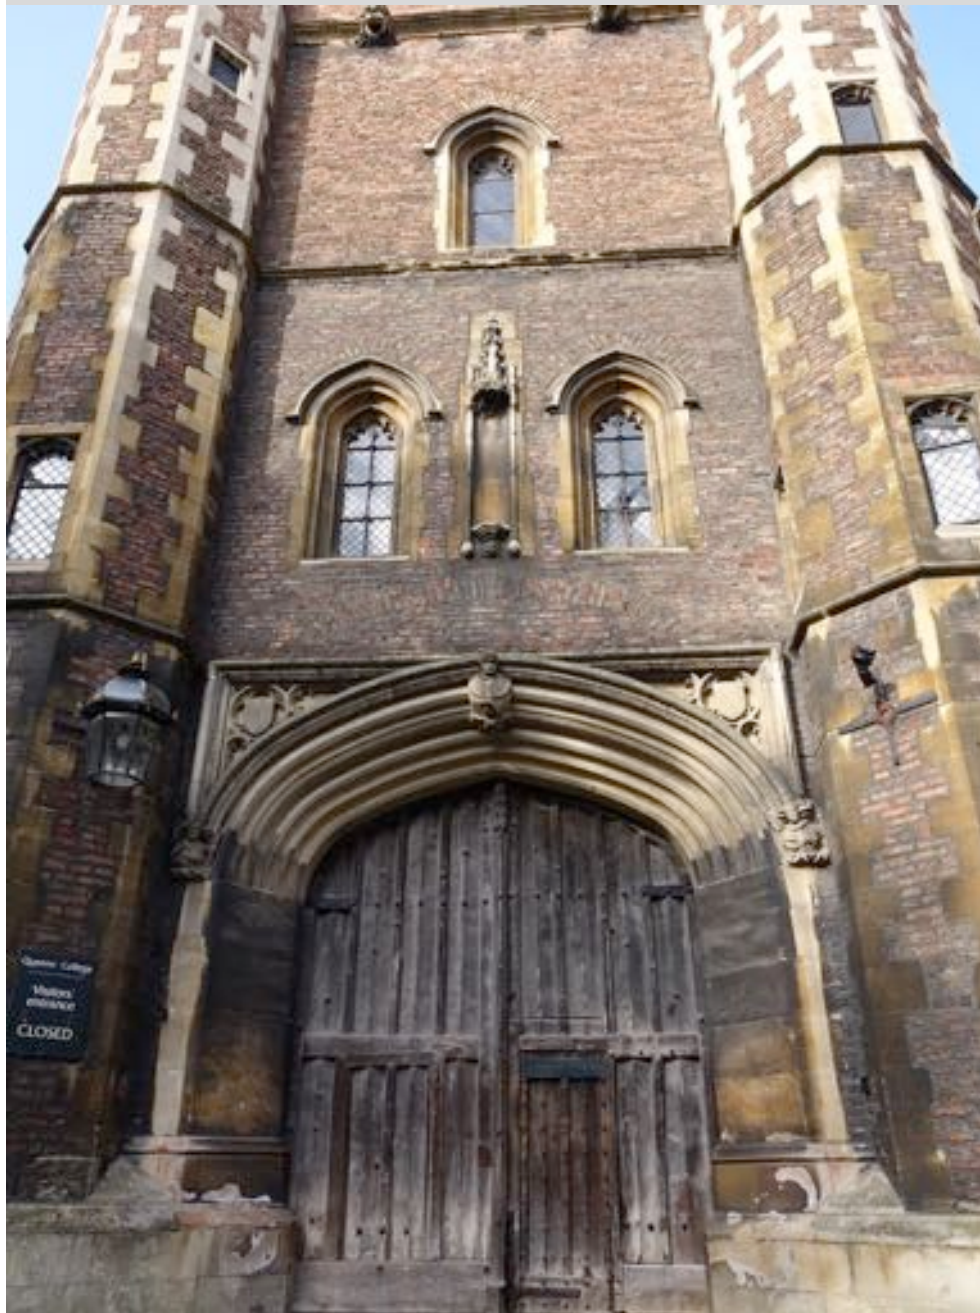
Below, the entrance door to Queens College, one of many medieval doors we examined during this trip.

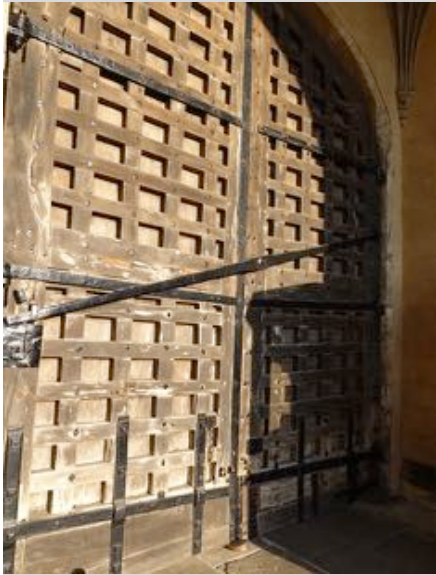
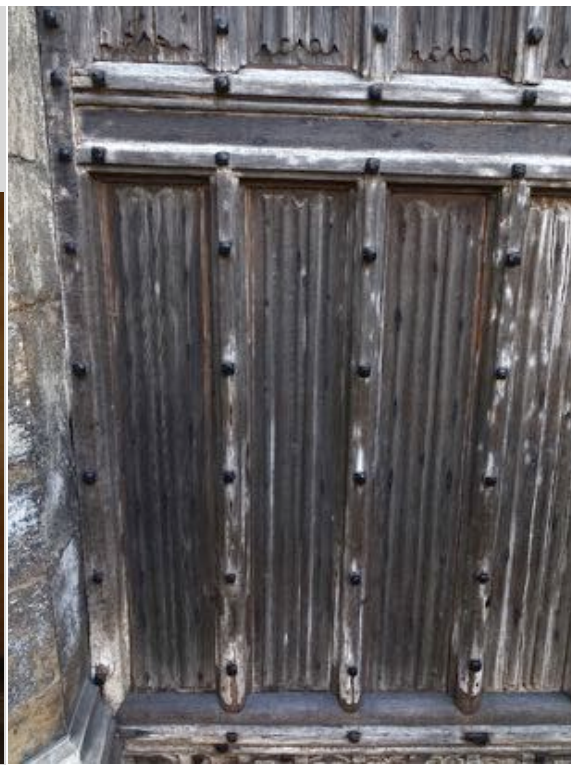
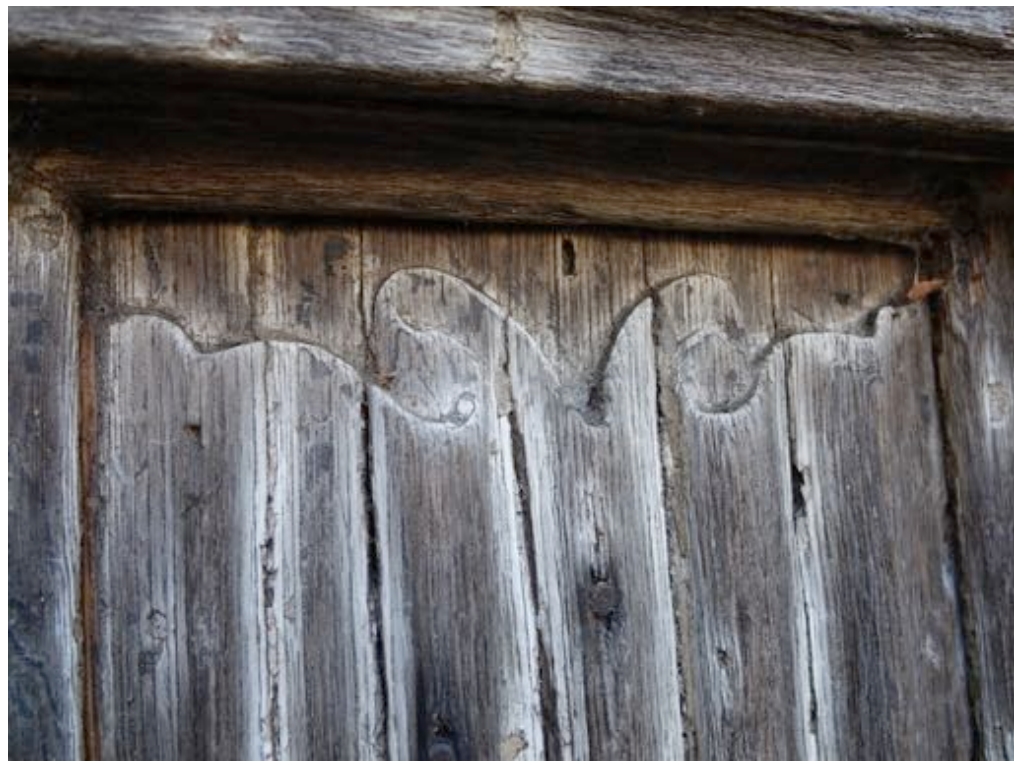
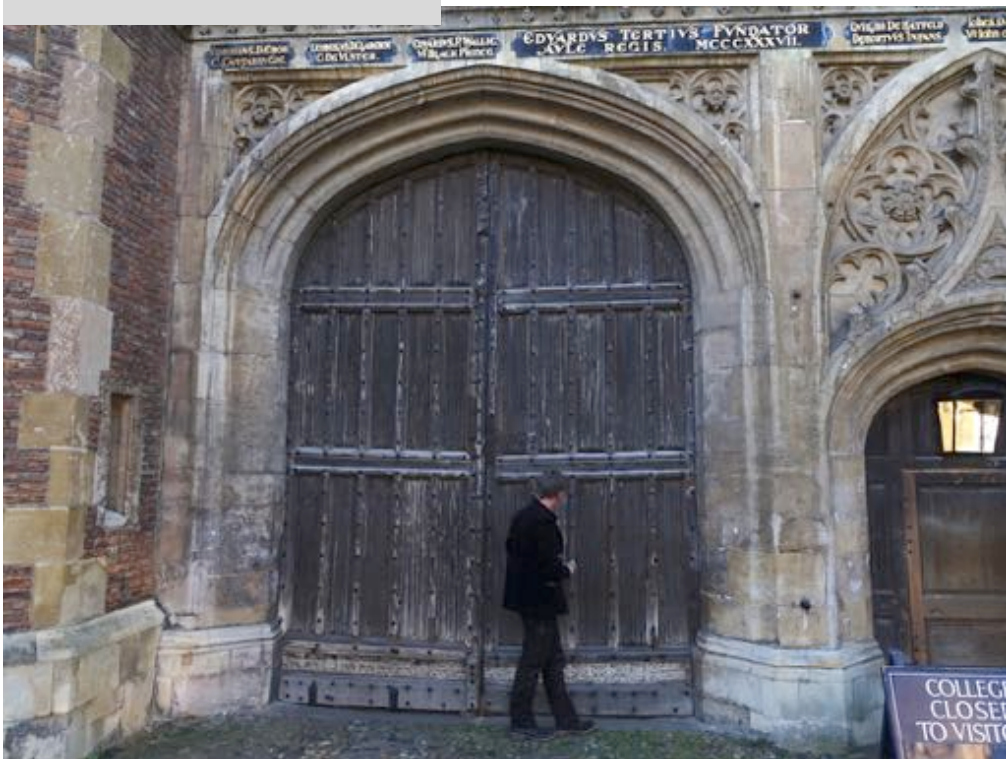
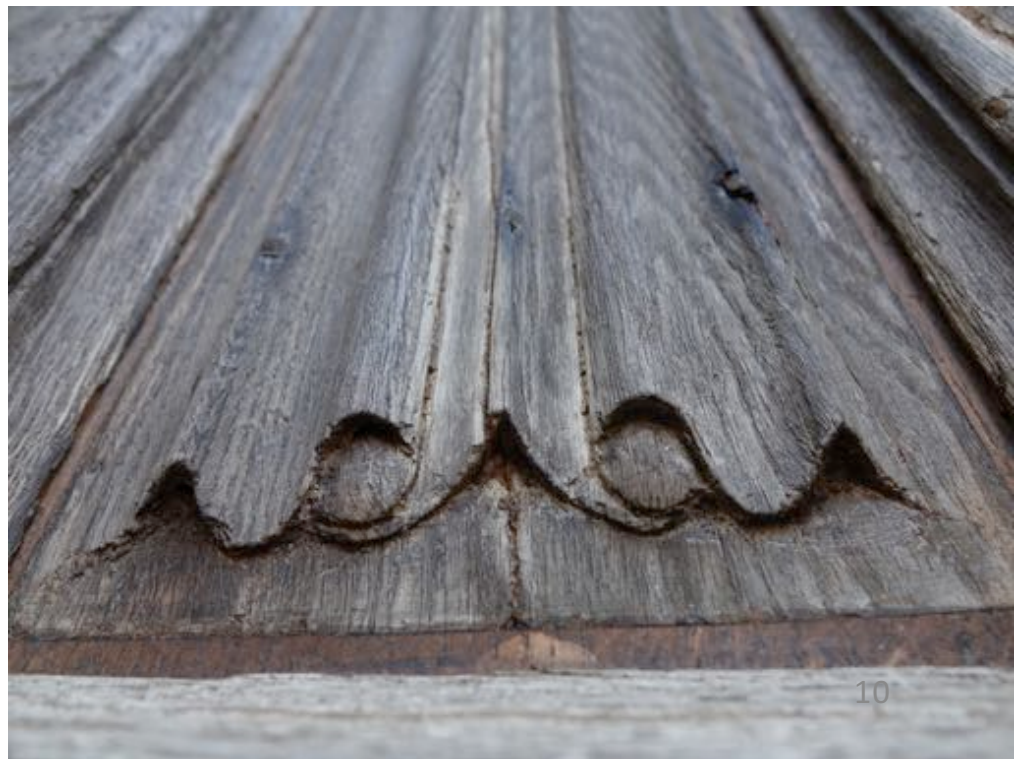
At Trinity college there was another medieval door with very fine woodwork. For more info see Yeomans et al 2013.

Yeomans, David, et al. (2013). Repairing a Medieval Door. In Advanced Materials Research, Vol. 778, pp. 739-746, 2013

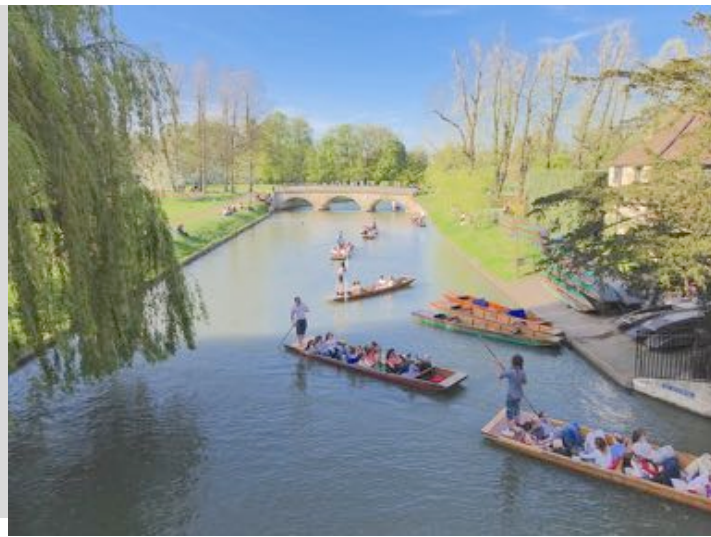
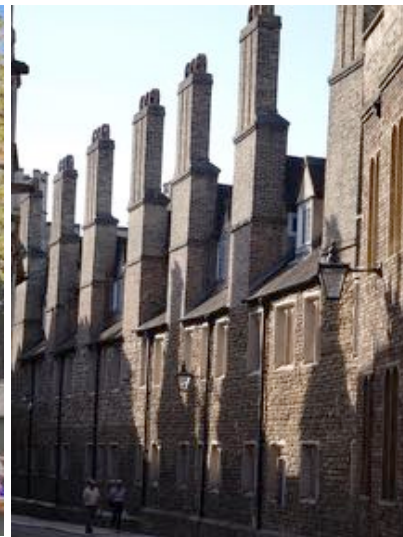
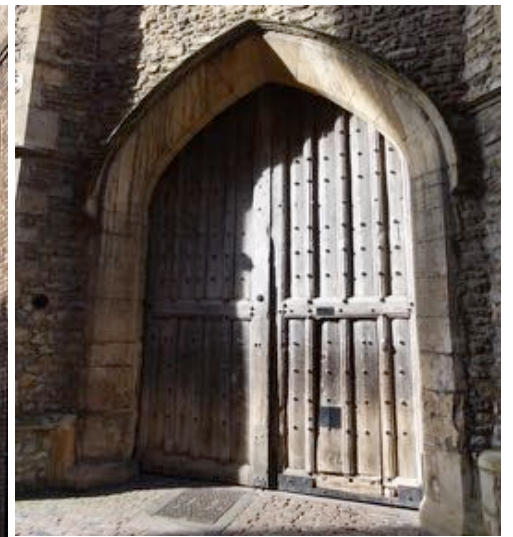
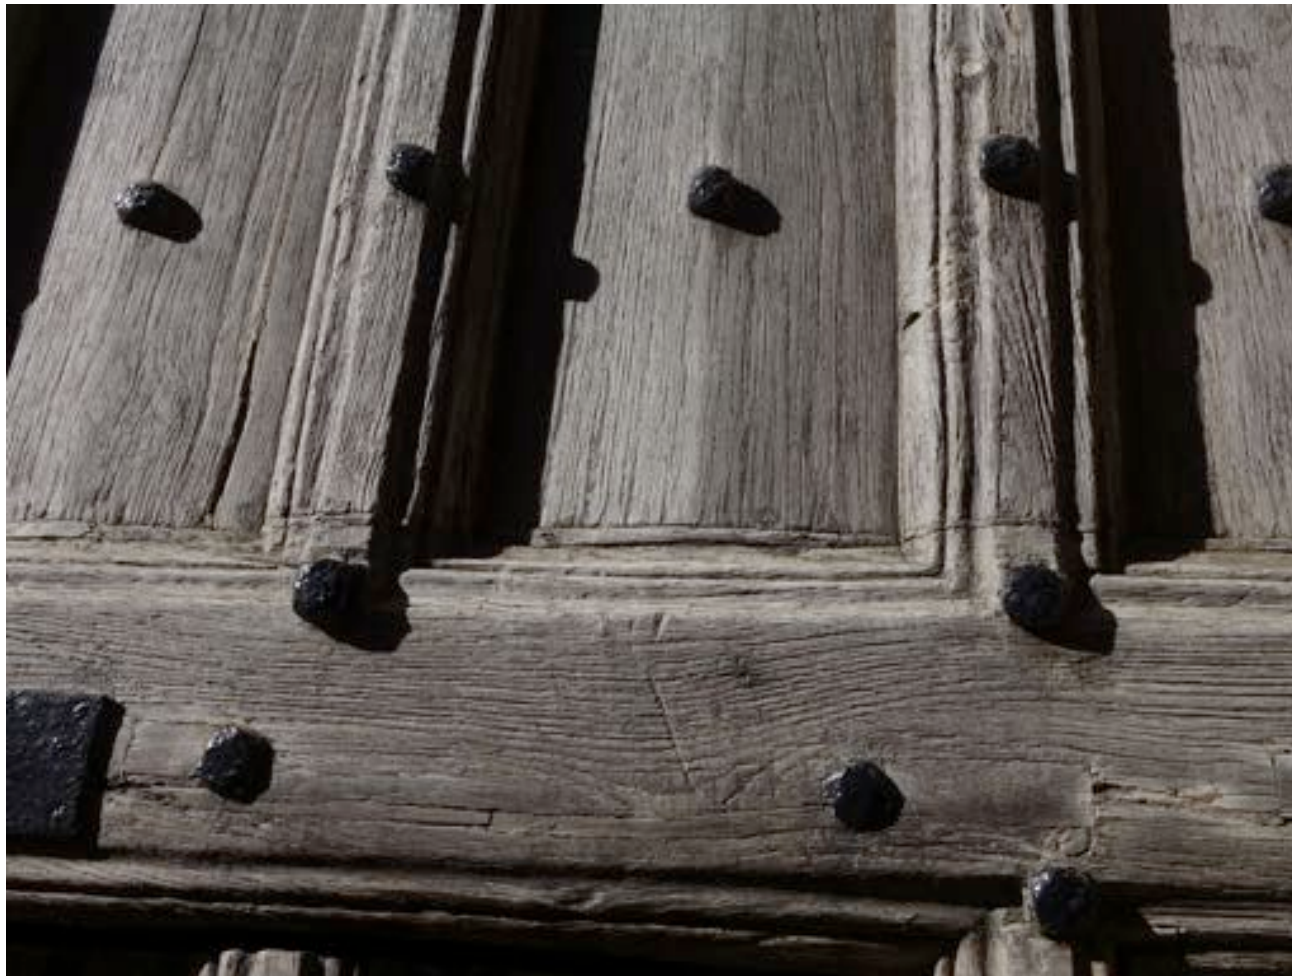
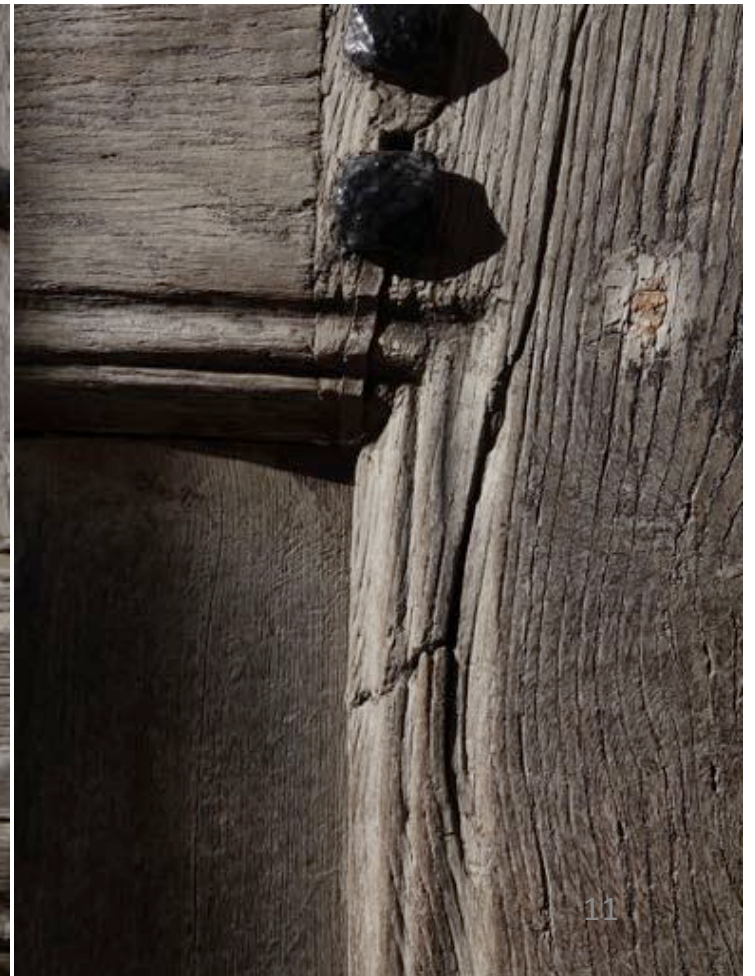
Yet another interesting door on the backside of Trinity college, next to the beautiful Trinity park.

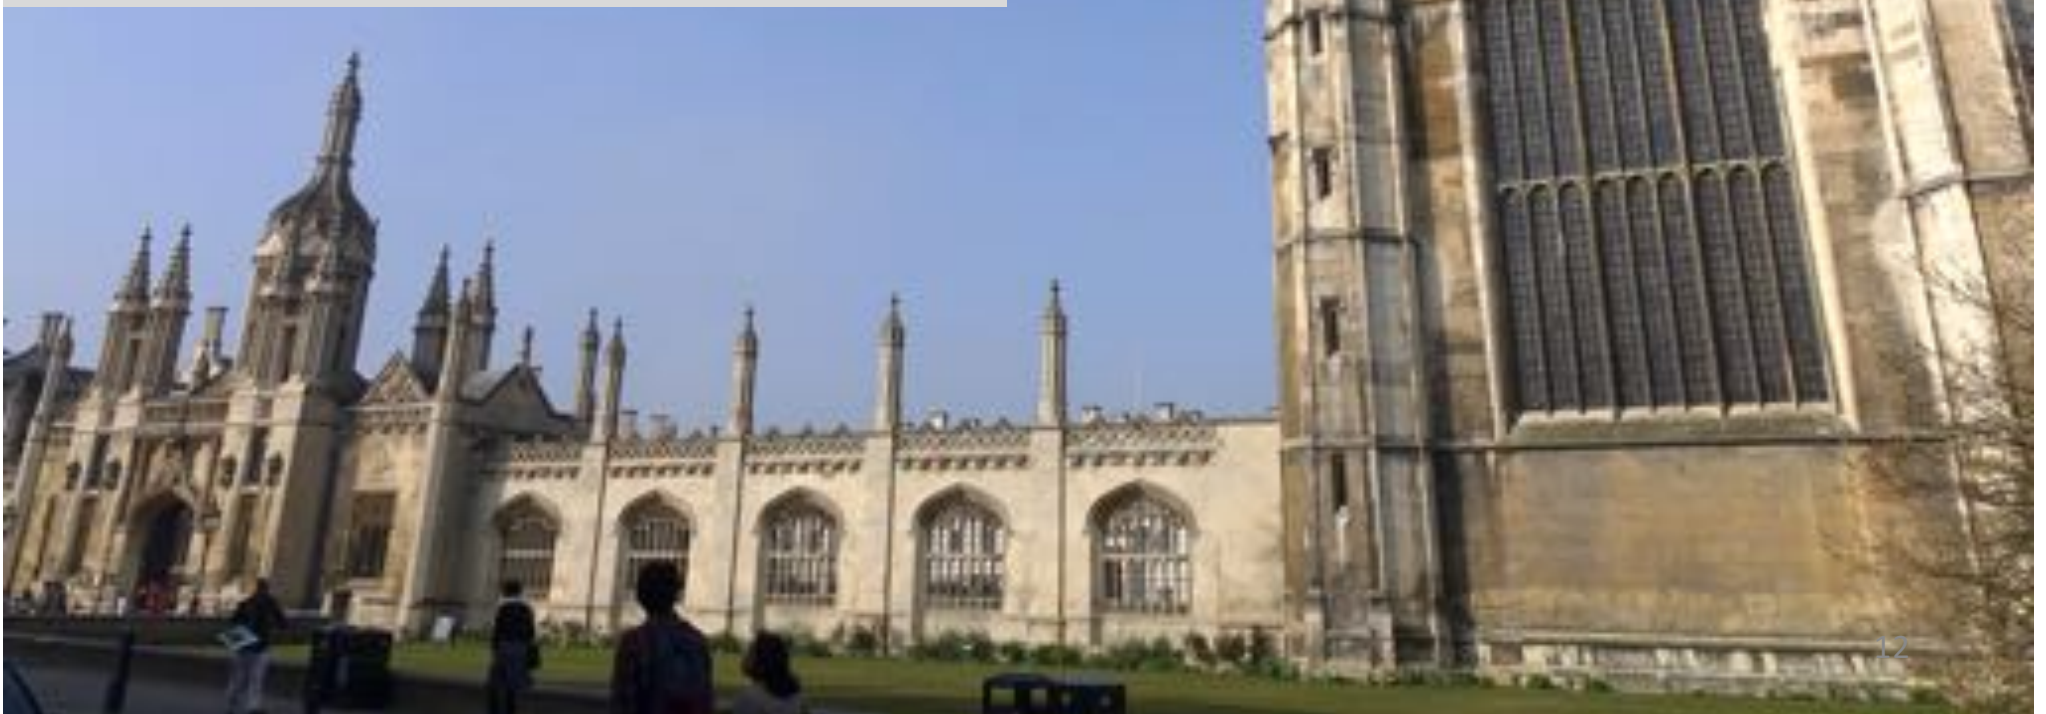
The chapel of Kings College in Cambridge with its famous inner roof.

It has the largest fan vault in the world and some of the finest medieval stained glass.

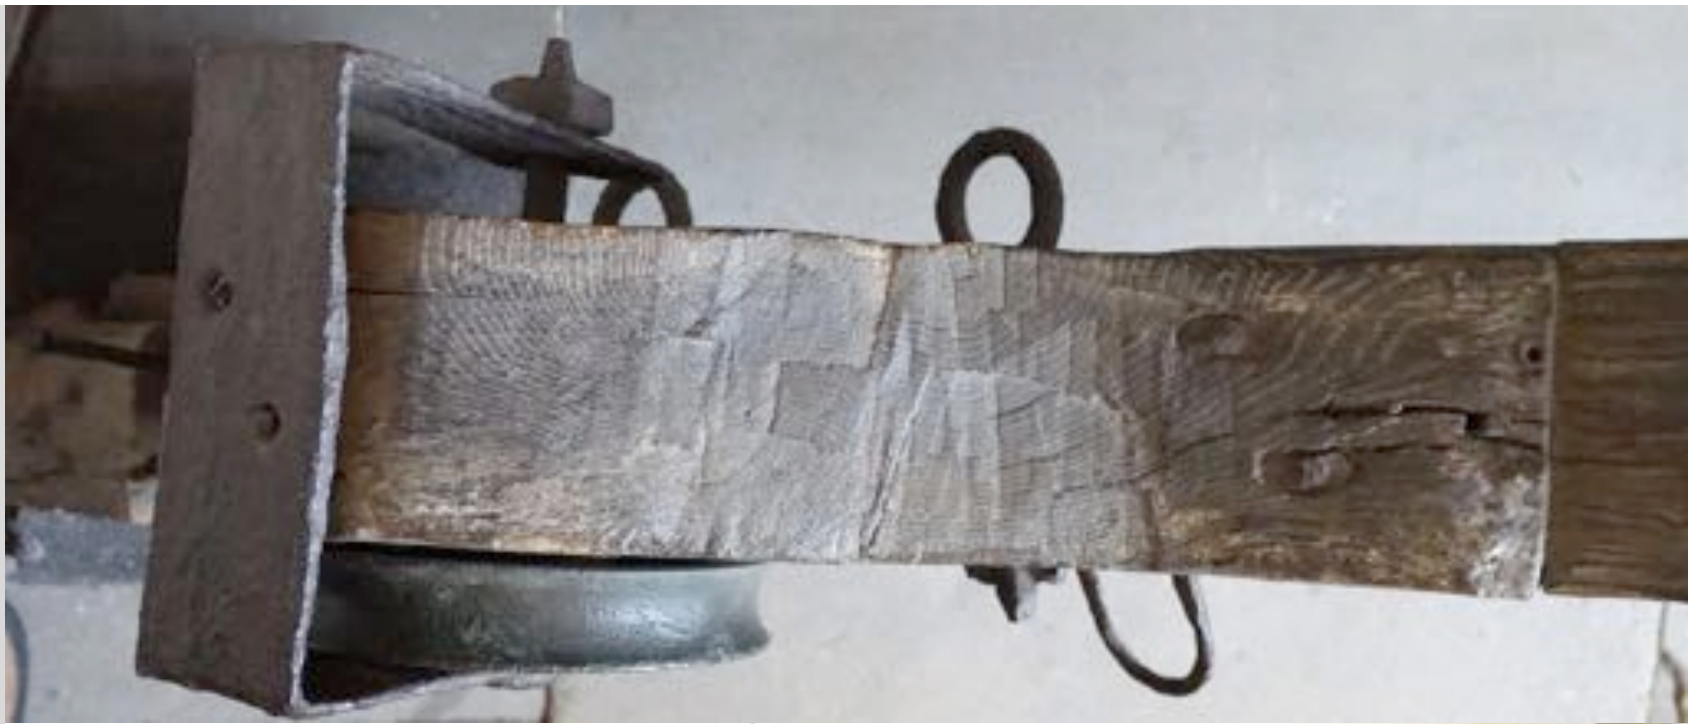
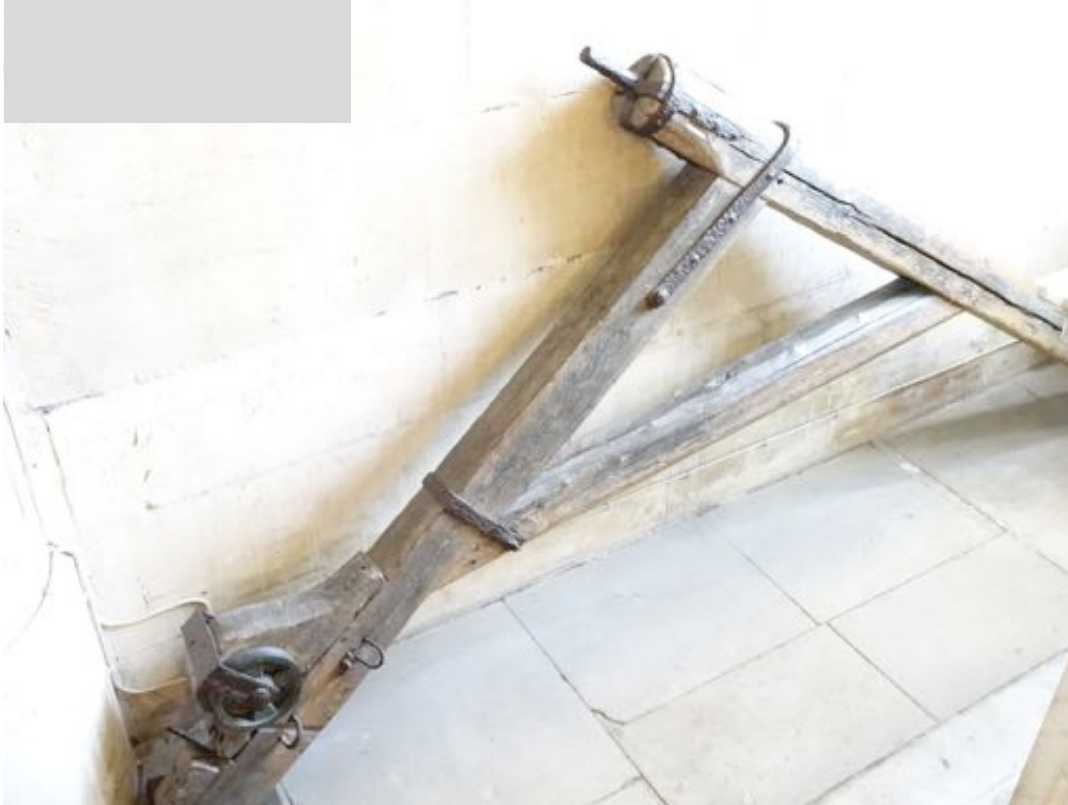
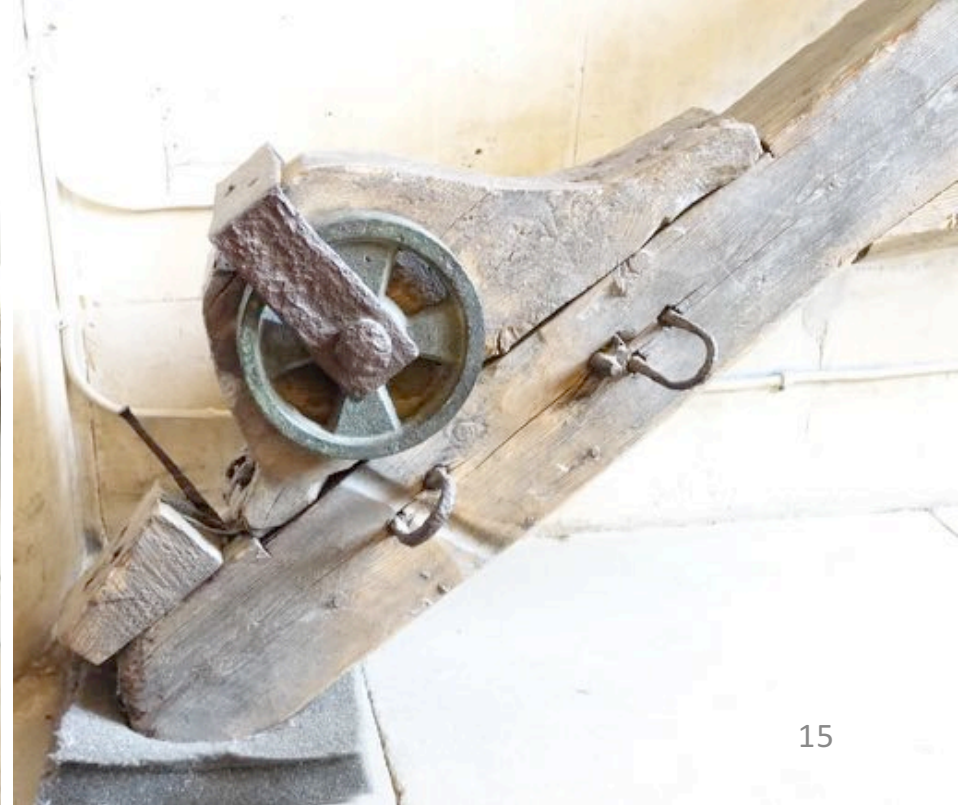
An old lifting device, a faucon, has been saved. According to Cecil Hewett the faucon might be from 1510 when work was carried out on the chapel, (Hewett 1985:192). It has a casted bronze wheel.

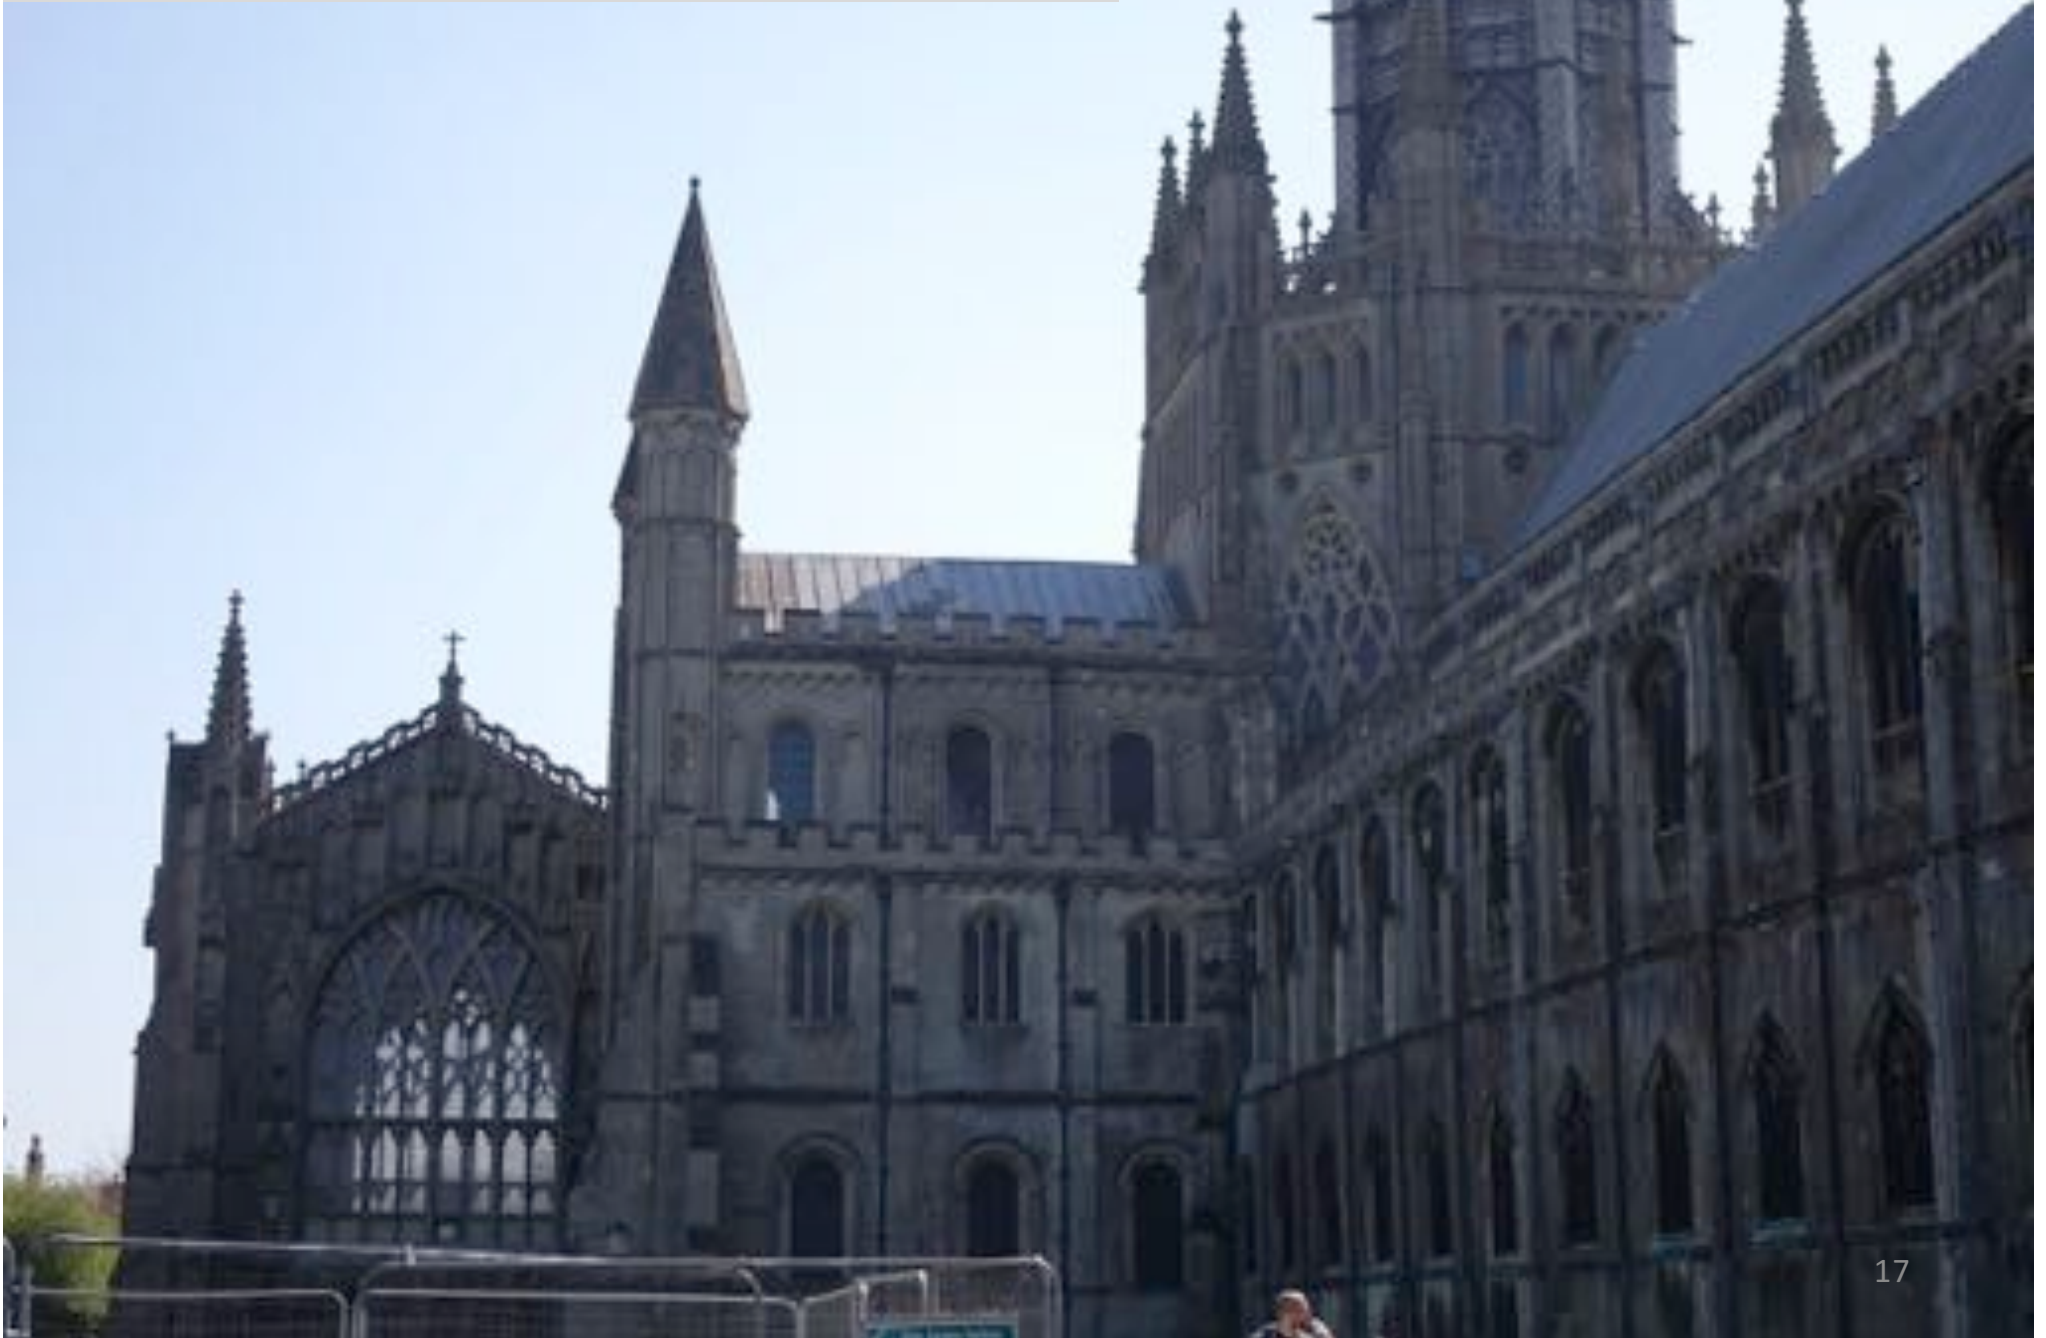
The last day at the CHS conference there was a trip arranged to the cathedral of Ely. It has a lantern with an inner vault made of 200 ton oak covered by 200 ton lead on the outside. The church was built in 1083-1109. The octagon collapsed 1322 and was rebuilt and completed in 1340 (Hewett 1985)

We tried to examine the counter rebated doors, but they were huge and we couldn't find any tool marks in the lower part, which had been restored.

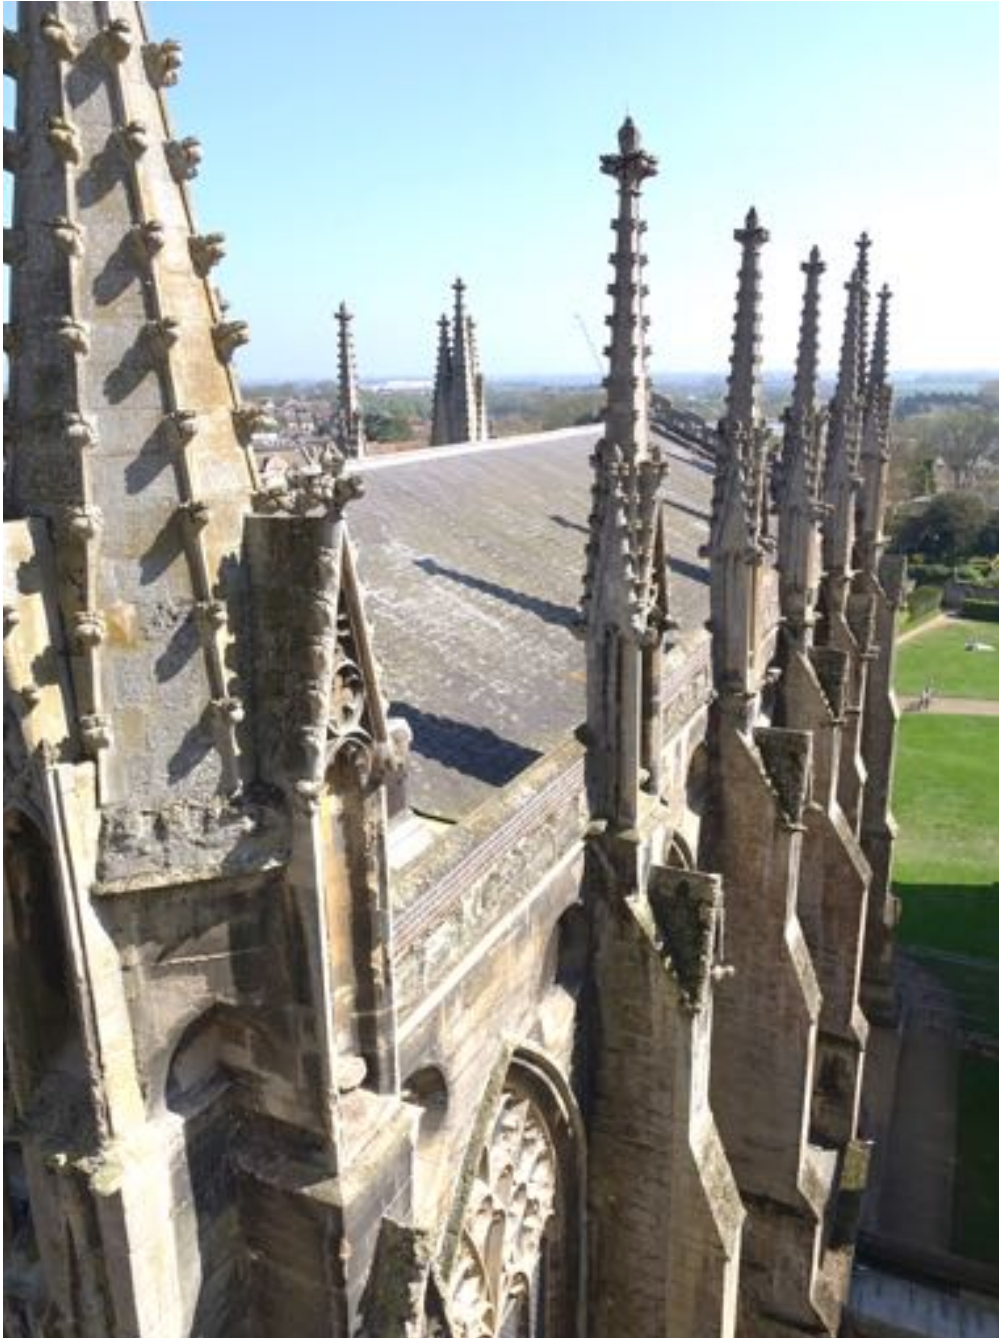
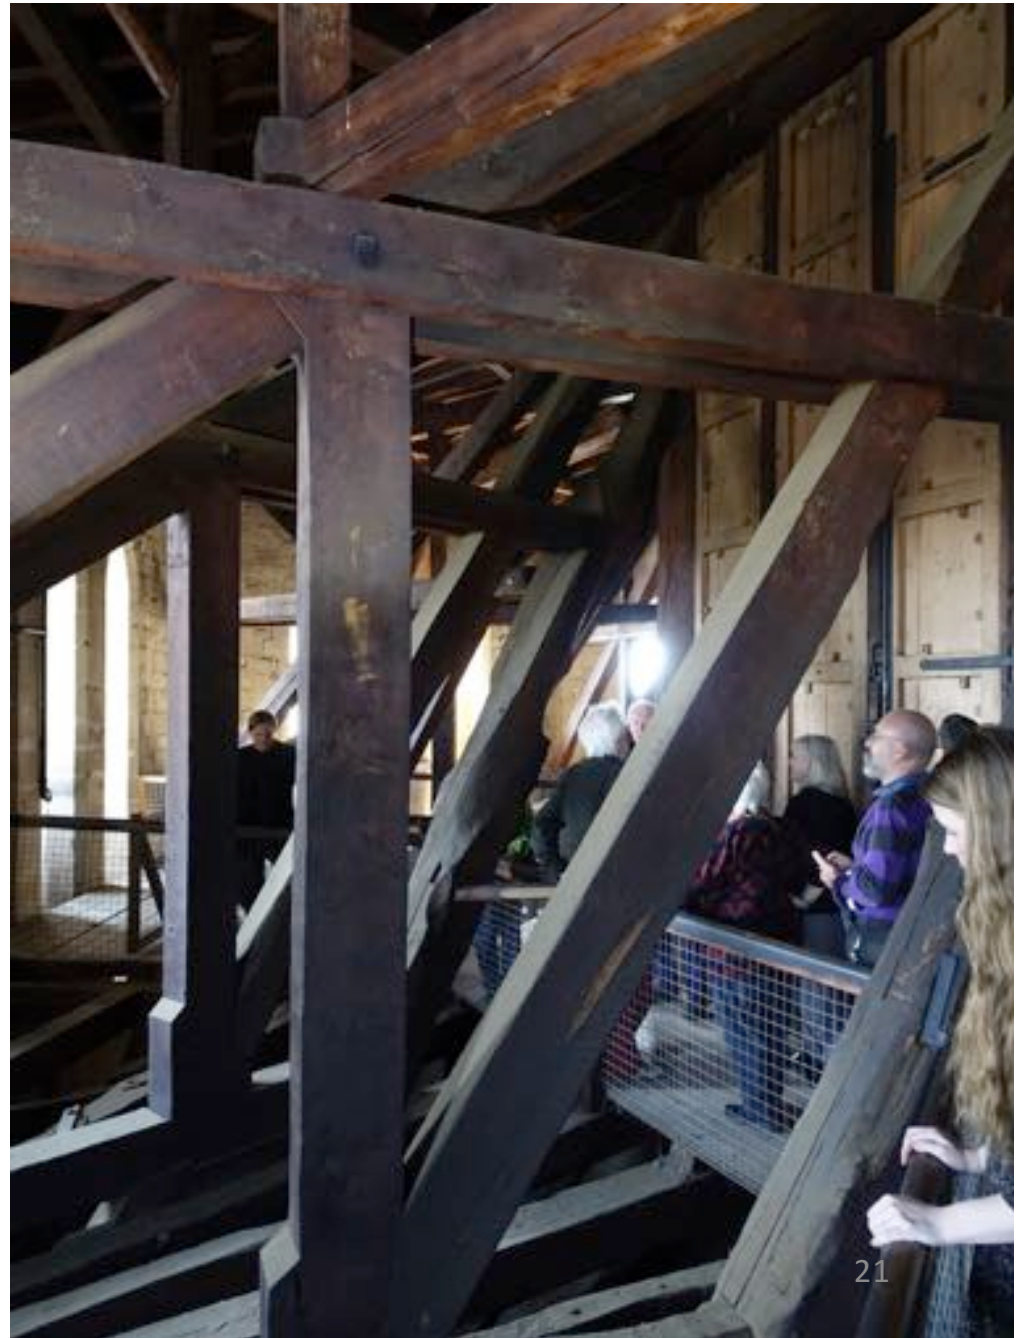
To reach the lantern we had to climb the outer roof. To the left, Lady chapel looking east.
To the right, the structure of the lantern. Many parts had been replaced in the original wooden construction. There was limited access so we had to quickly find out which pieces were the oldest and most interesting ones for our questions

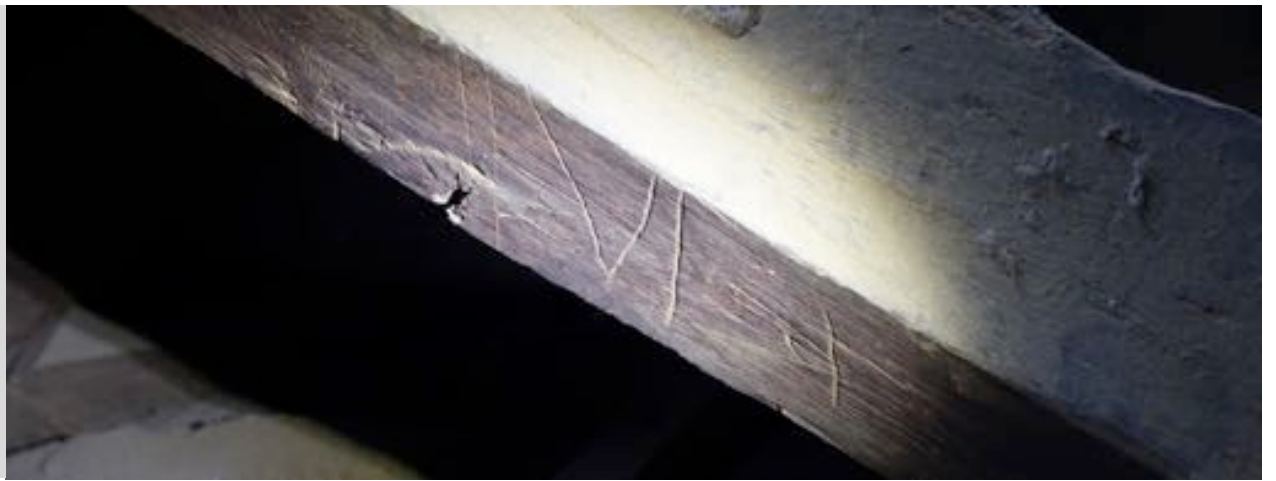
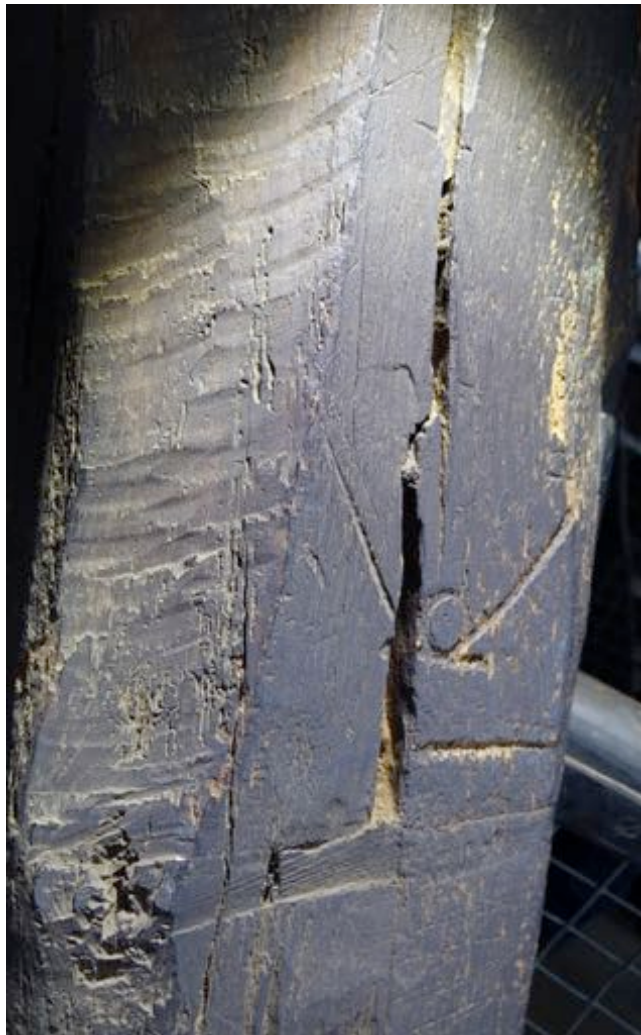
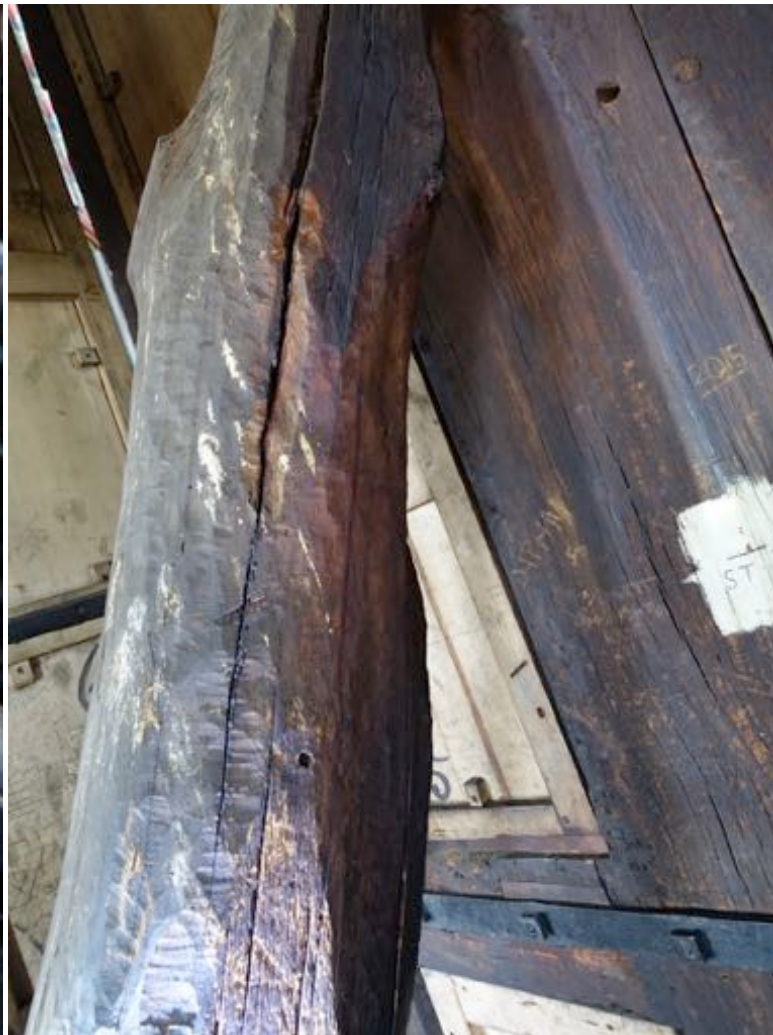
We had looked at Cecil Hewetts drawings of the wooden construction and knew there were assembly marks done with race knife, (Hewett 1985).

The timber in the Ely lantern is hewn with a straight edged broadaxe. The surface is very smooth. A fine work.

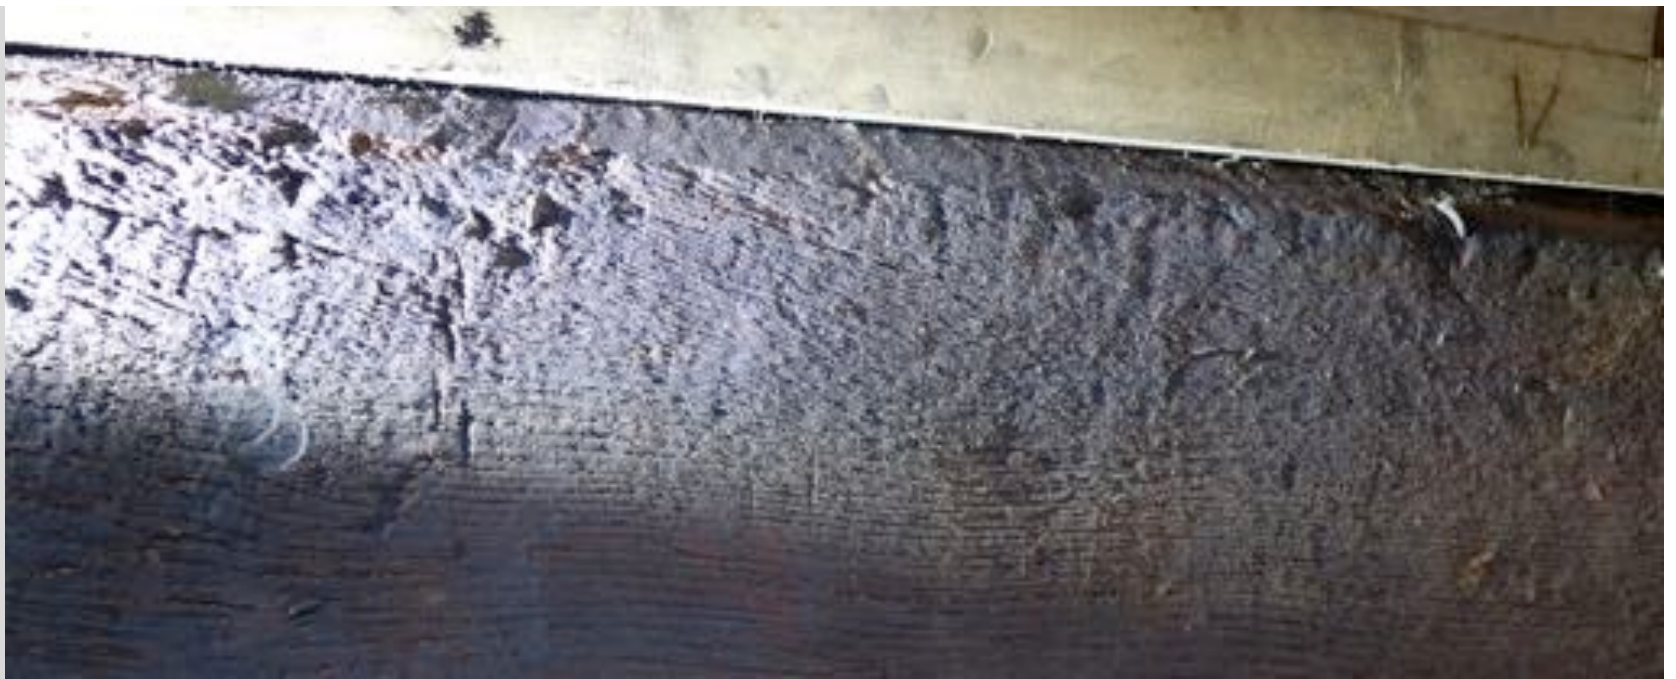
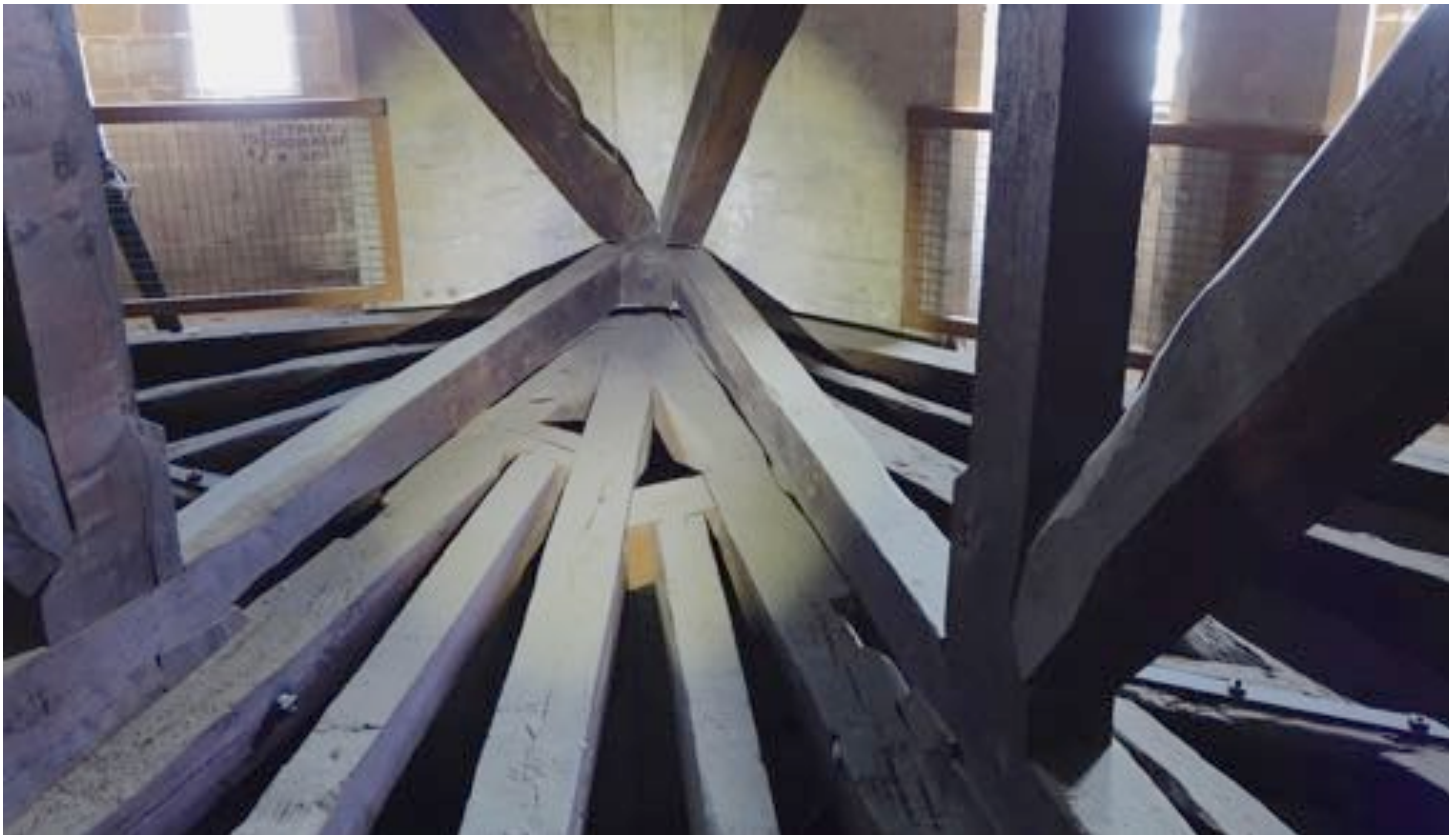
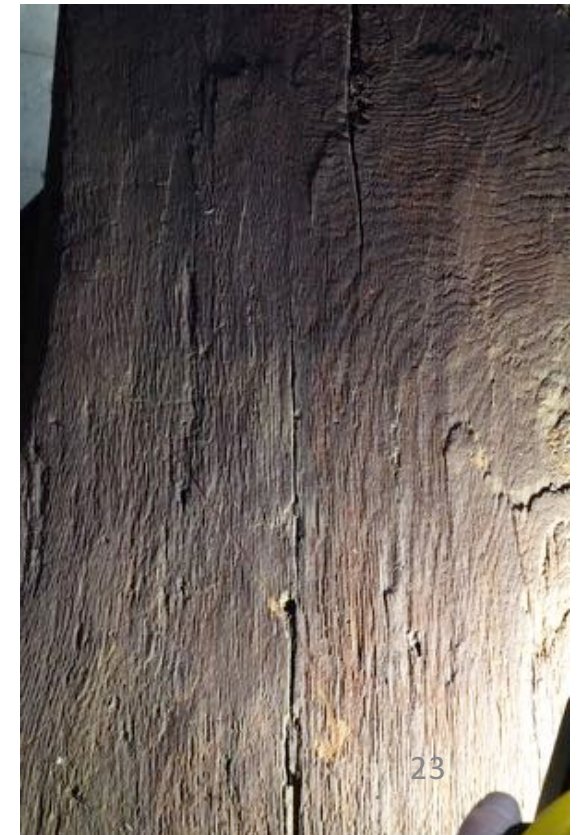
Picture below, showing a mix of old and new beams together.
