Carpentry art, excursion to England

The search for comparison of Scandinavian craftsmanship in medieval English carpentry art

This PM is the result of a carpentry art excursion made by Karl-Magnus Melin and Mattias Hallgren in april 2017. Karl-Magnus works as a carpenter and craft researcher at Knadriks Kulturbbygg, is project leader for the diocese project Historic carpentry art in the diocese of Lund and is a doctoral student at the University of Gothenburg.

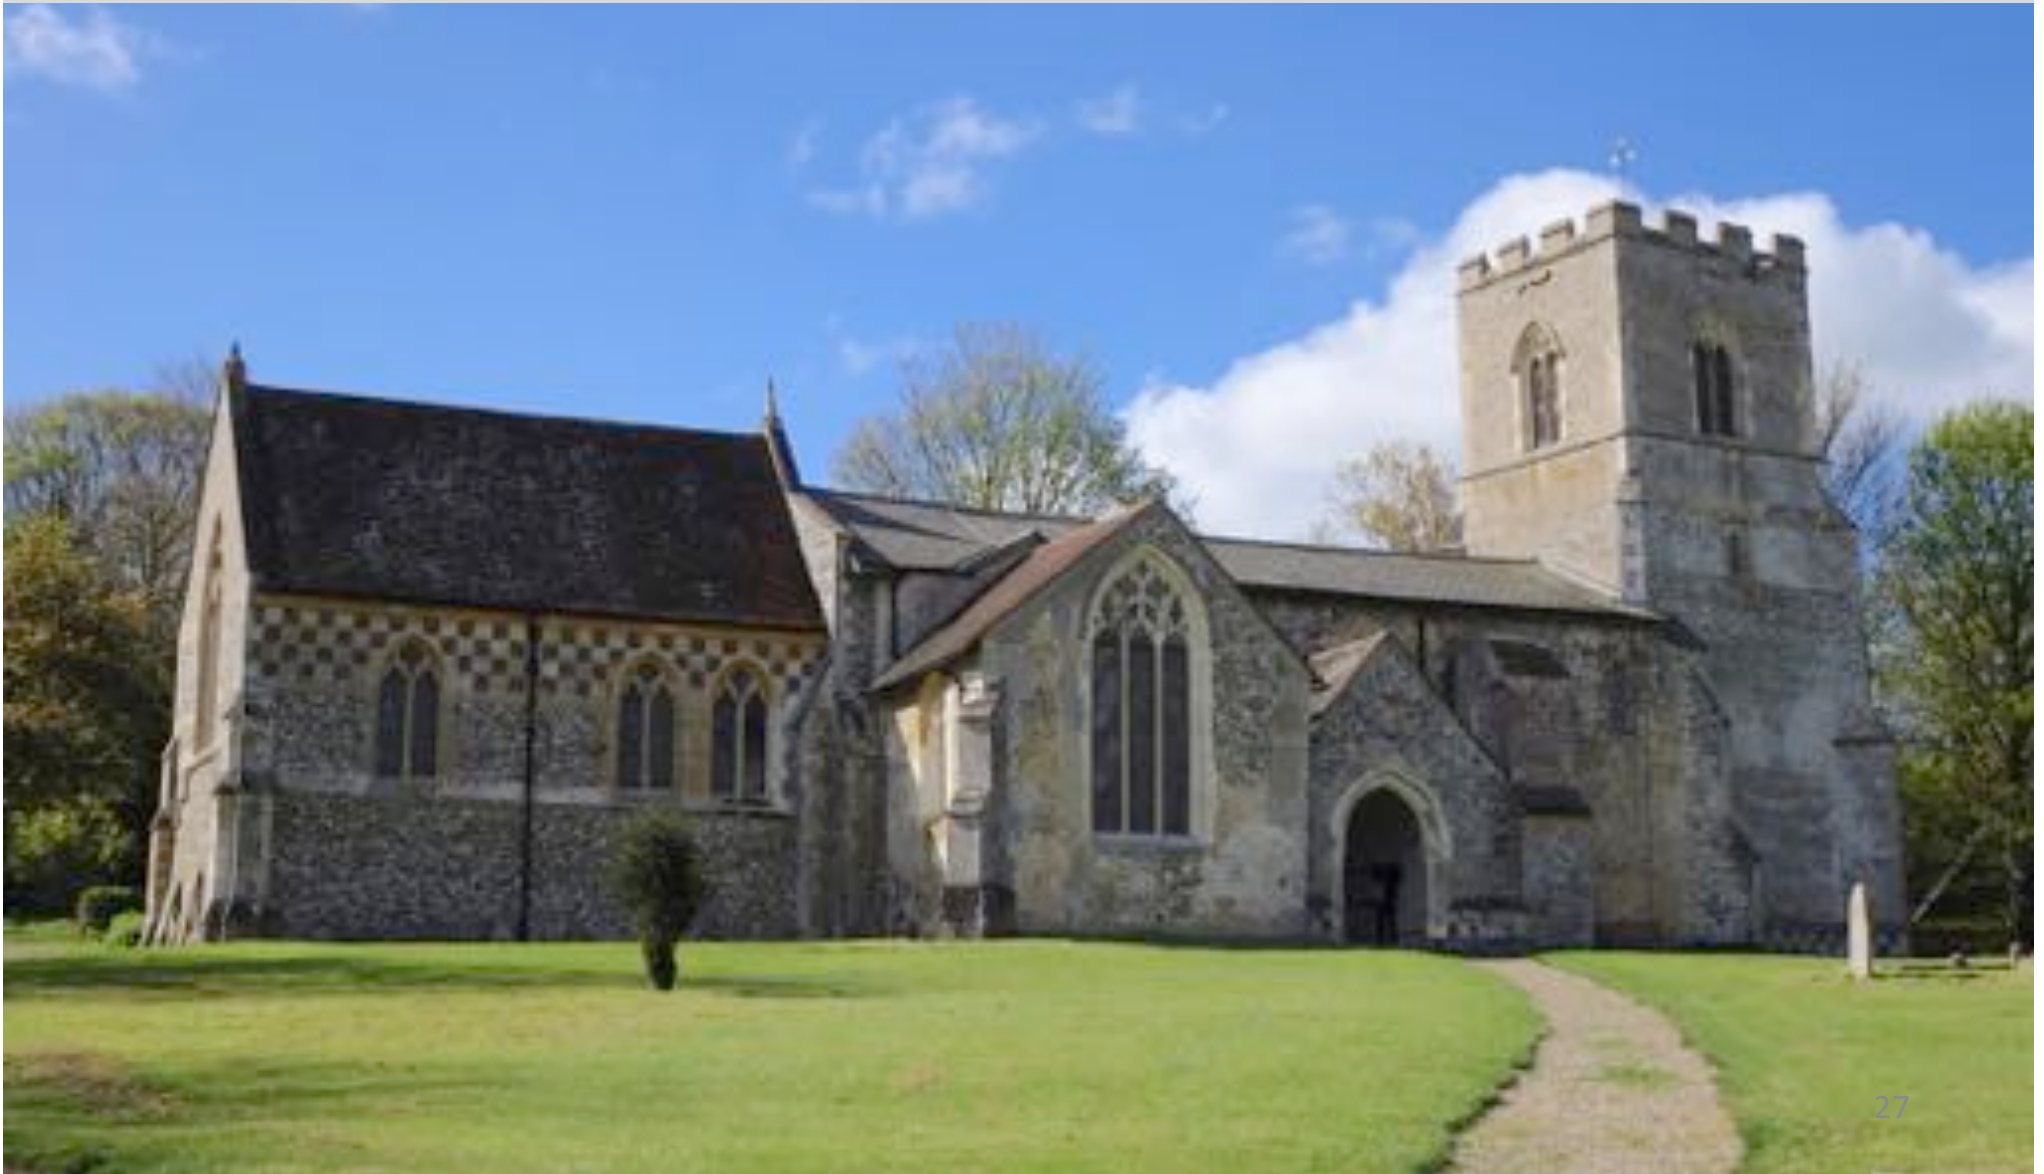
The outside of the door used to be covered with skin and has a lot of nail holes. The folklore tells that Daneskins were used to cover the door, but DNA analysis revealed it was cowhide, (Andrews 2003). The door was repaired in 1830 and the iron hinges were probably replaced with new ones. Some of the original ironwork and the "daneskin" are in the collections of Saffron Walden museum, (Geddes 1999:54).

The door is made of four cleaved oak boards that overlap each other with splayed rebates. On the inside there are 3/4 rounded ledges fixed by clinched nails and roves. The frame around the door has the same cross section as the ledges. This frame consists of several parts that join each other with splayed scarfs. Only two doors with clinched nails and roves are known in Scandinavia, one from Skanör church in the Diocese of Lund - that used to be part of Denmark until 1658 but now is a part of current Sweden - and one door from Hafslo church in Norway.

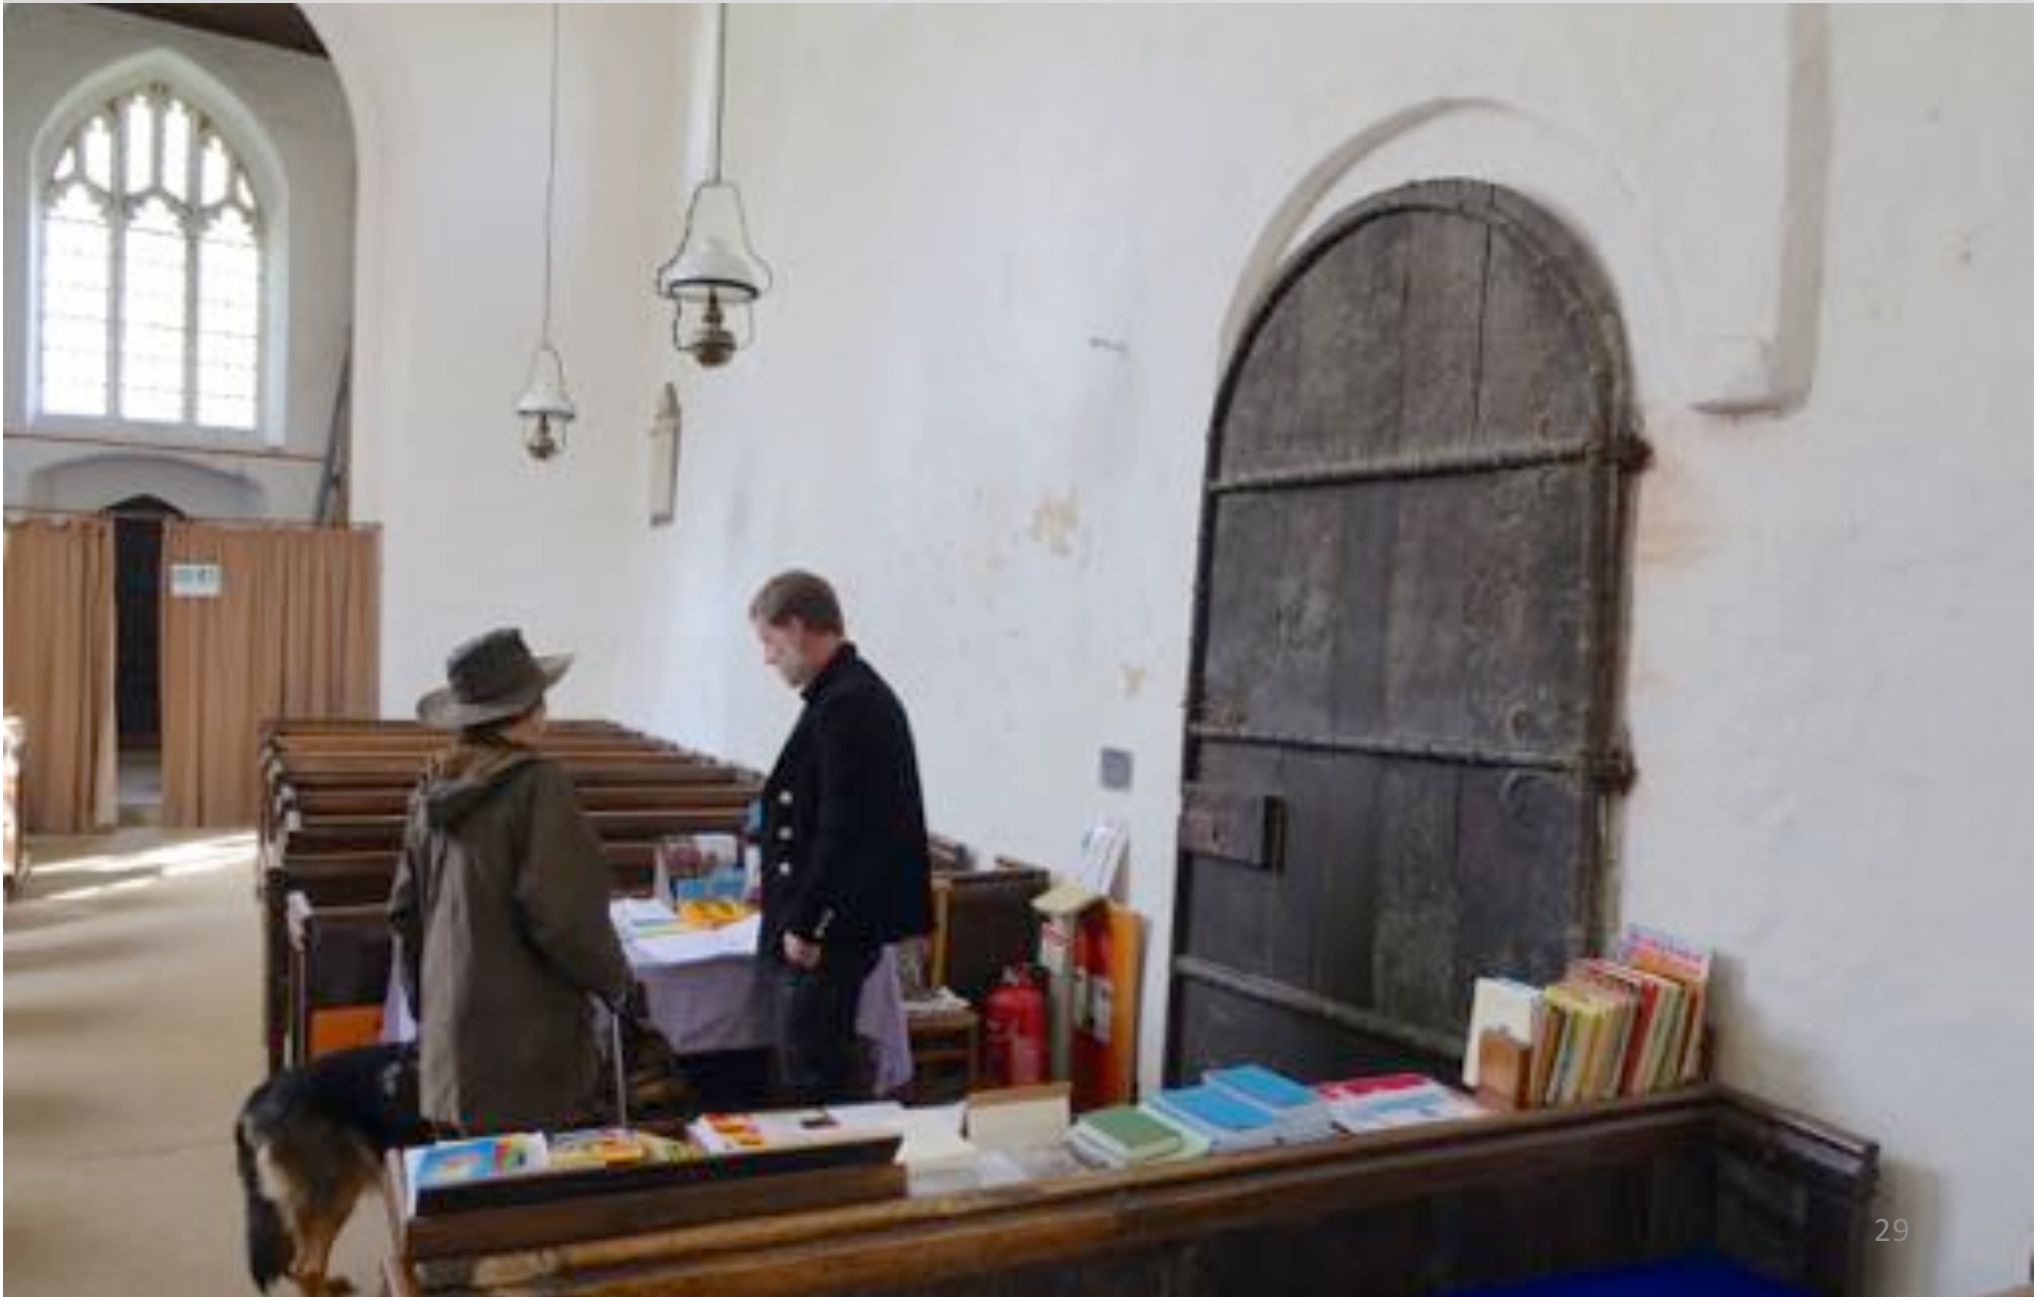
The door is weathered and there were not so many visible tool marks. On the end grain at the top, where dendrochronologists had cut with a razorblade, we could see that the boards had been radially cleft. Small tool marks from a broadaxe could be seen on the inside of the door blade.

Parts of the boards had been changed over the years, but most of the original construction was intact.

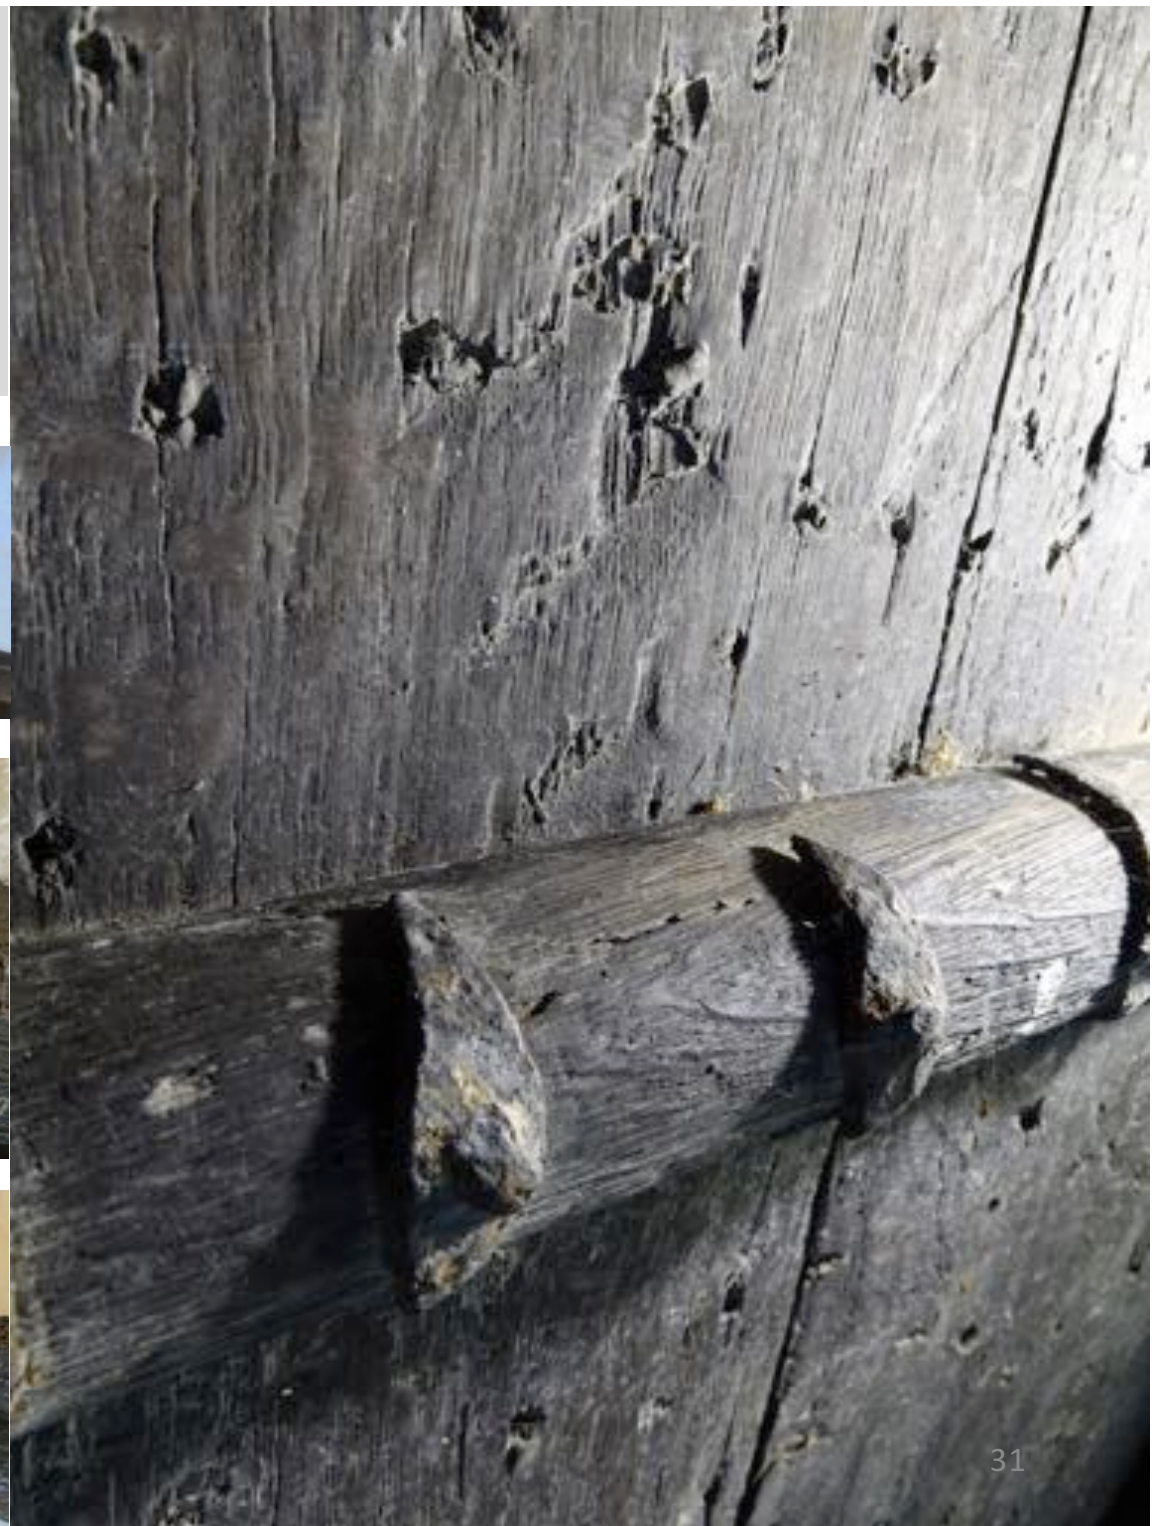
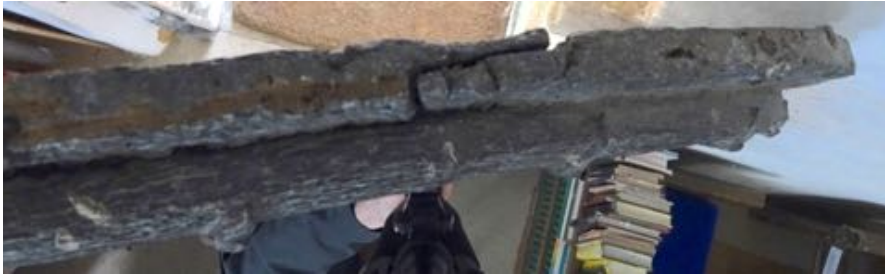
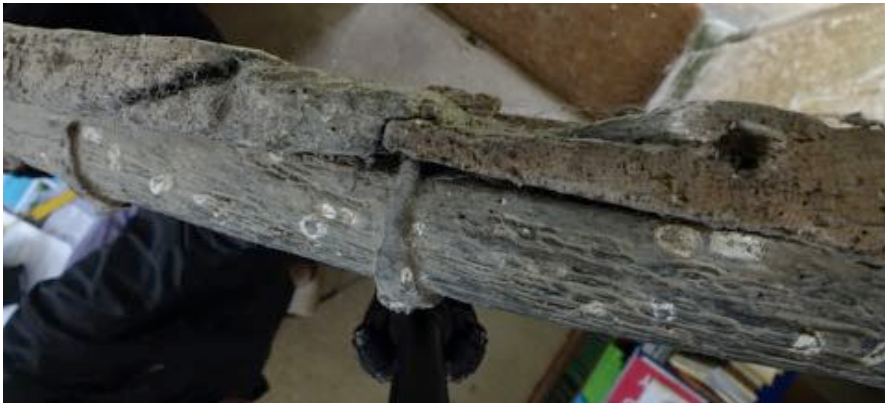
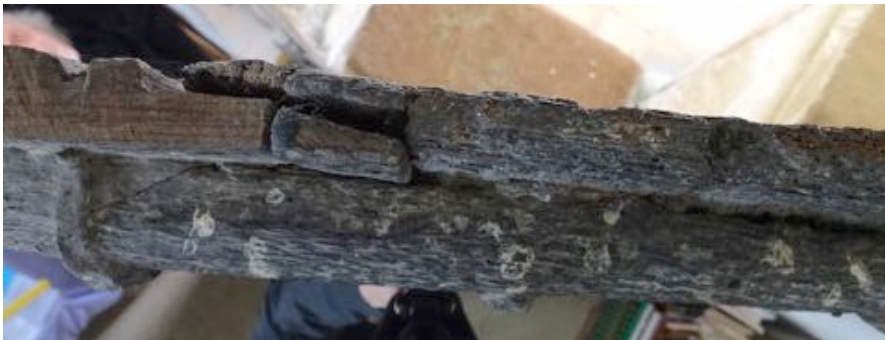
Below, the door is seen from above. The photos shows how the boards overlaps with splayed rebates.
We noticed many other interesting details. A valuable construction from a time with a different logic.

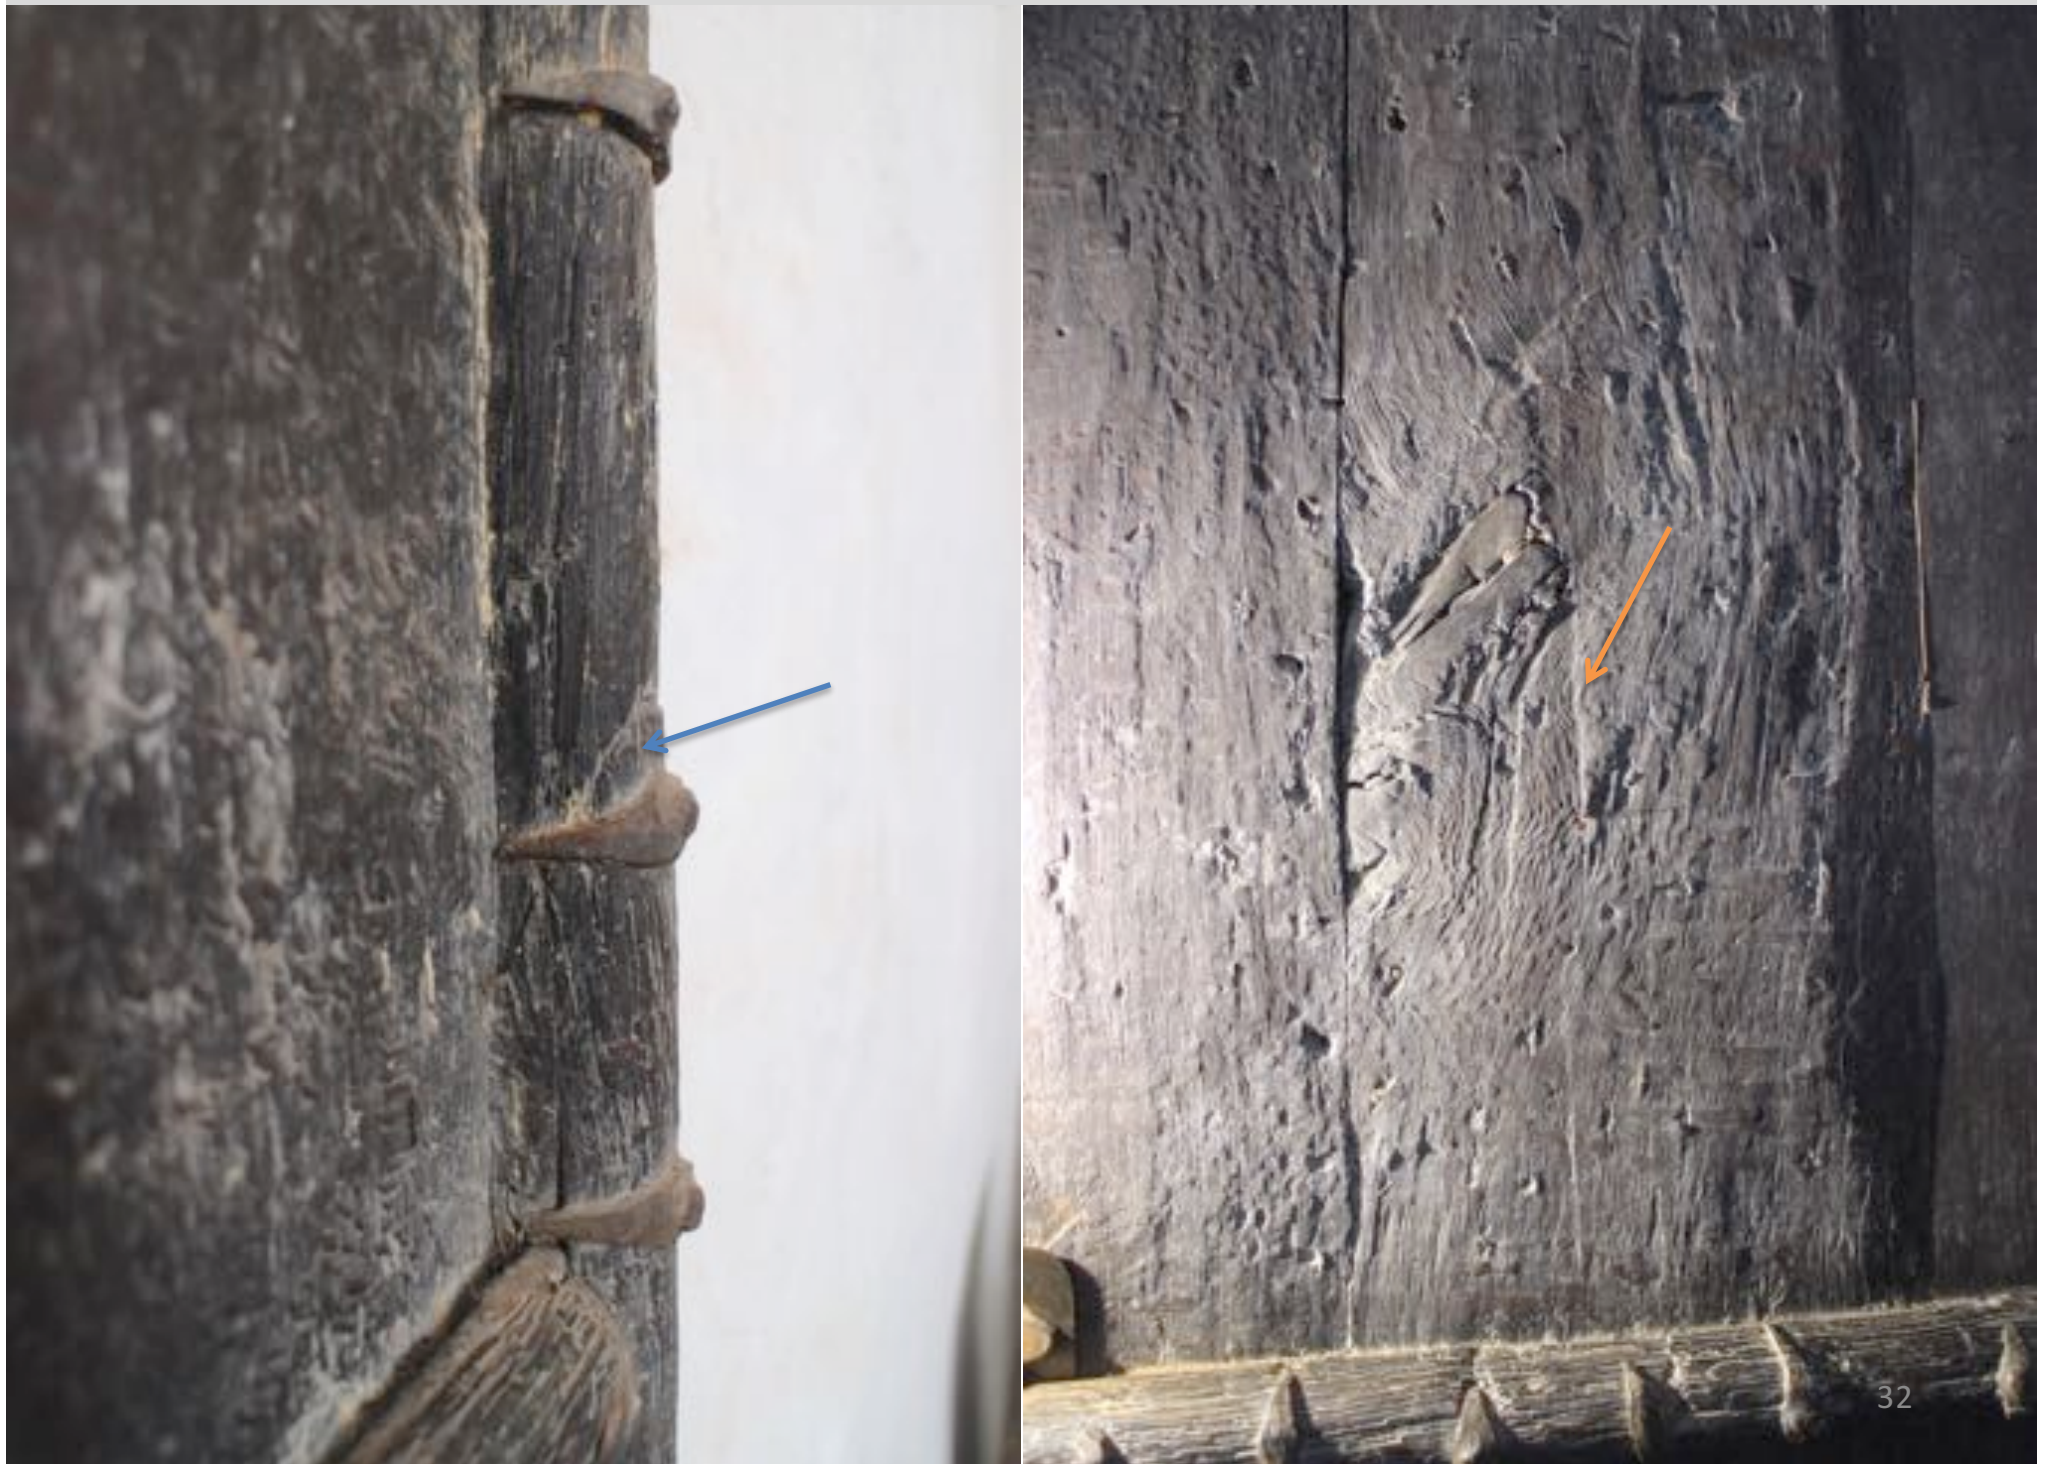
Left, a scarf joint with a clinched nail and row. Right, toolmarks, made against the grain with a straight edged broad axe,.

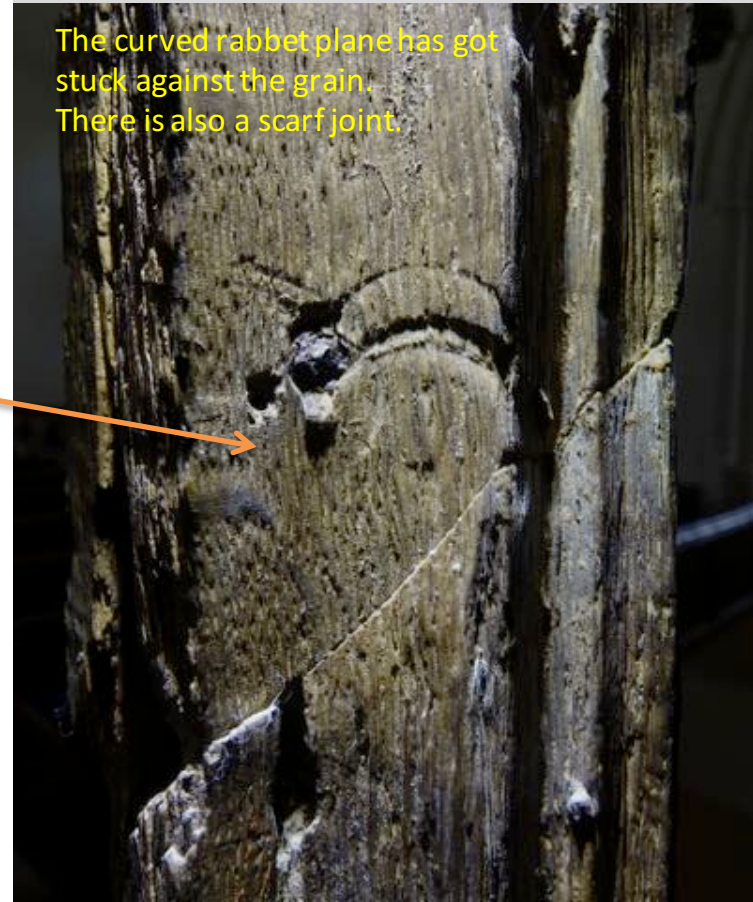
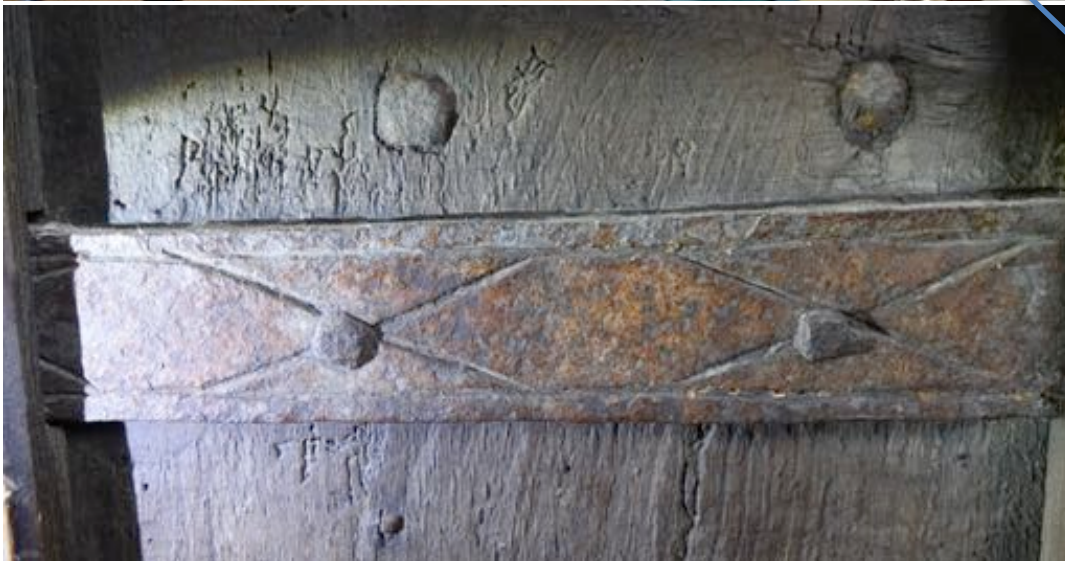
The curved rabbet plane has got stuck against the grain. There is also a scarf joint.

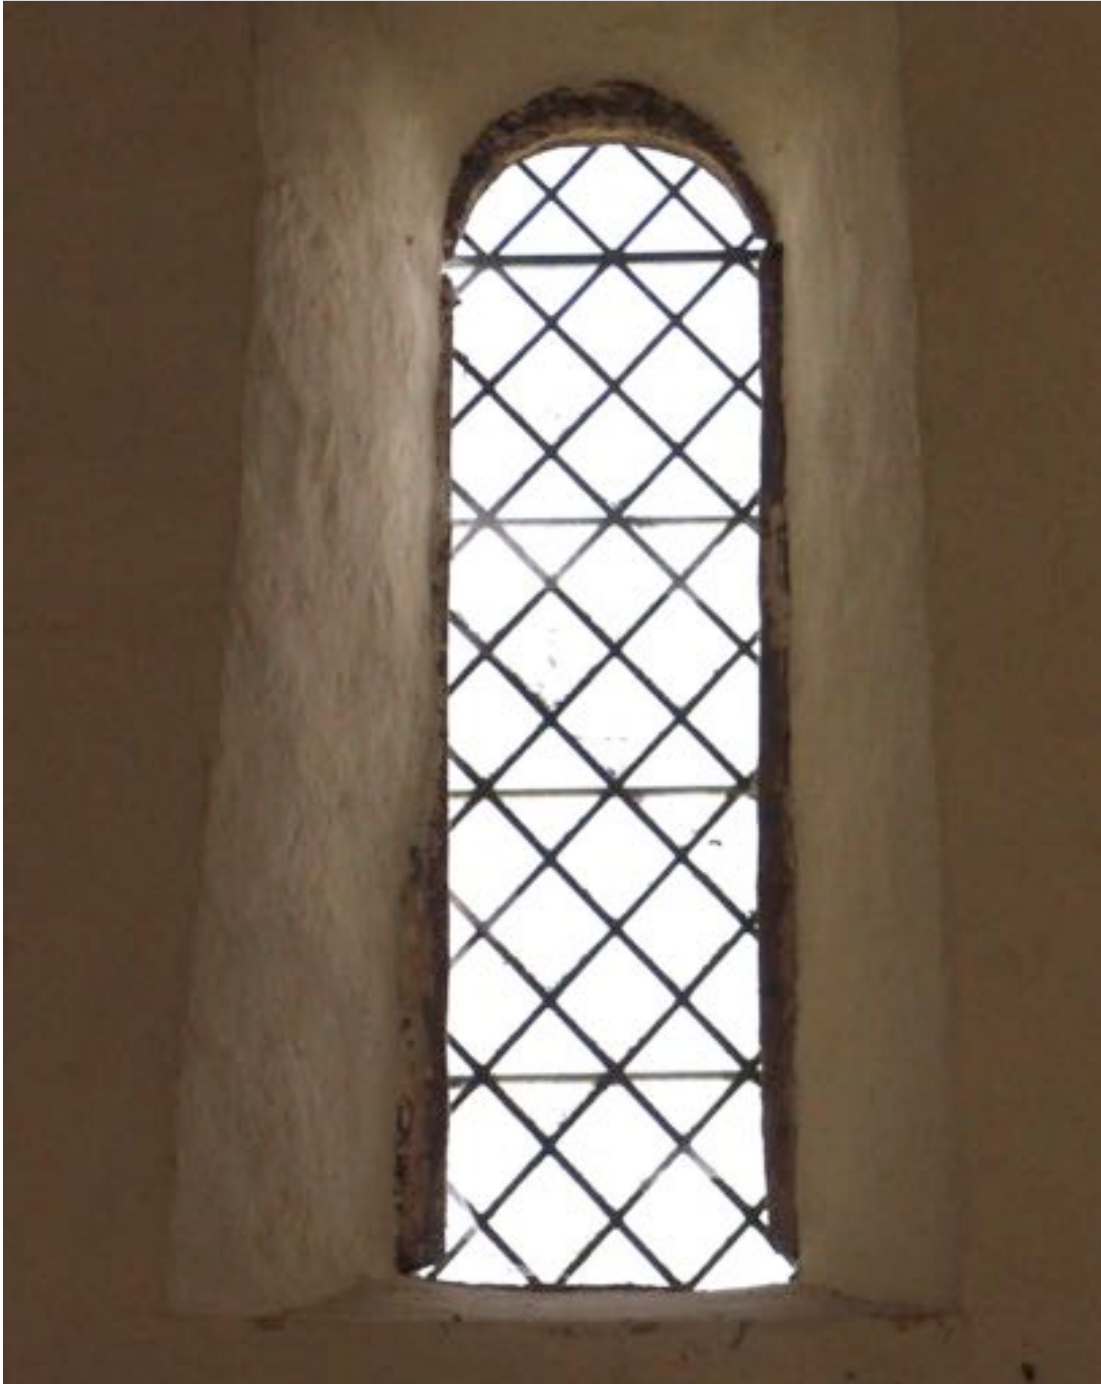
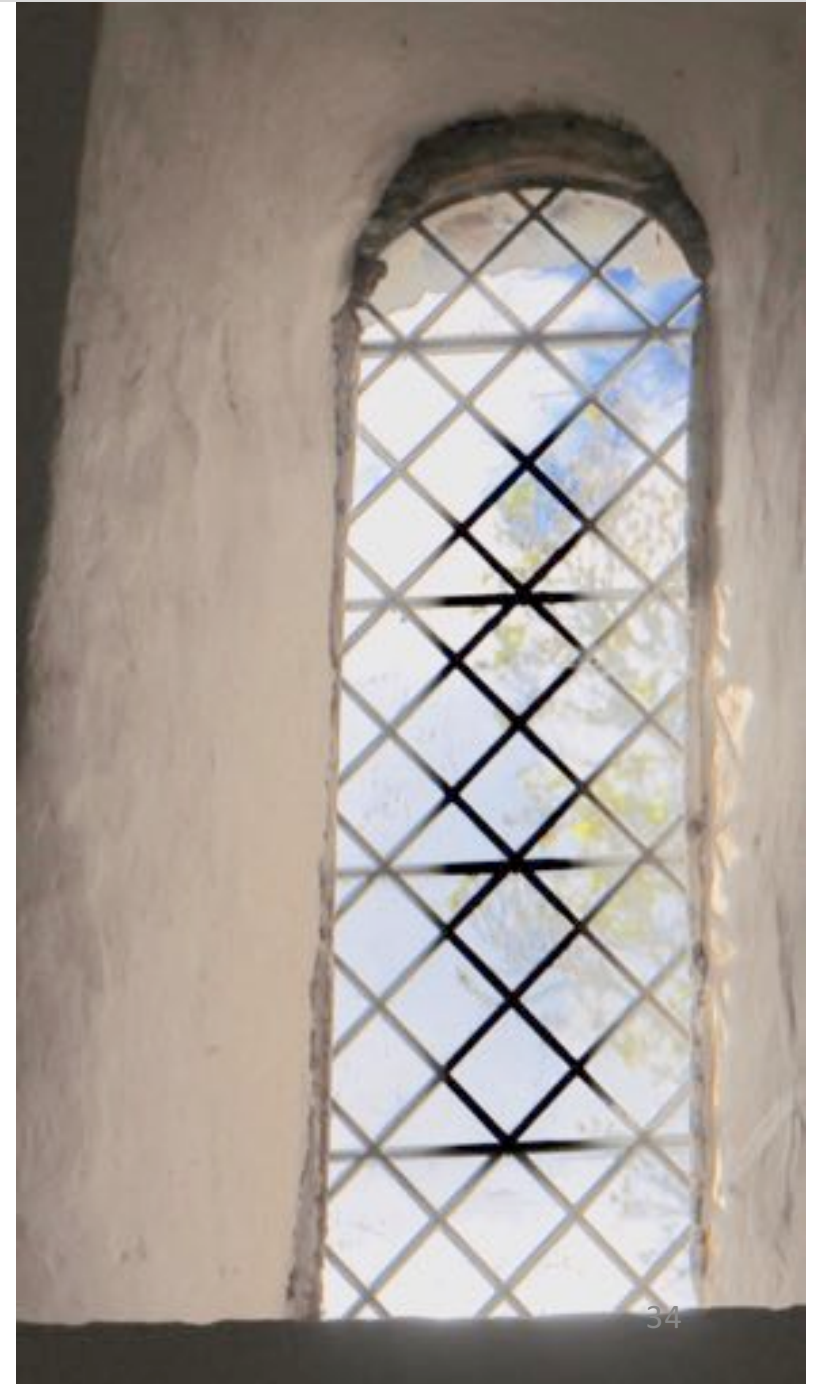
The oak frames in the double splayed windows are of the same age and building phase as the dendrochronological dated door, (Rodwell 1974:13).⁶ There are four intact frames and each frame is made of four parts. Similar frames have been recorded in Framlev church in Denmark. Since we had no ladder we could not make a close inspection.

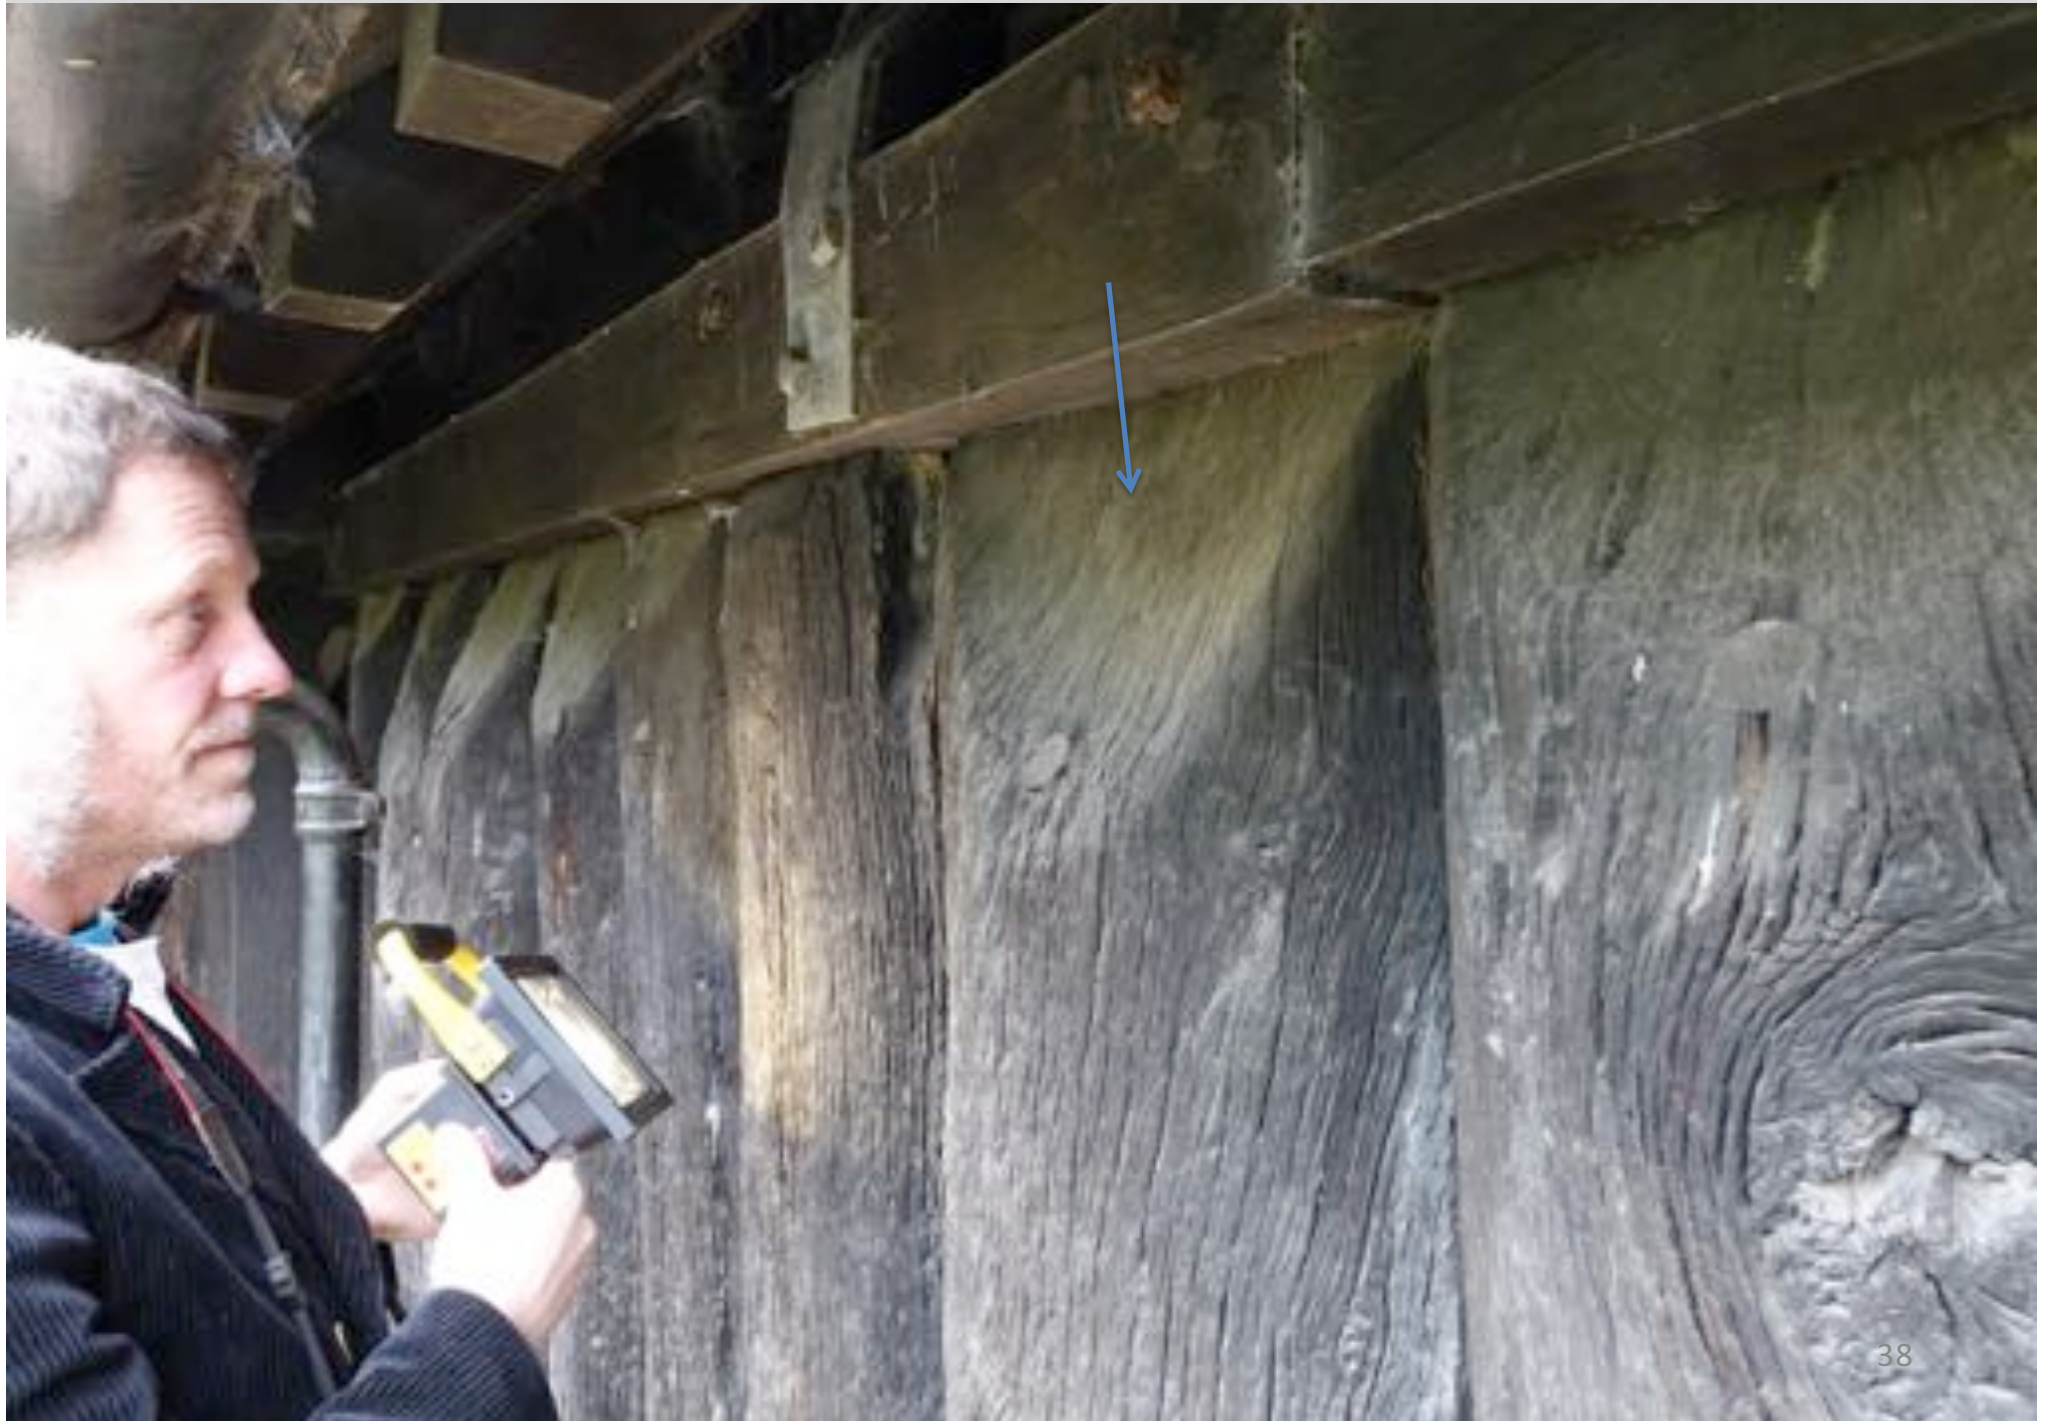
It could also be debated if this is the oldest stave church still standing or a church built 1848 with a lot of reused medieval timbers. Most probable all the staves are rearranged more than once, they are surely shortened (probably a lot), the ground- and roof- constructions are from 1848.

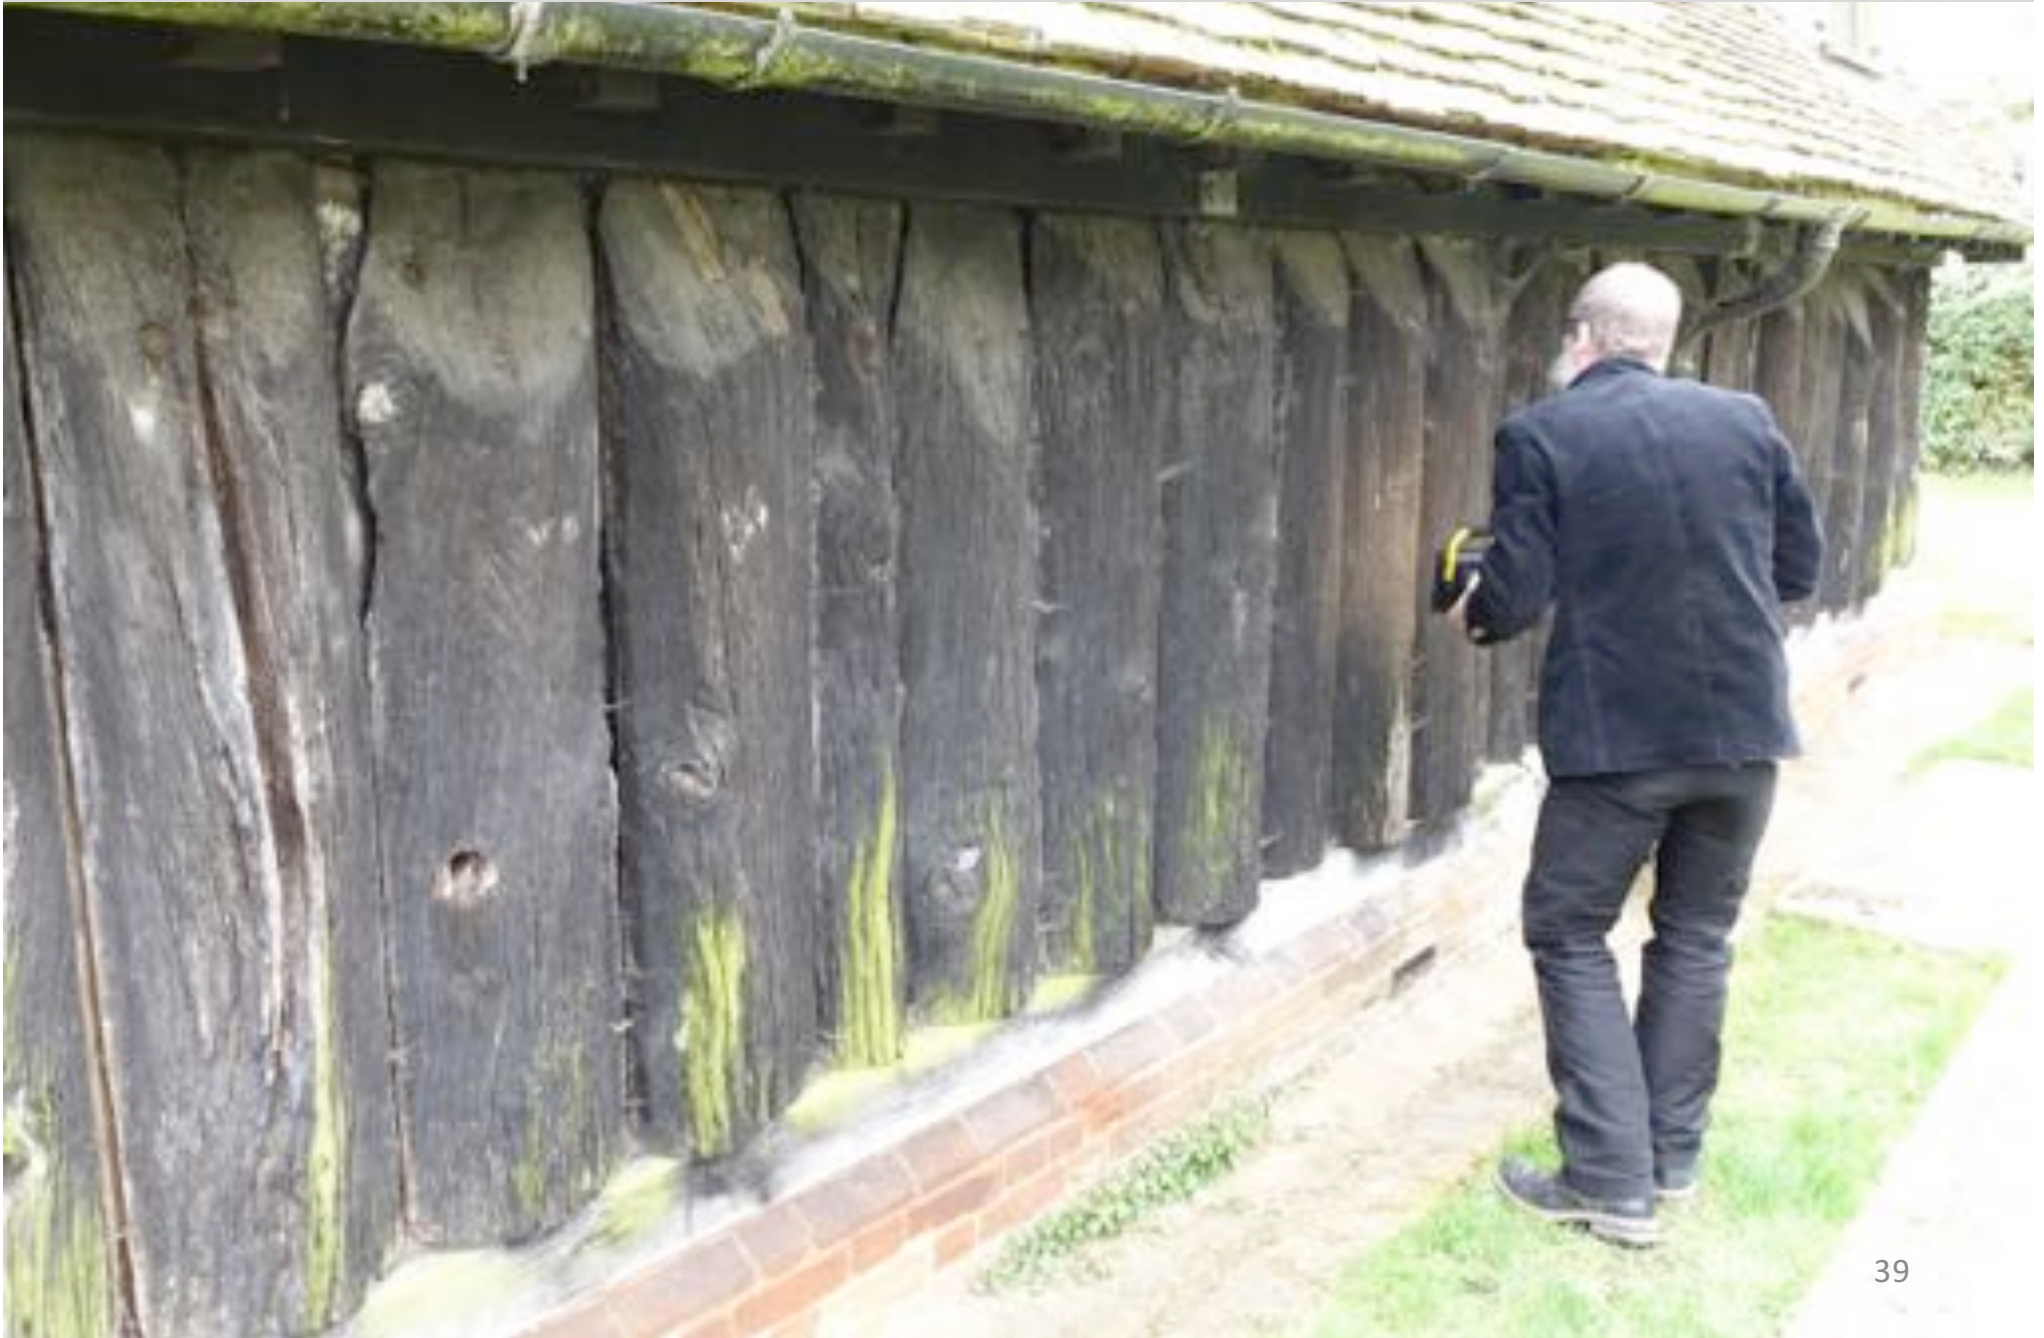
There were a mix of reused parts, original and new ones. Interestingly some of the older repairs had almost the same patina as the assumed original parts.
