Carpentry art, excursion to England

The search for comparison of Scandinavian craftsmanship in medieval English carpentry art

This PM is the result of a carpentry art excursion made by Karl-Magnus Melin and Mattias Hallgren in april 2017. Karl-Magnus works as a carpenter and craft researcher at Knadriks Kulturbbygg, is project leader for the diocese project Historic carpentry art in the diocese of Lund and is a doctoral student at the University of Gothenburg.

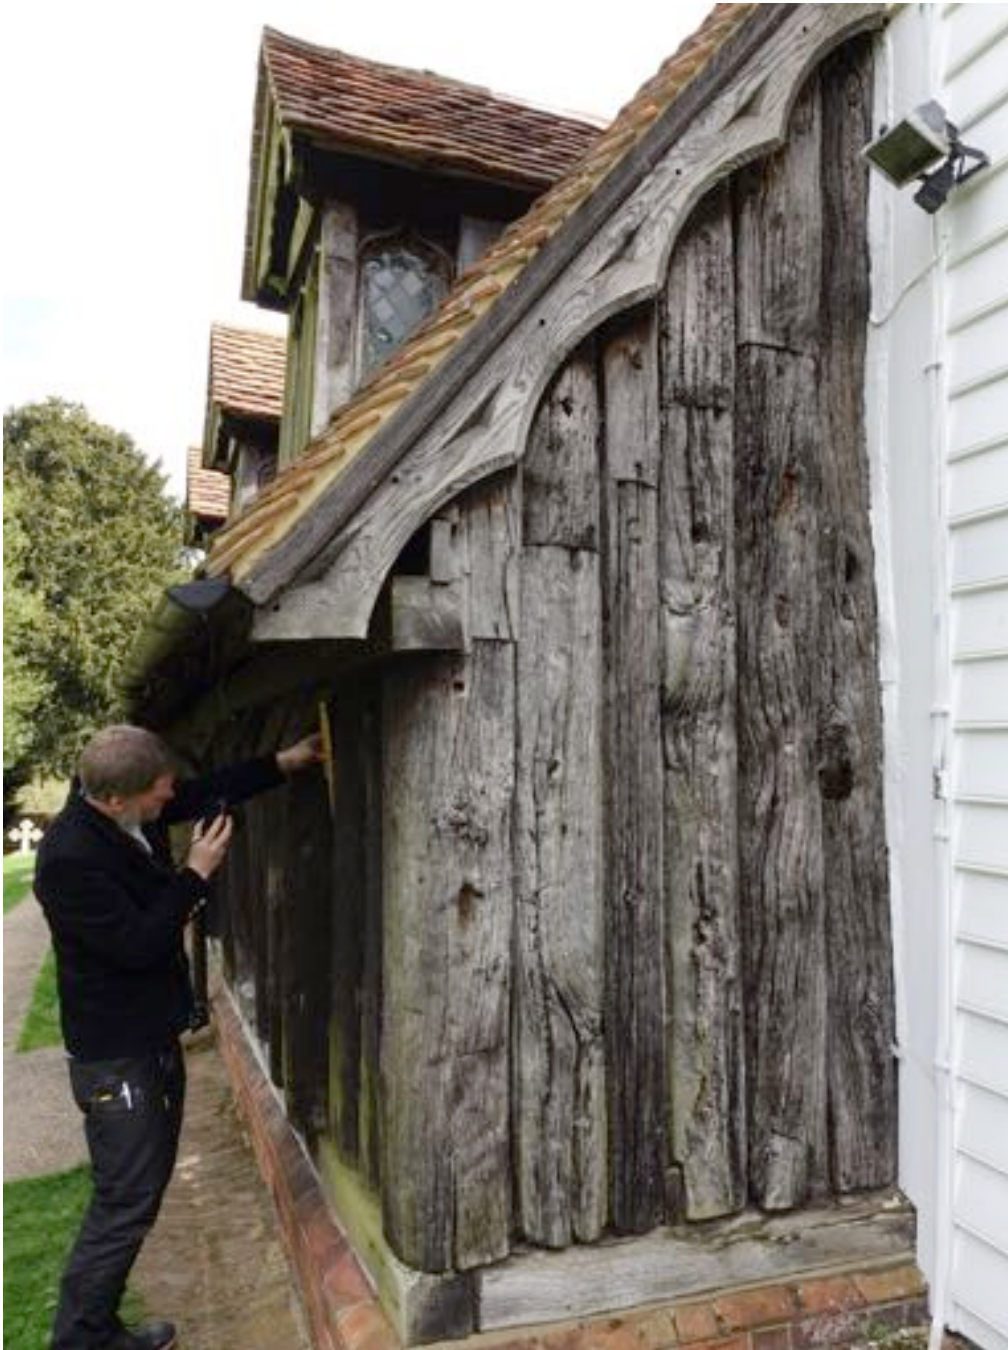
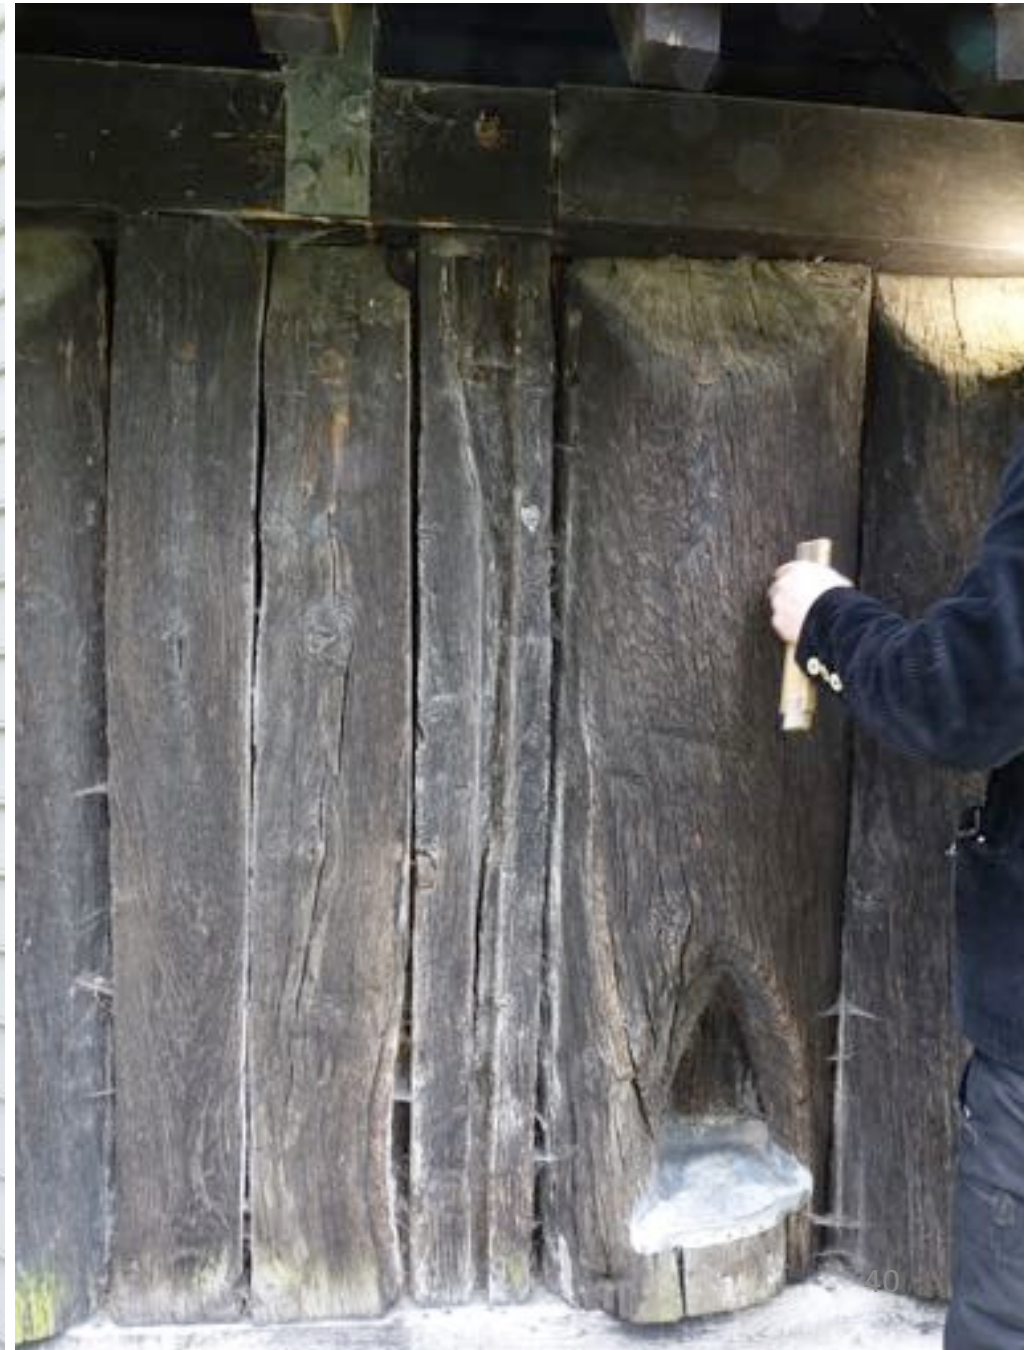
The northwest corner post is supposed to be original. Though it is not as weathered as the other original staves.

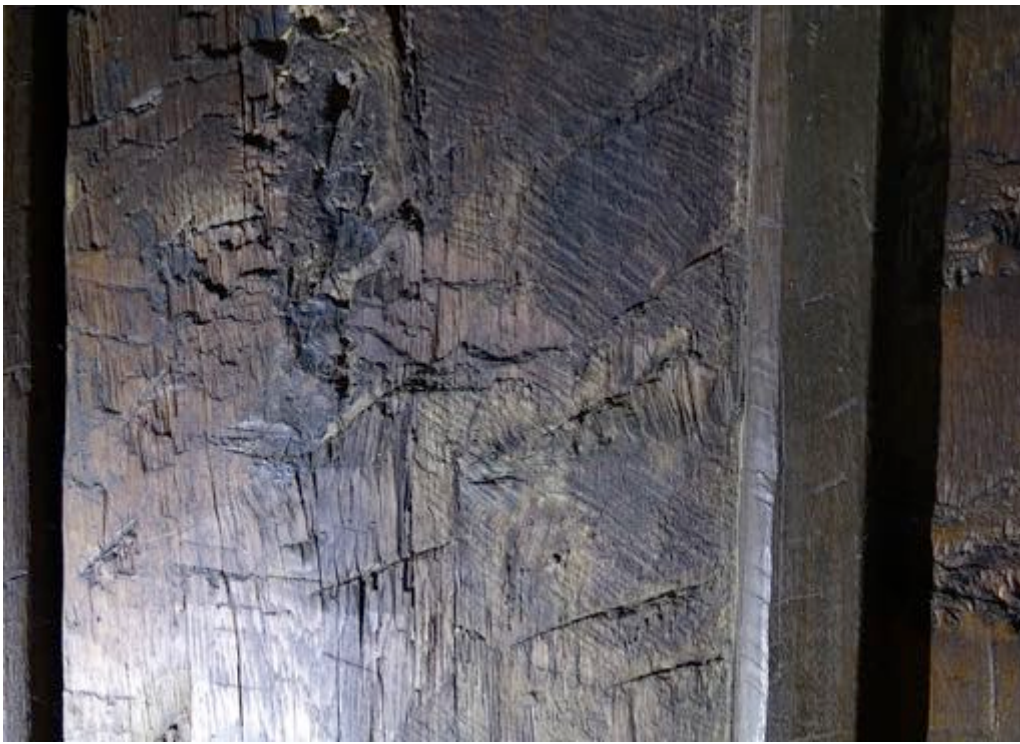
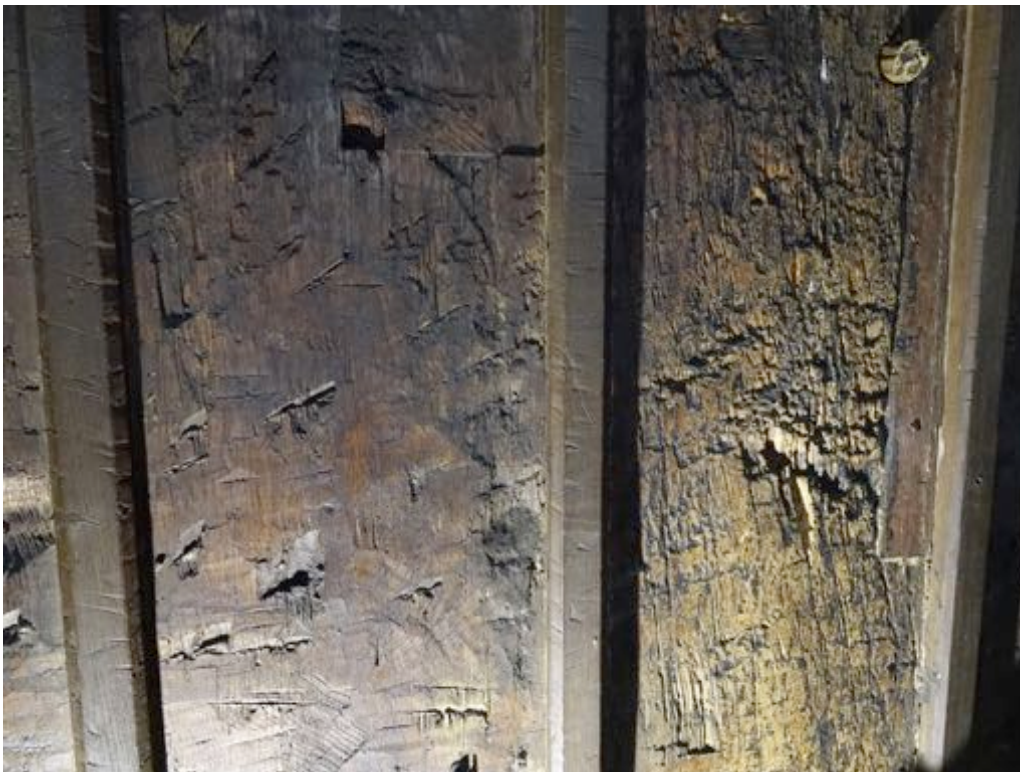
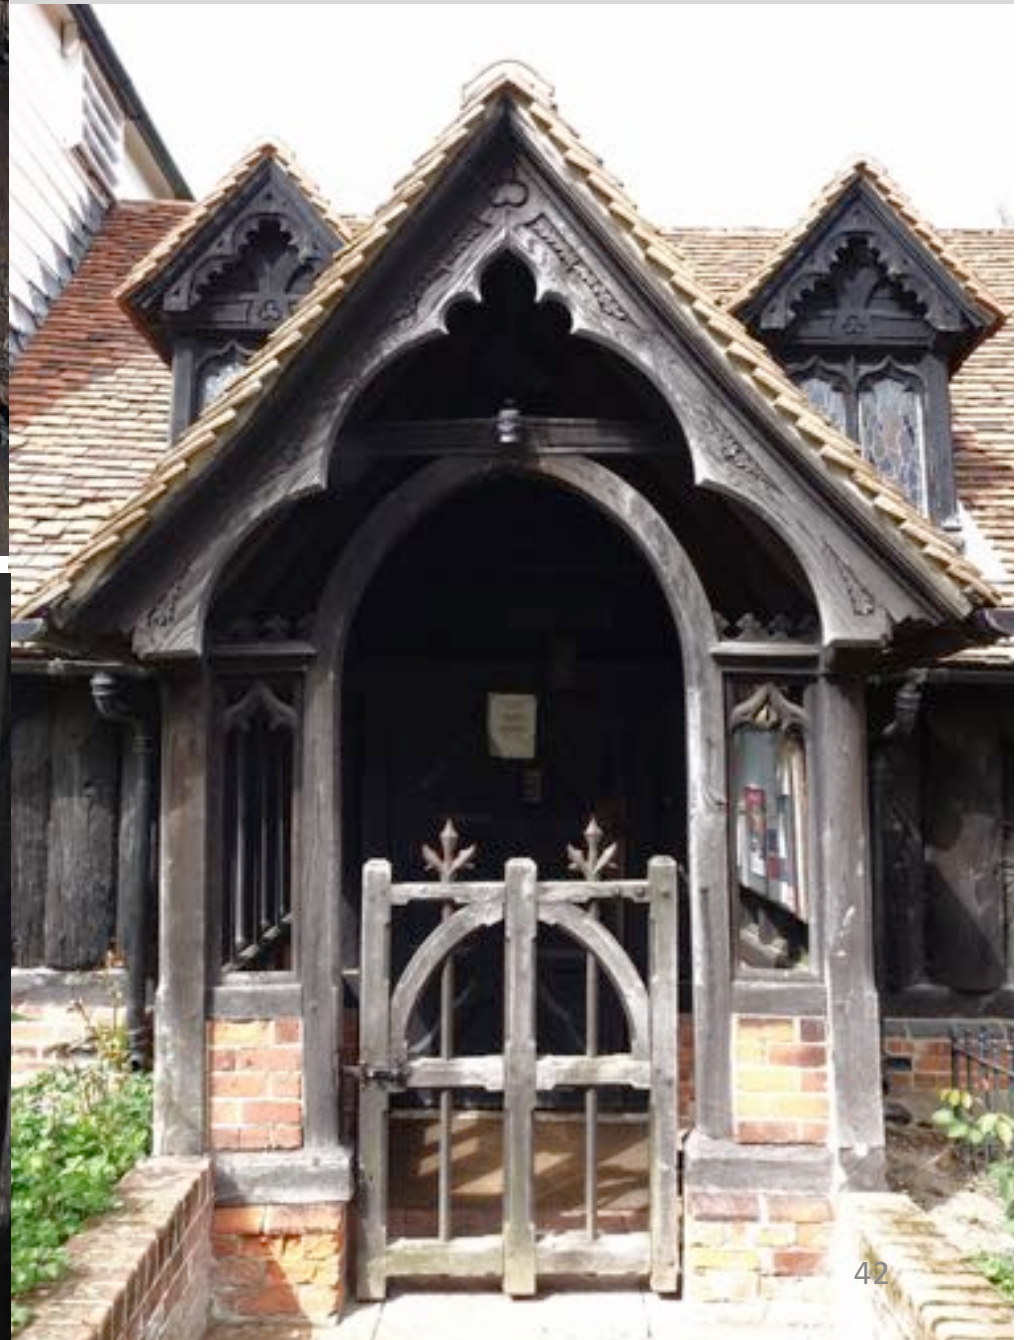
To the left, the inside of the staves that we believe are cut flat. How the staves looked originally is hard to tell. Some strange cutting marks from a very damaged axe can be seen in deeper dens here and there.

The tool marks are done with the same axe and at the same time on the old staves and the inserted repair wood. Therefore it is safe to conclude that the tool marks are not original but done later.

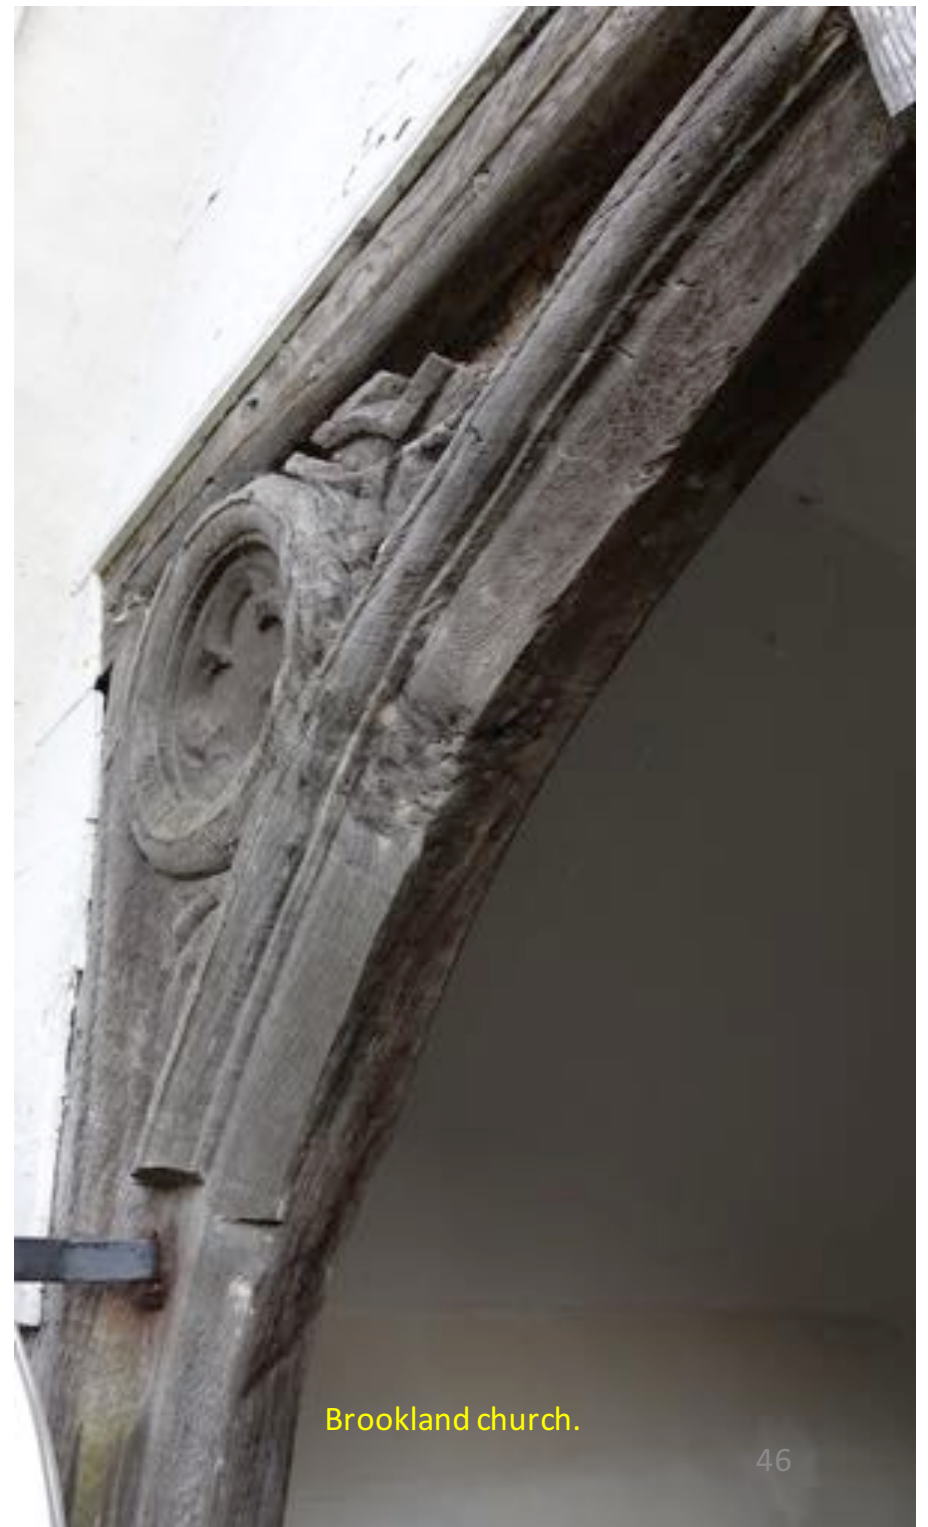
Brookland church.

The bell tower has at least three generations of building periods. The original oak tower has four large corner posts 22"x22" standing on even bigger sills. It is worrying to see the concrete that has been poured out around the sills. This is a very bad solution, especially over time. It would be better to lift the tower up, create a new stone grounding that is ventilated. The sills are probably rotten and need to be repaired. It is of great importance that this unique construction will be preserved and taken care of in a proper manner.

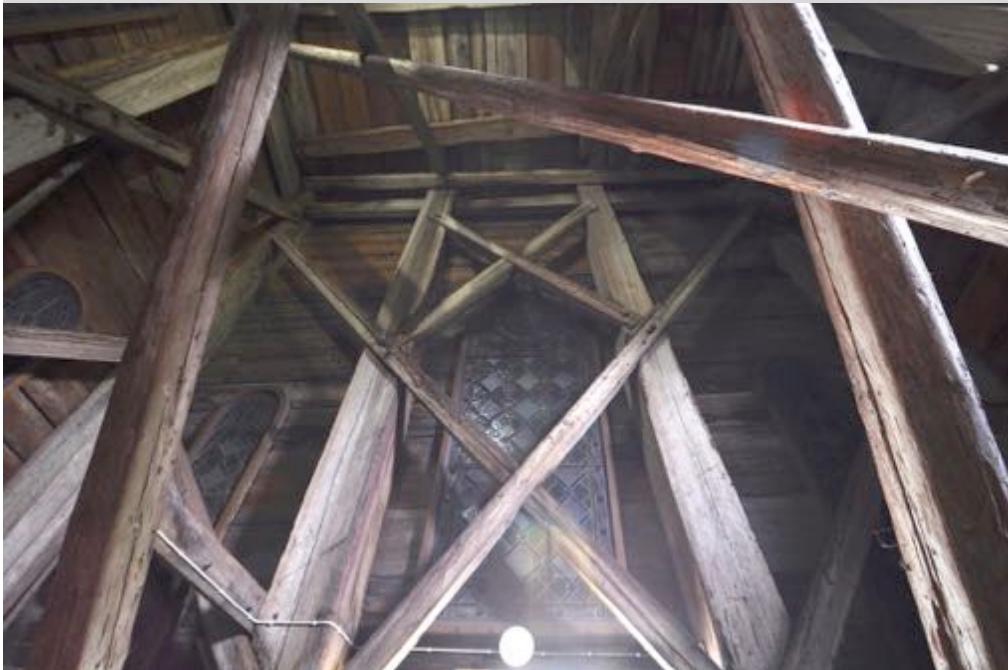
Grevbäck campanile Sweden dendrochronologically dated 1304.

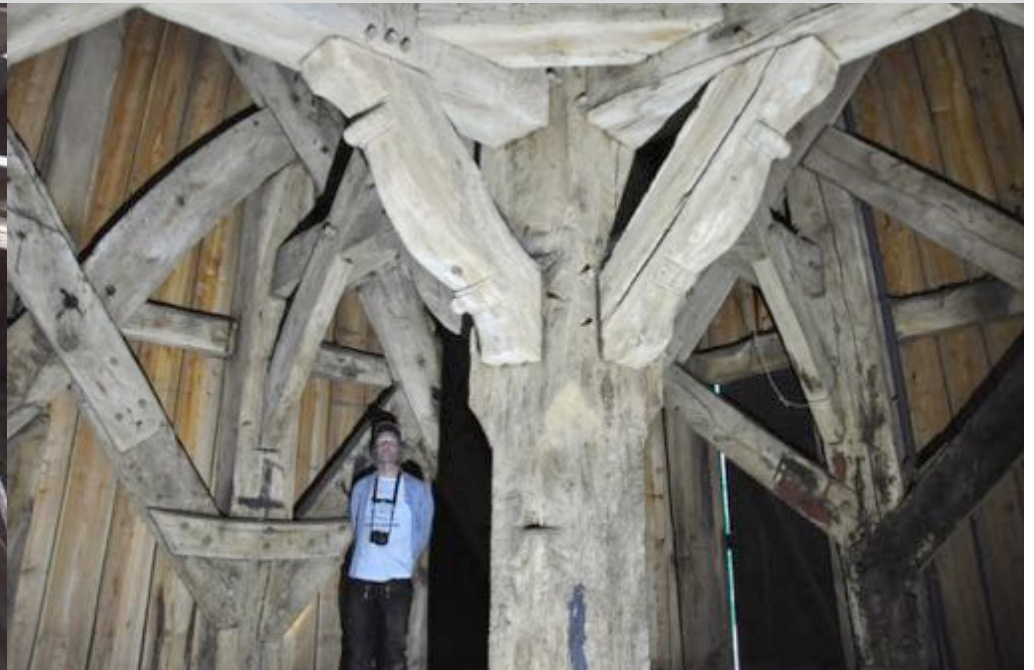
Kliplev campanile Denmark dendrochronologically dated 14th century.

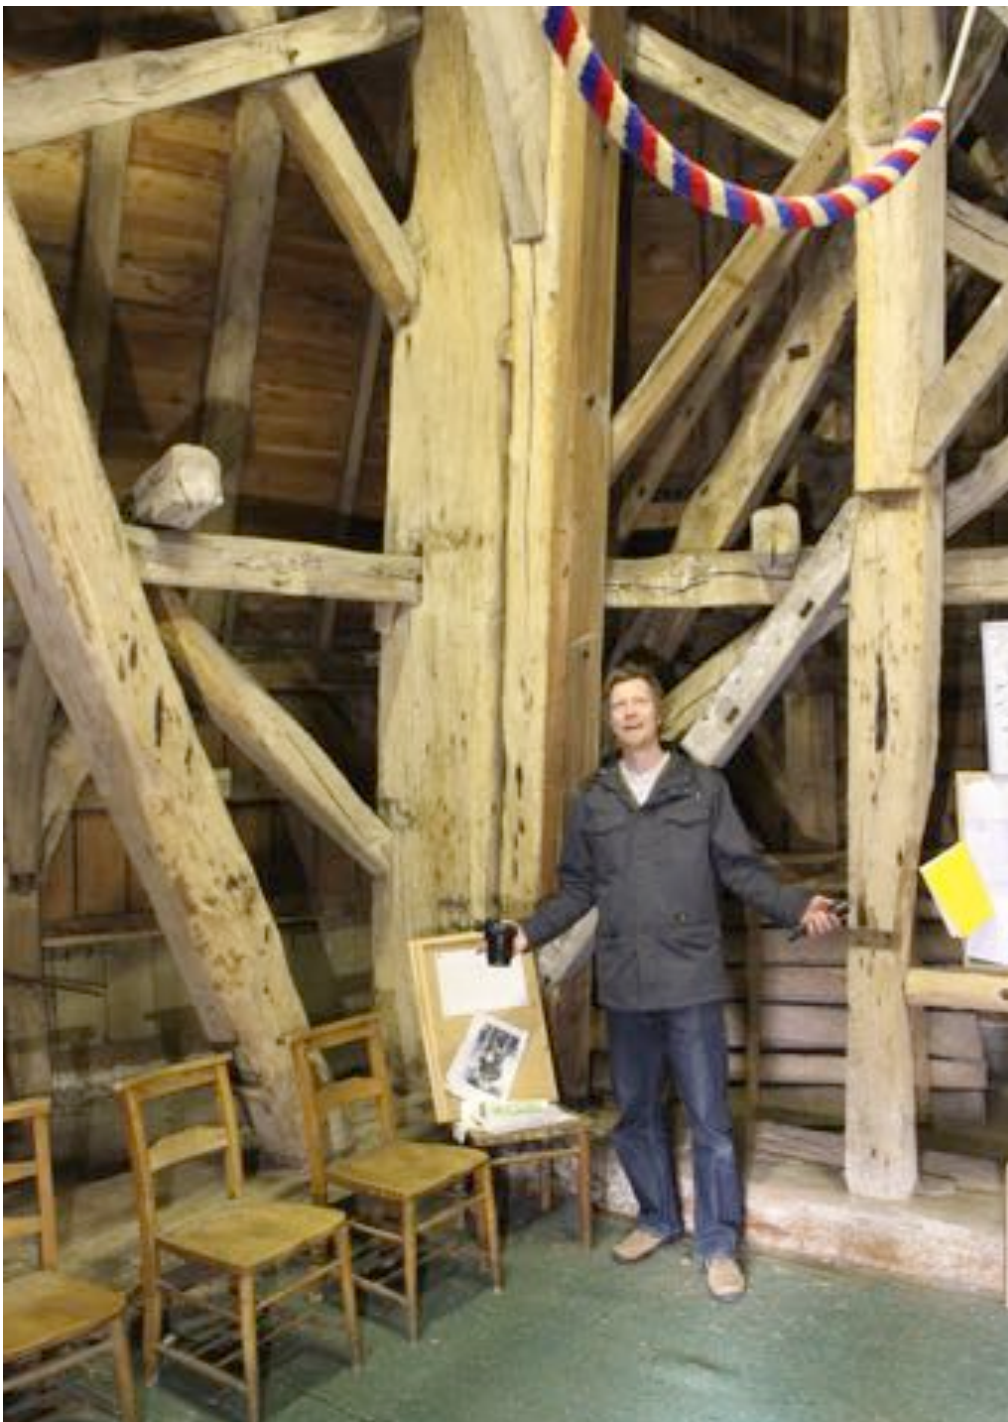
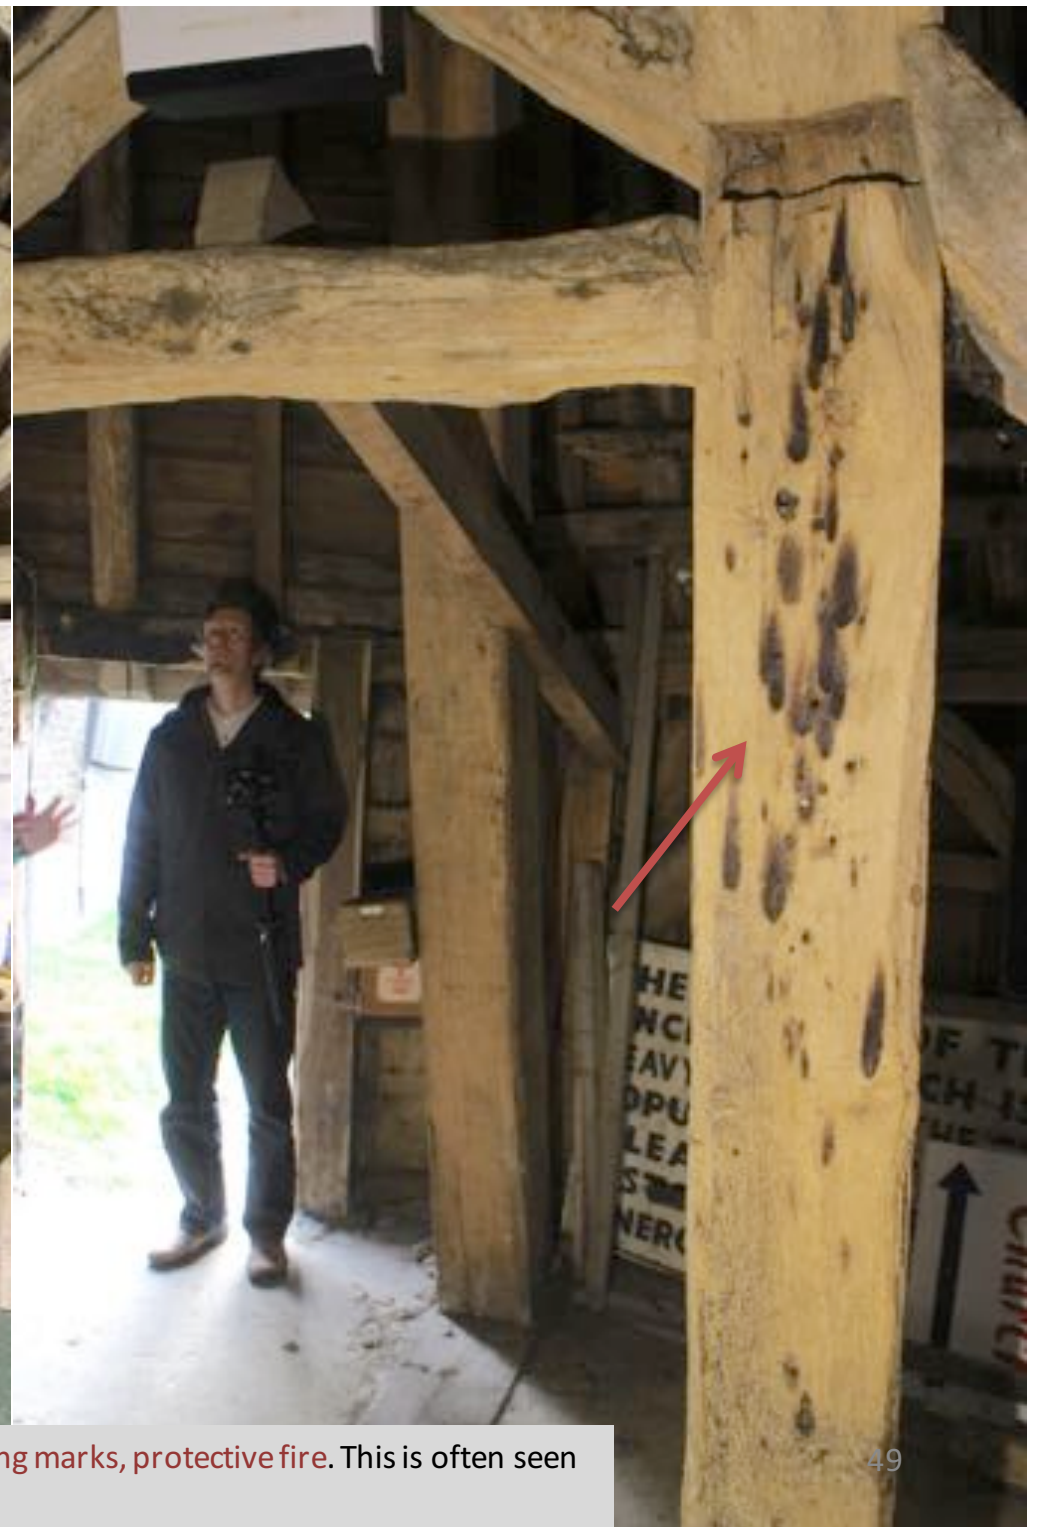
Mattias is euphoric finding this fantastic campanile. To the right, branding marks, protective fire. This is often seen in medieval buildings in Scandinavia.

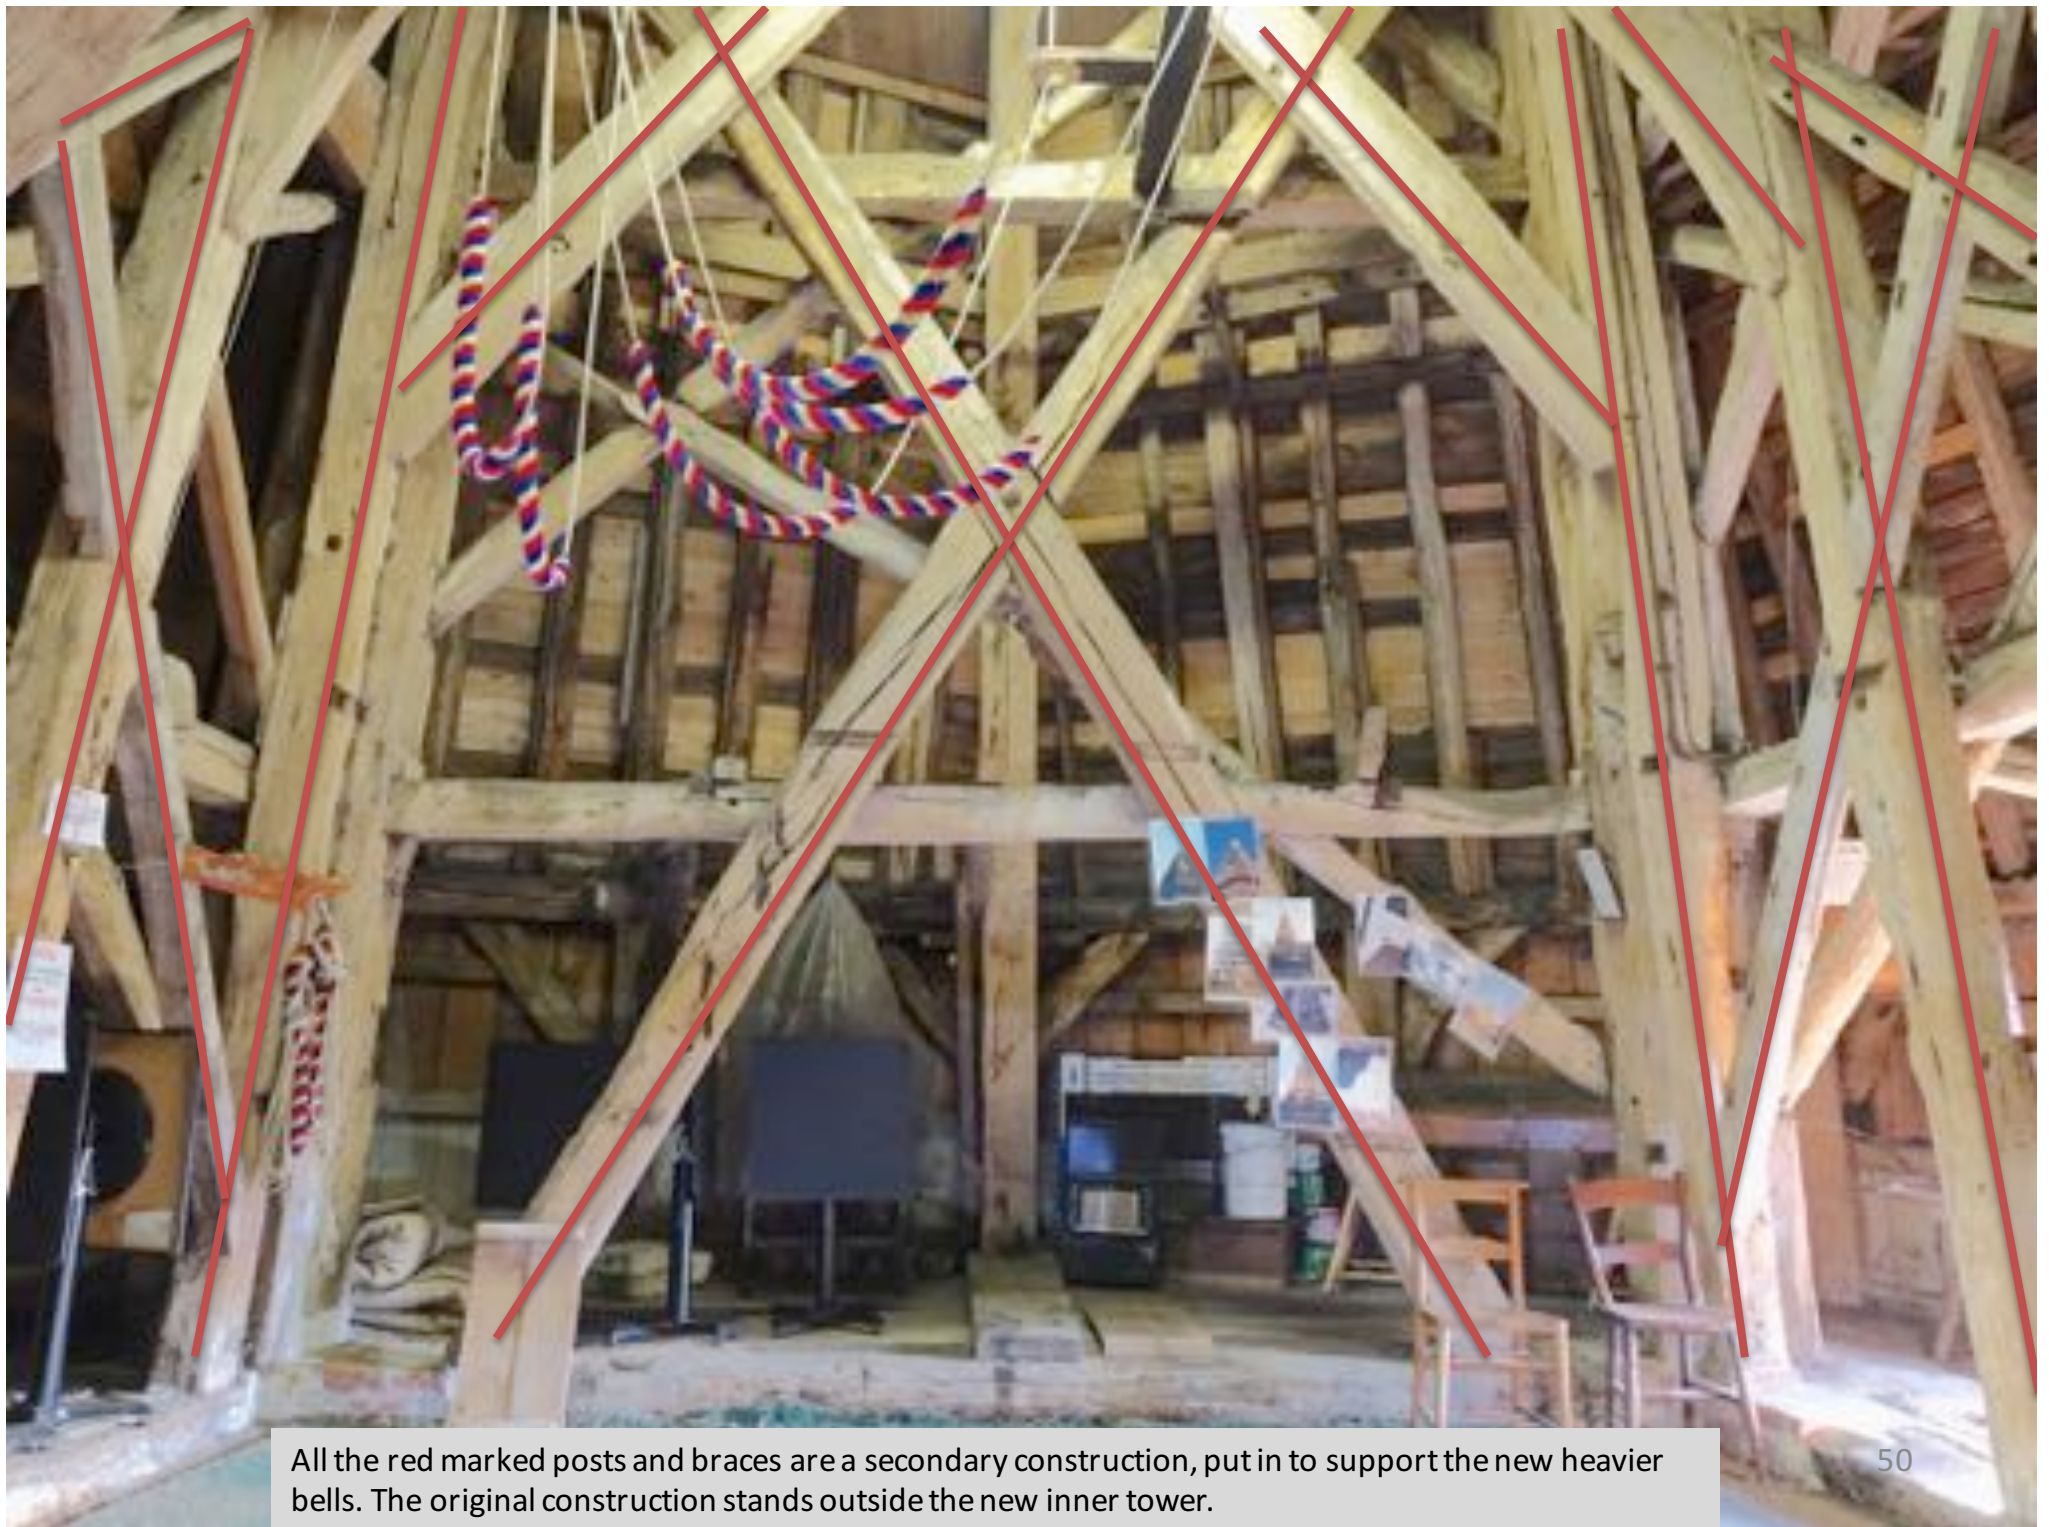
All the red marked posts and braces are a secondary construction, put in to support the new heavier bells. The original construction stands outside the new inner tower.

The older tower seen from its former outside. Red lines mark the new added tower construction.

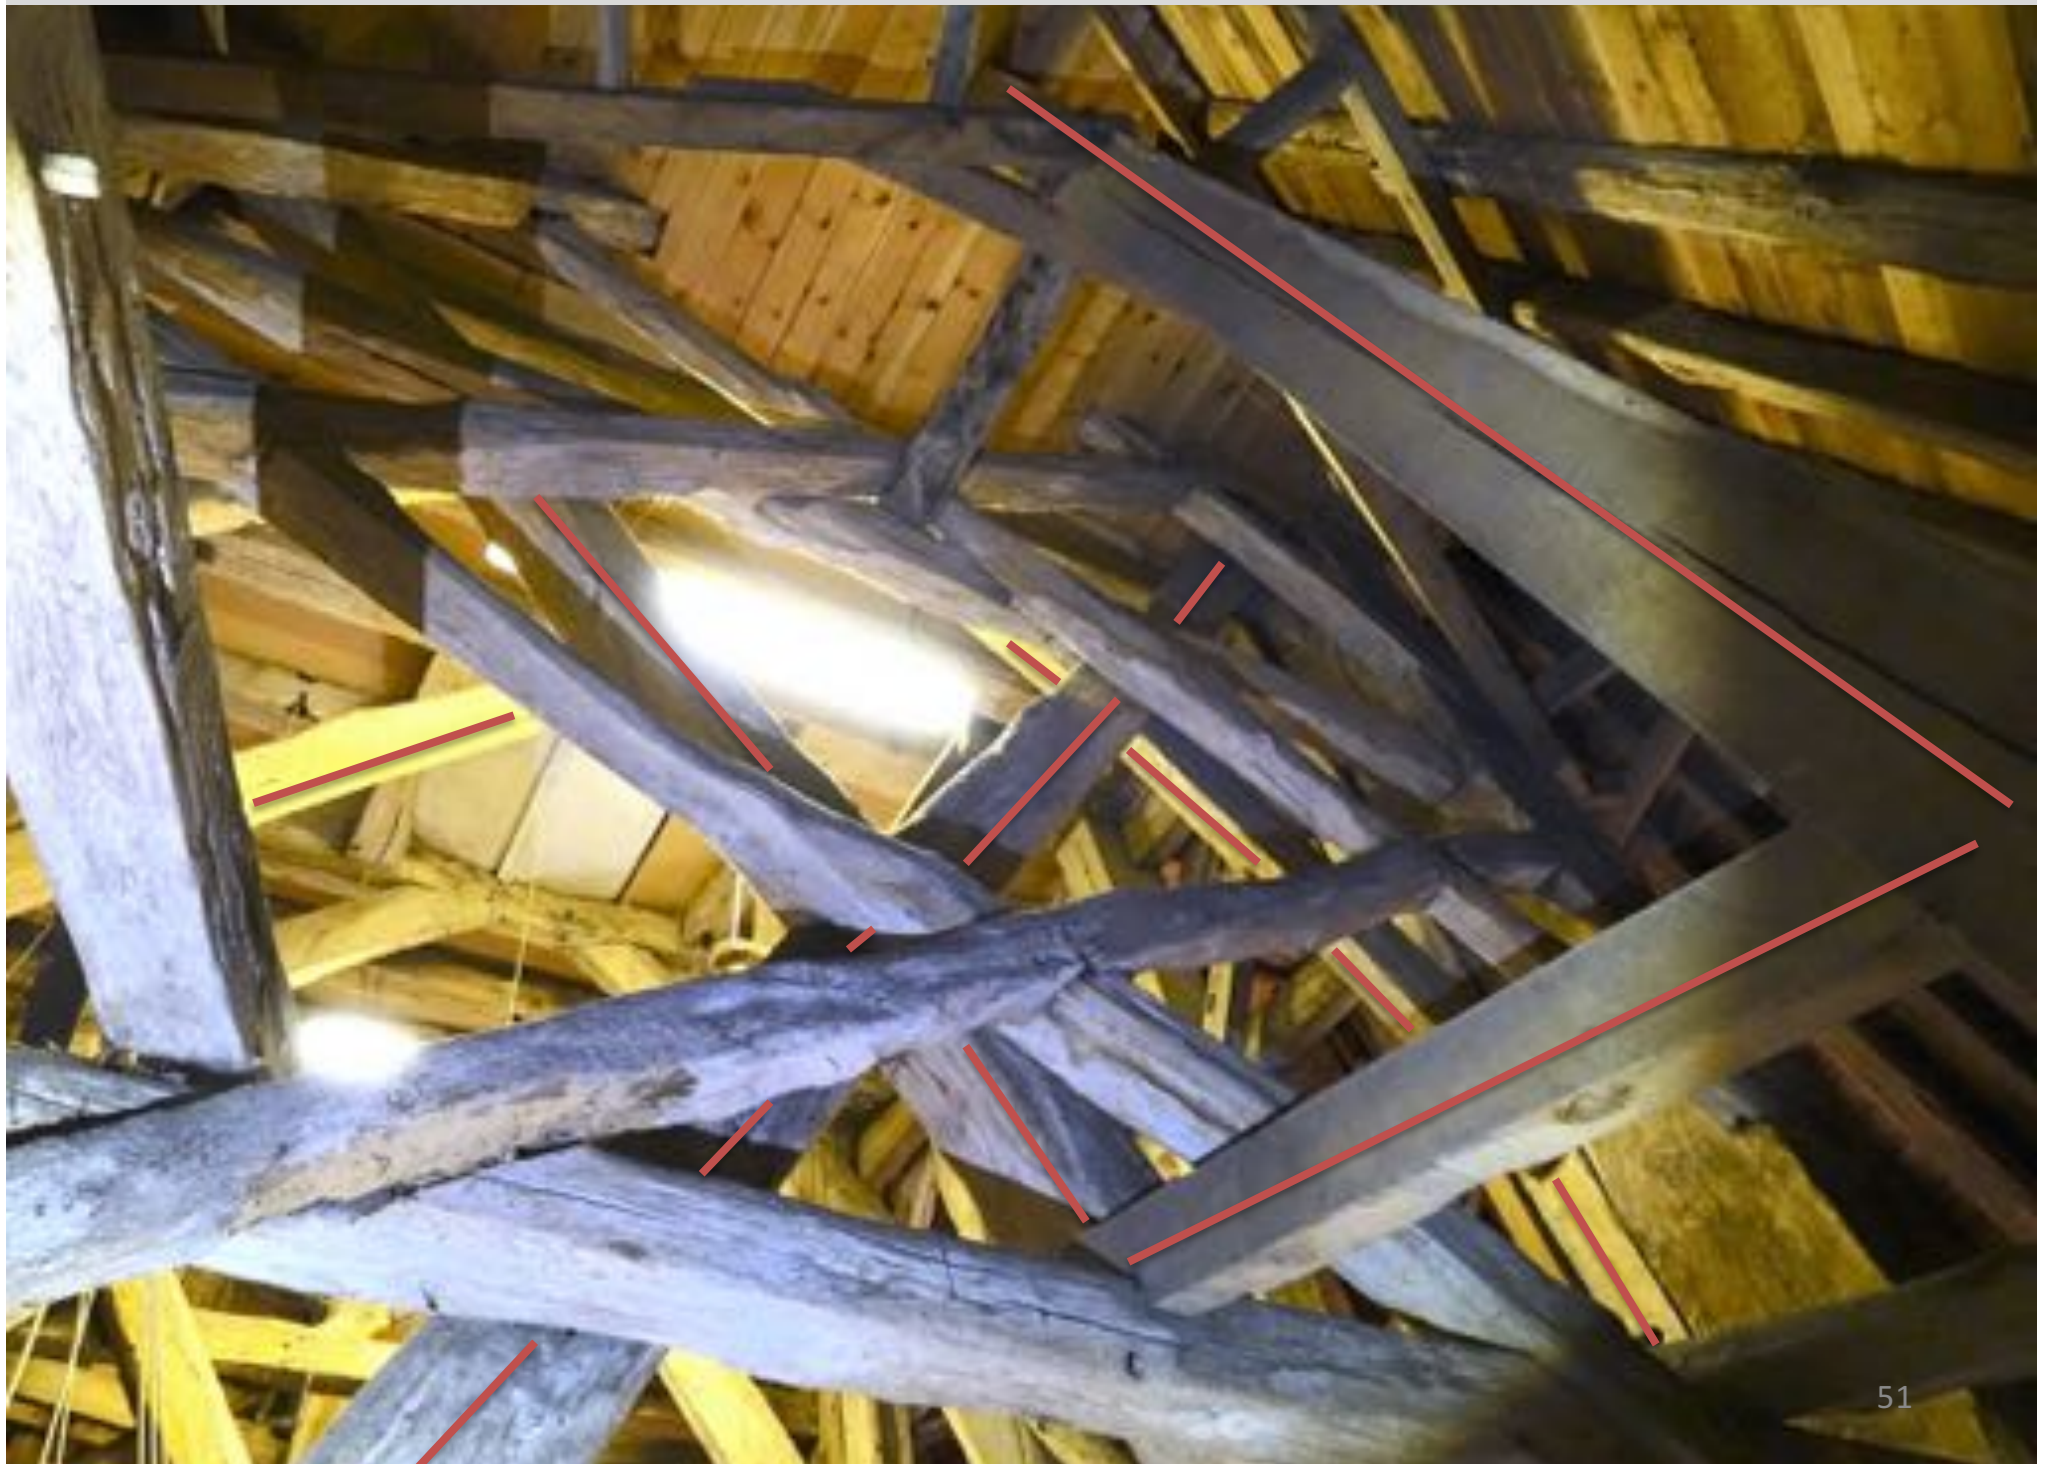
Originally the bell tower might have had some kind of skirt, similar to the one it has today or just a protection for the sills. There are **several mortices left open that reveal that parts have been removed**. The tower is stabilized by a system of lattice braces, open notch lapped to the posts outside. (On bell towers in Denmark and Sweden the braces are generally on the inside.) It is interesting to see that the original bell tower has sharp canted corners on the posts, compared to the younger tower. This can be compared with what we know from the Scandinavian towers. They had a different logic and preferred irregularities and sharp corners on the hewn timber instead of regular dimensions and round corners. The older braces have sapwood that has rotted and fallen off. Originally they may have had canted corners.

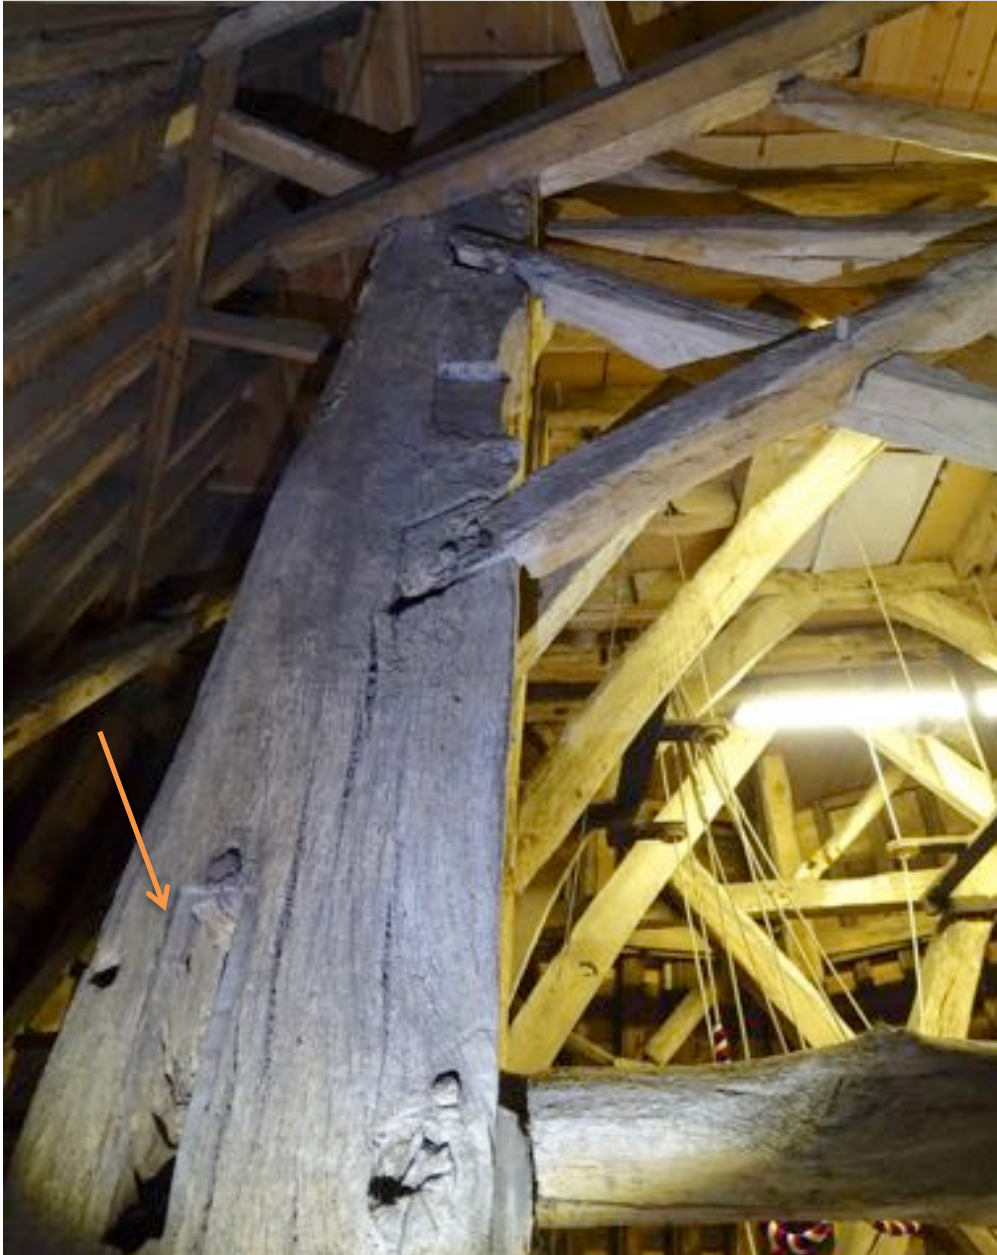
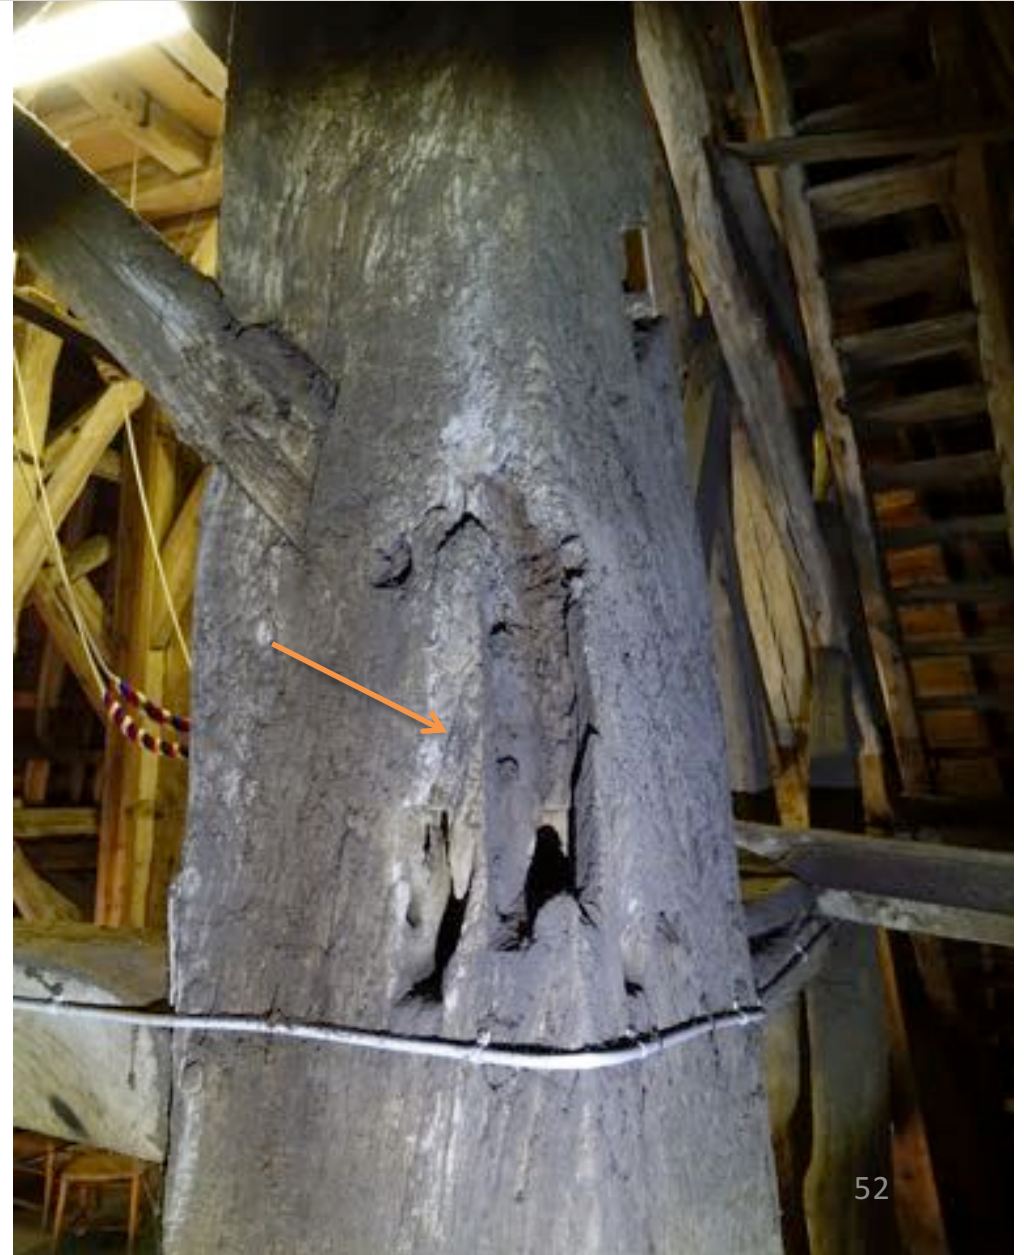
The lattice braces has been connected to the posts with open notched laps. The curved ends on the laps is a craft phenomena that we find occasionally all over Europe on campaniles and belfrys dating from 1250-1510.
