Carpentry art, excursion to England

The search for comparison of Scandinavian craftsmanship in medieval English carpentry art

This PM is the result of a carpentry art excursion made by Karl-Magnus Melin and Mattias Hallgren in april 2017. Karl-Magnus works as a carpenter and craft researcher at Knadriks Kulturbbygg, is project leader for the diocese project Historic carpentry art in the diocese of Lund and is a doctoral student at the University of Gothenburg.

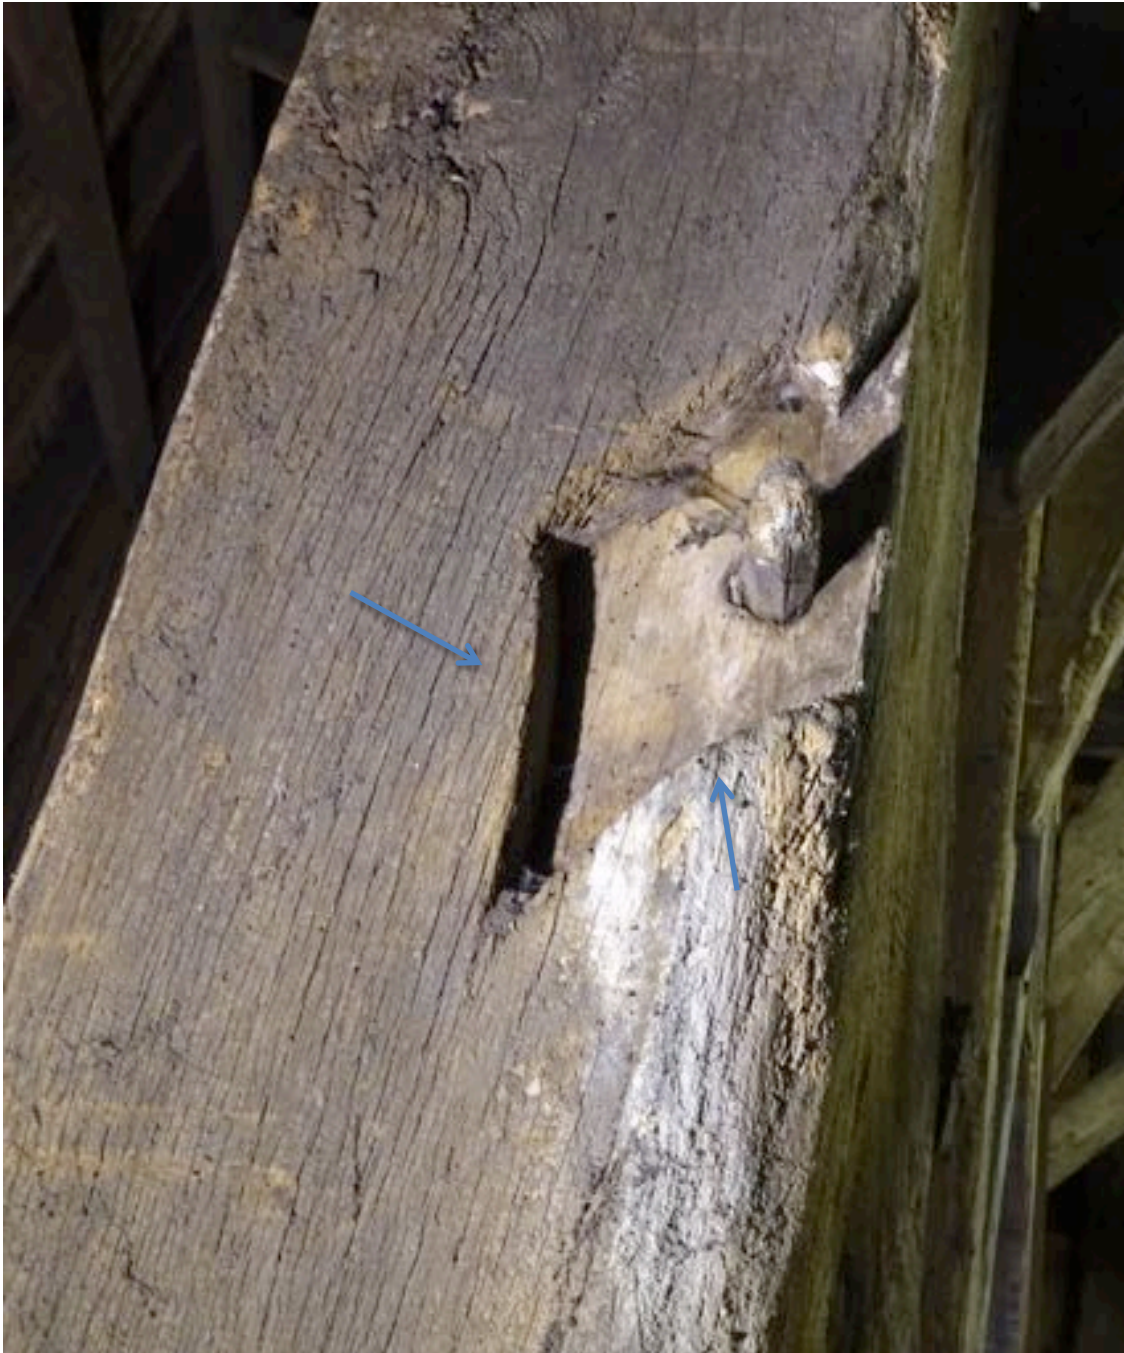
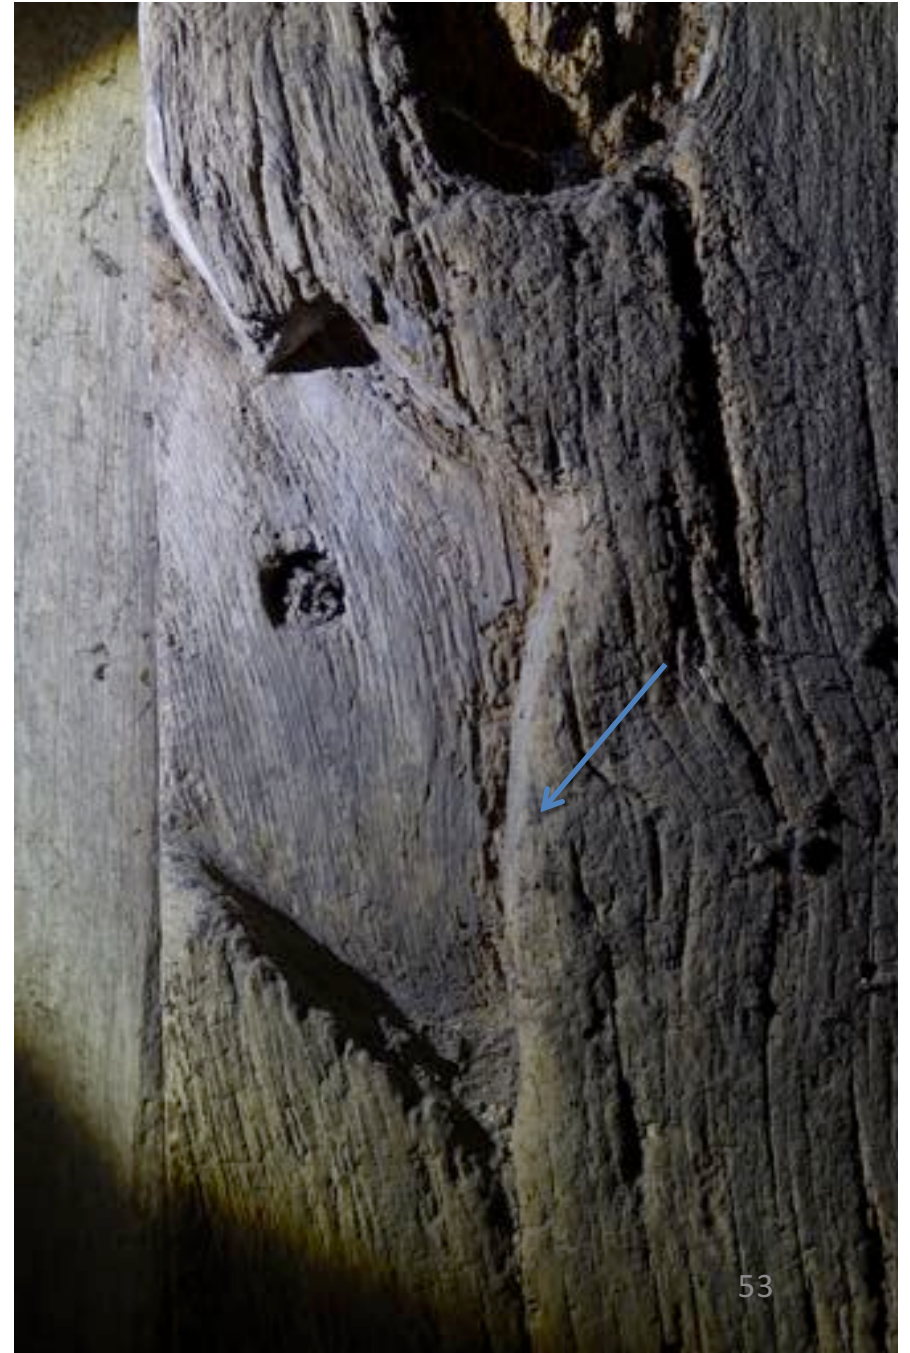
There are assembly marks on the old tower. One beam is full of other markings, we don't know if they are grafitti or not.

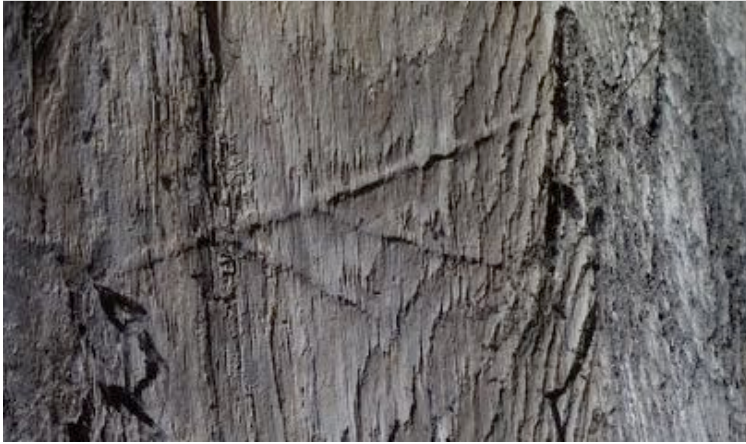
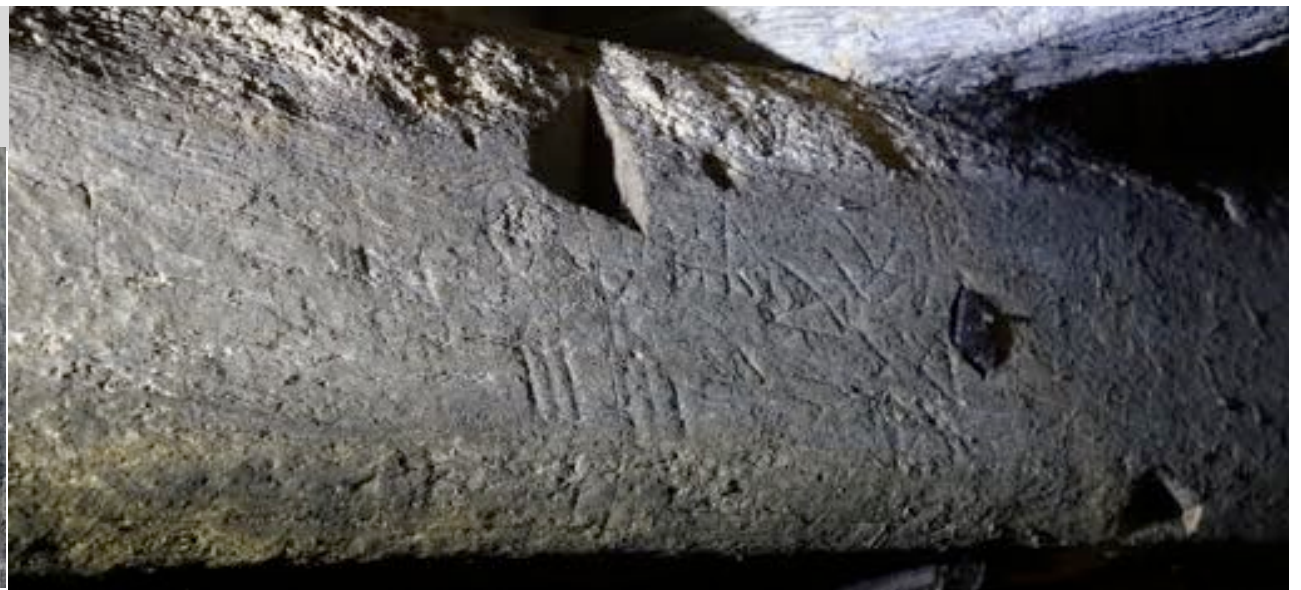
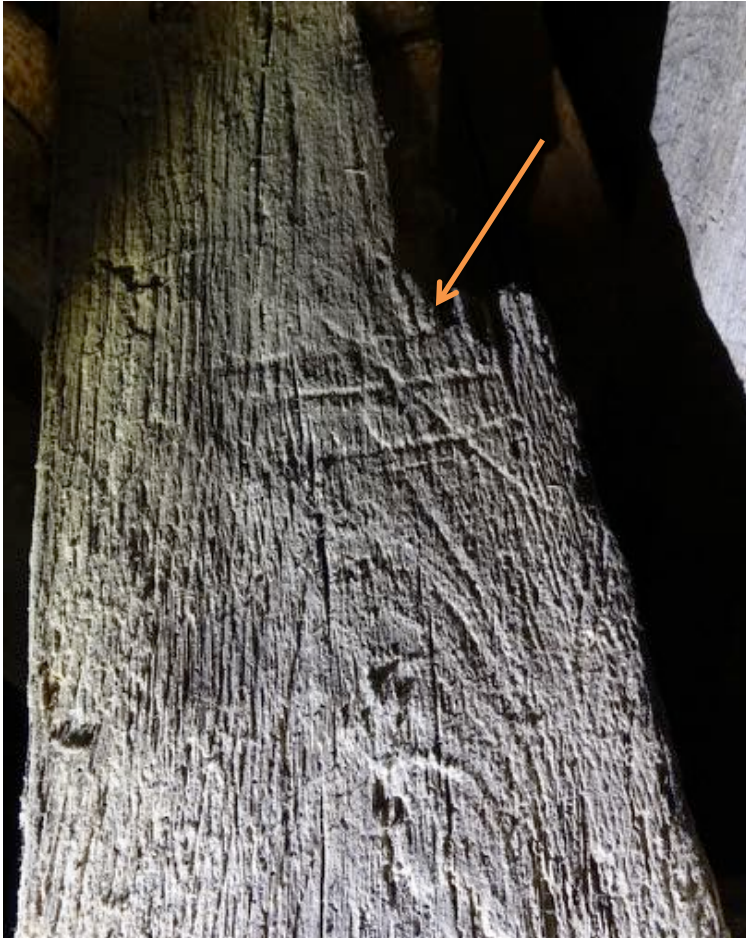
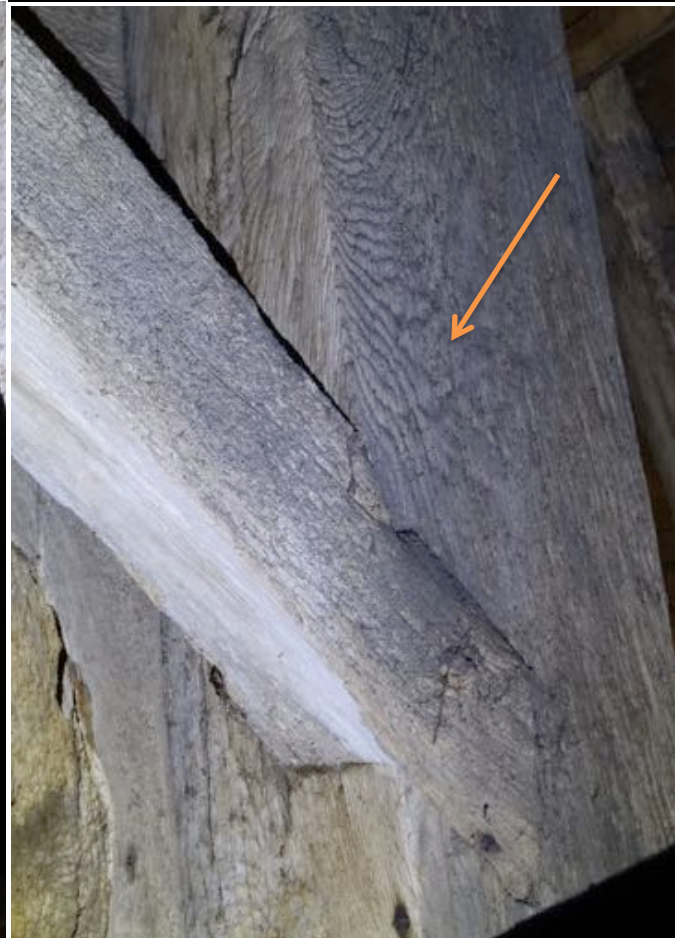
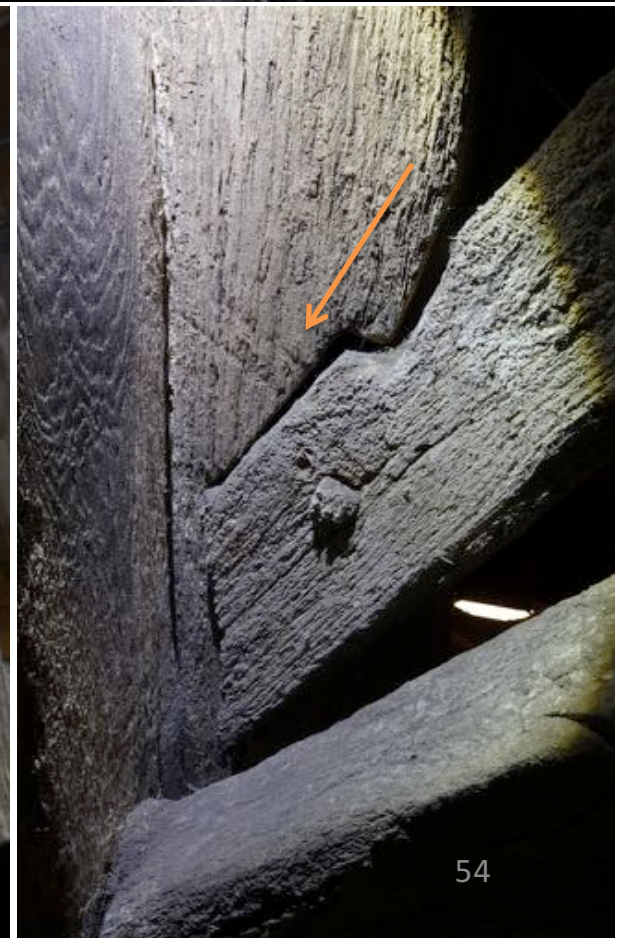
One very valuable piece is the only survivor of the octagonal ring beams, which have carried the heads and feet of the rafters of the three roof stages. If **this 1/8 of the ring beam** hadn't been there, the original roof construction would have been difficult to explain.

Left, seen from north and right, seen from south.

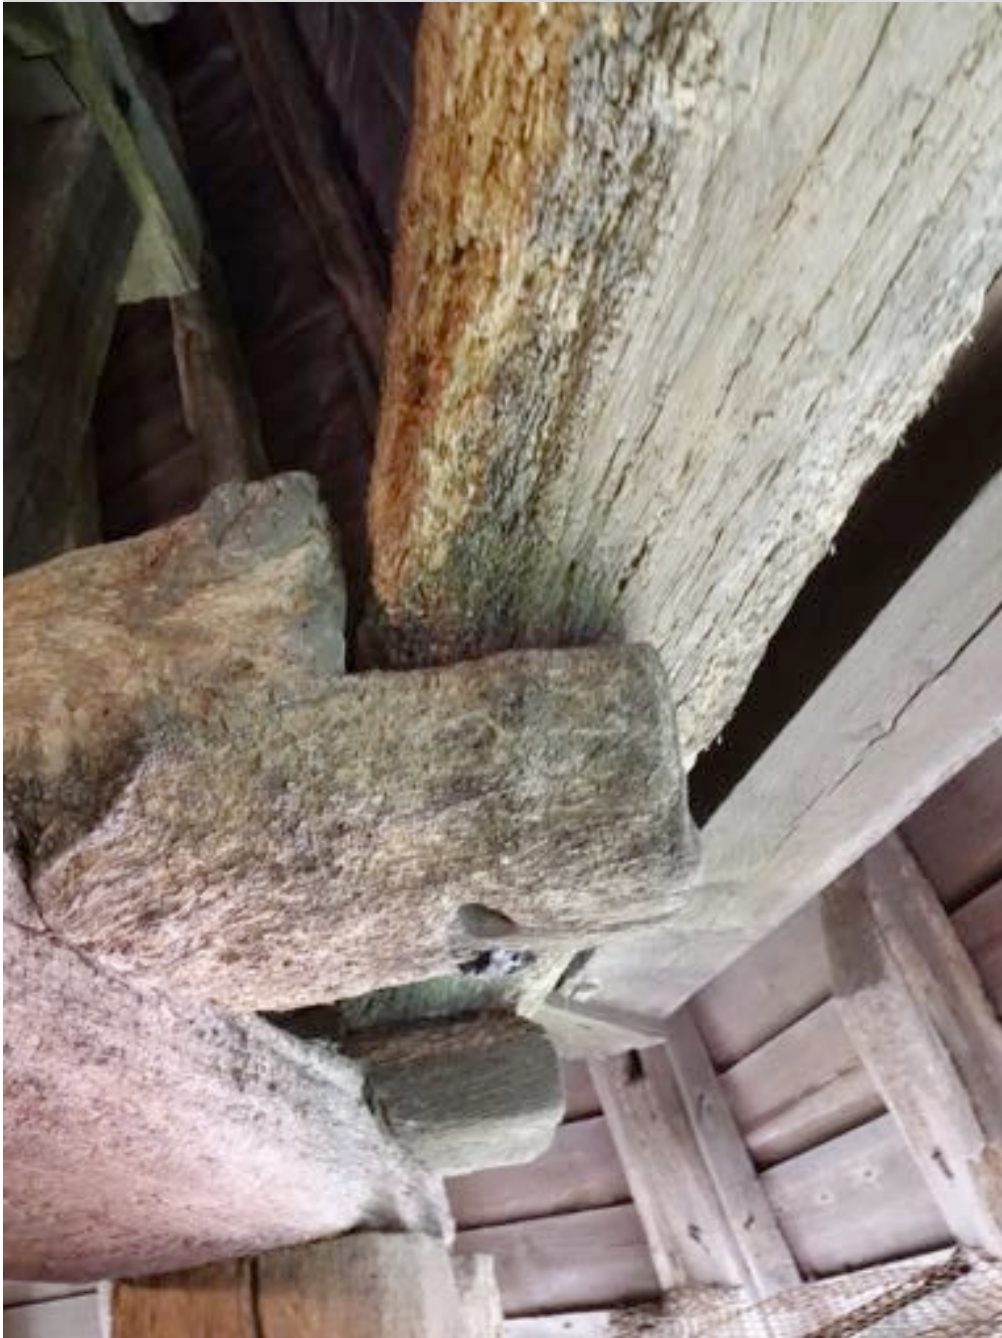
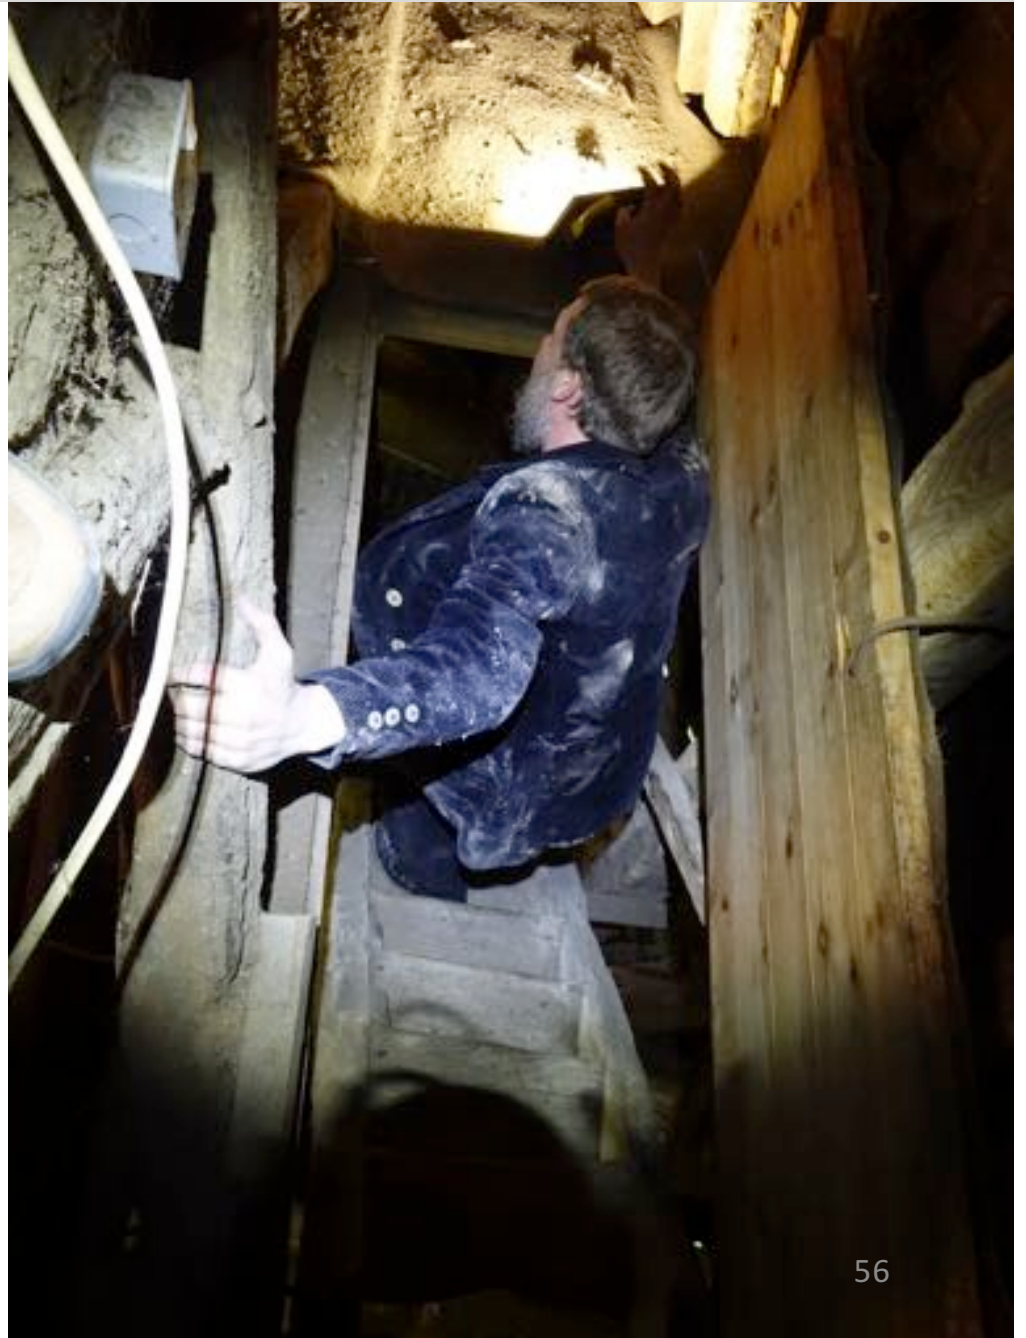
Left, the octagonal frame seen from underneath, supported by the tiebeams hanging out.

Right, Karl-Magnus searching for toolmarks in the dusty environment.

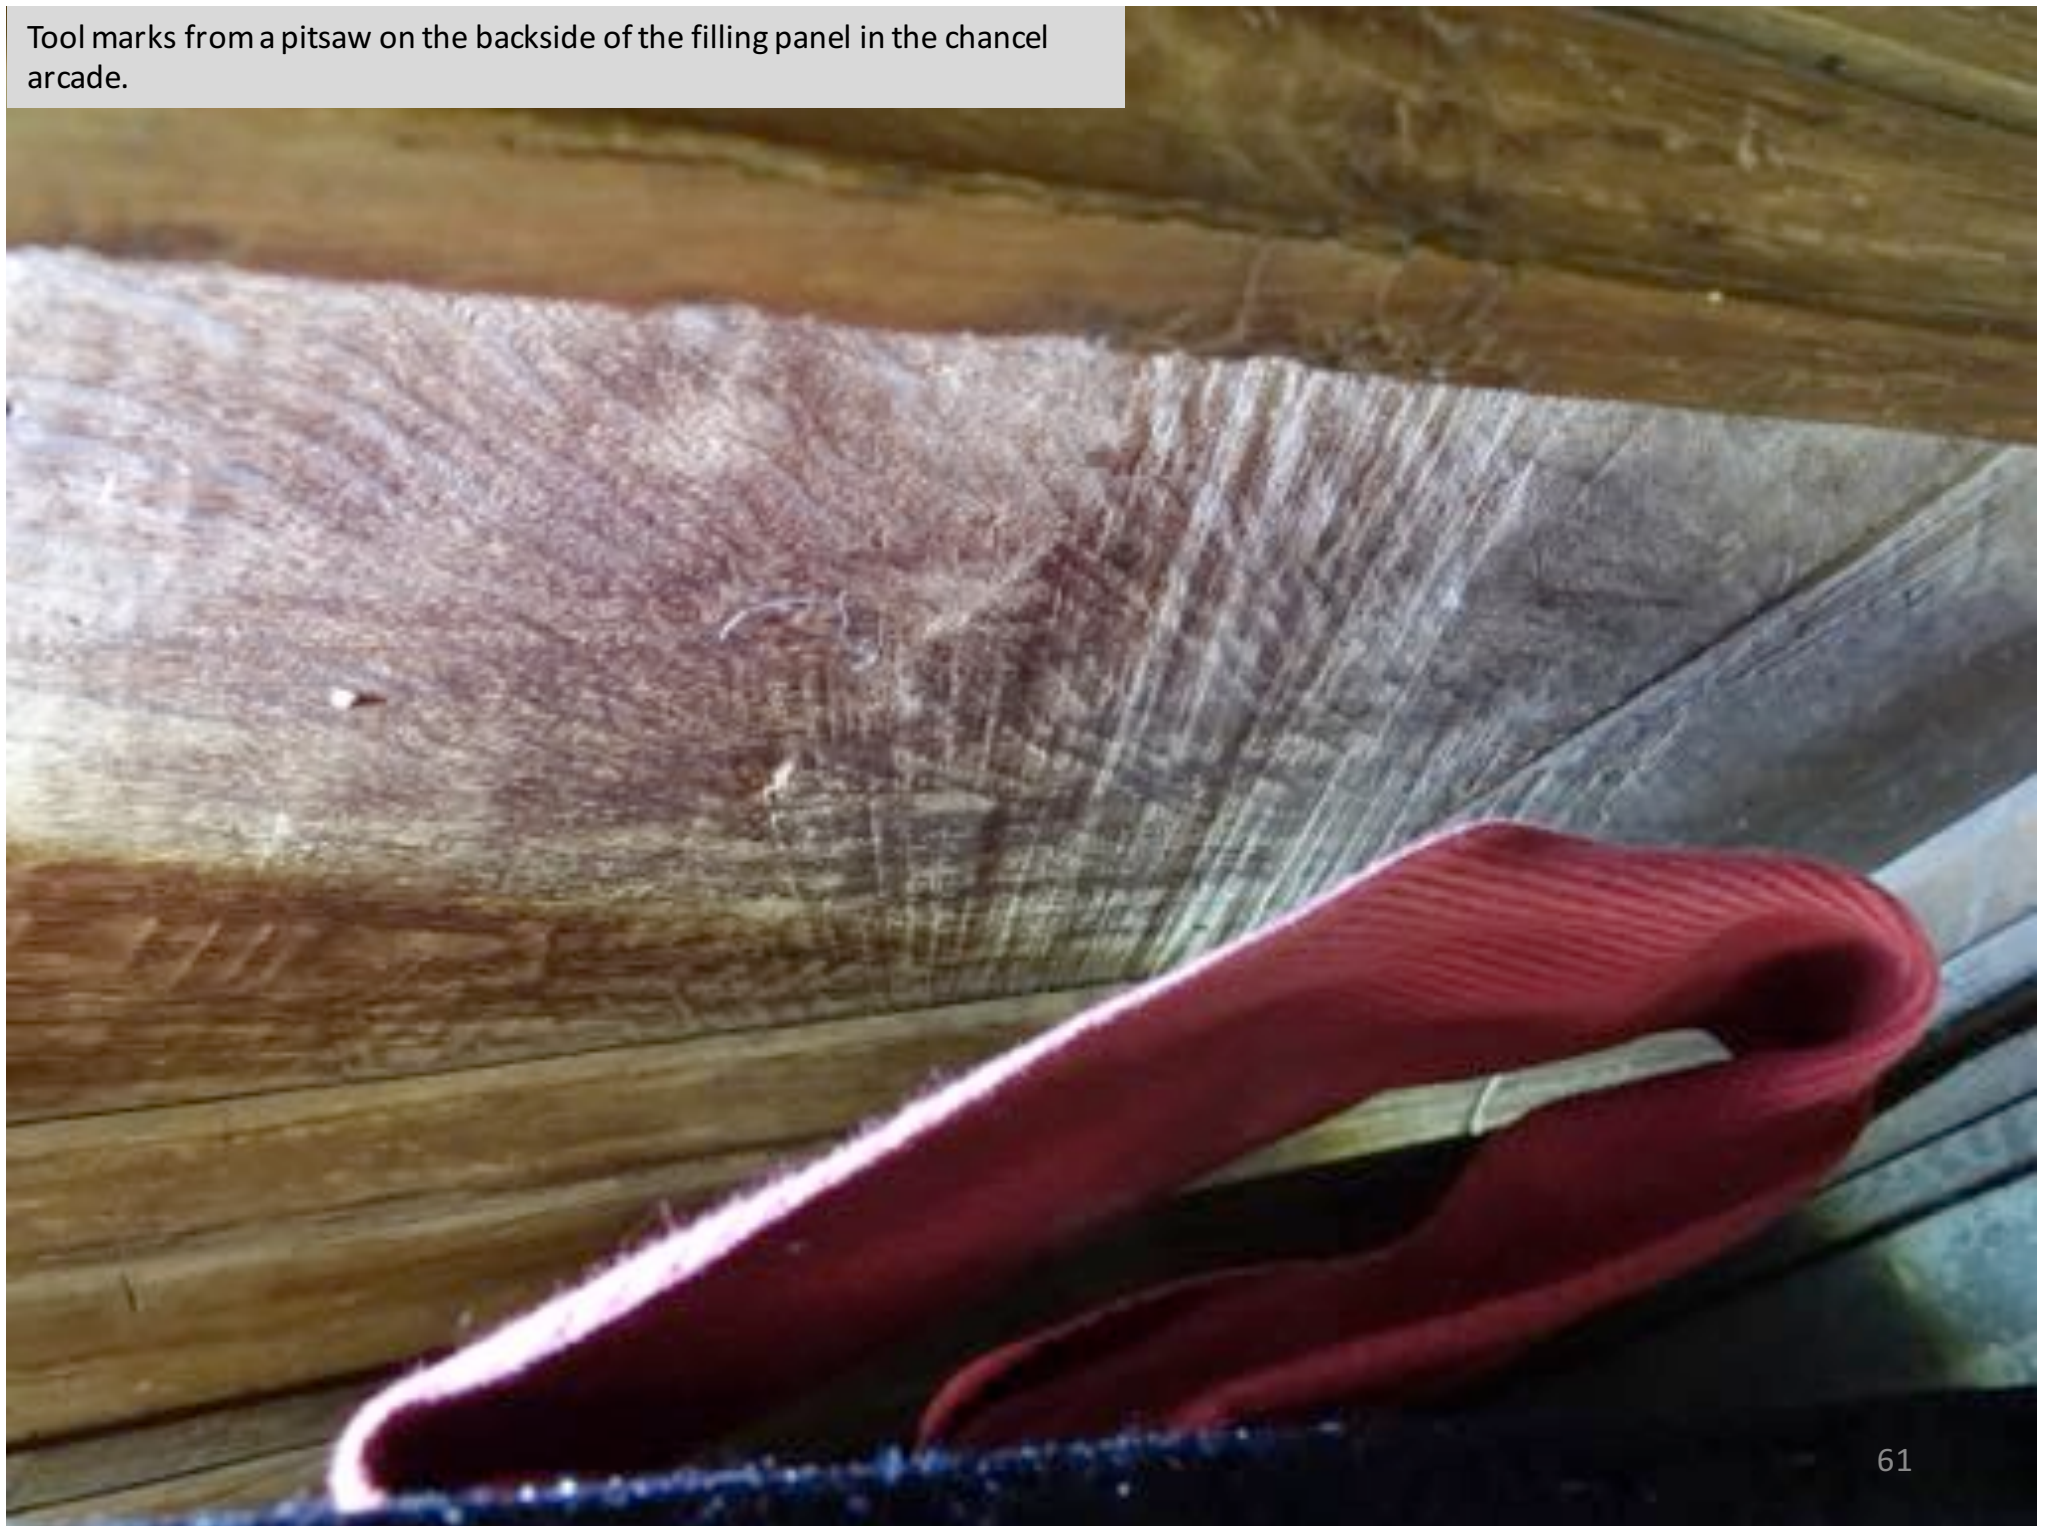
Tool marks from a pitsaw on the backside of the filling panel in the chancel arcade.

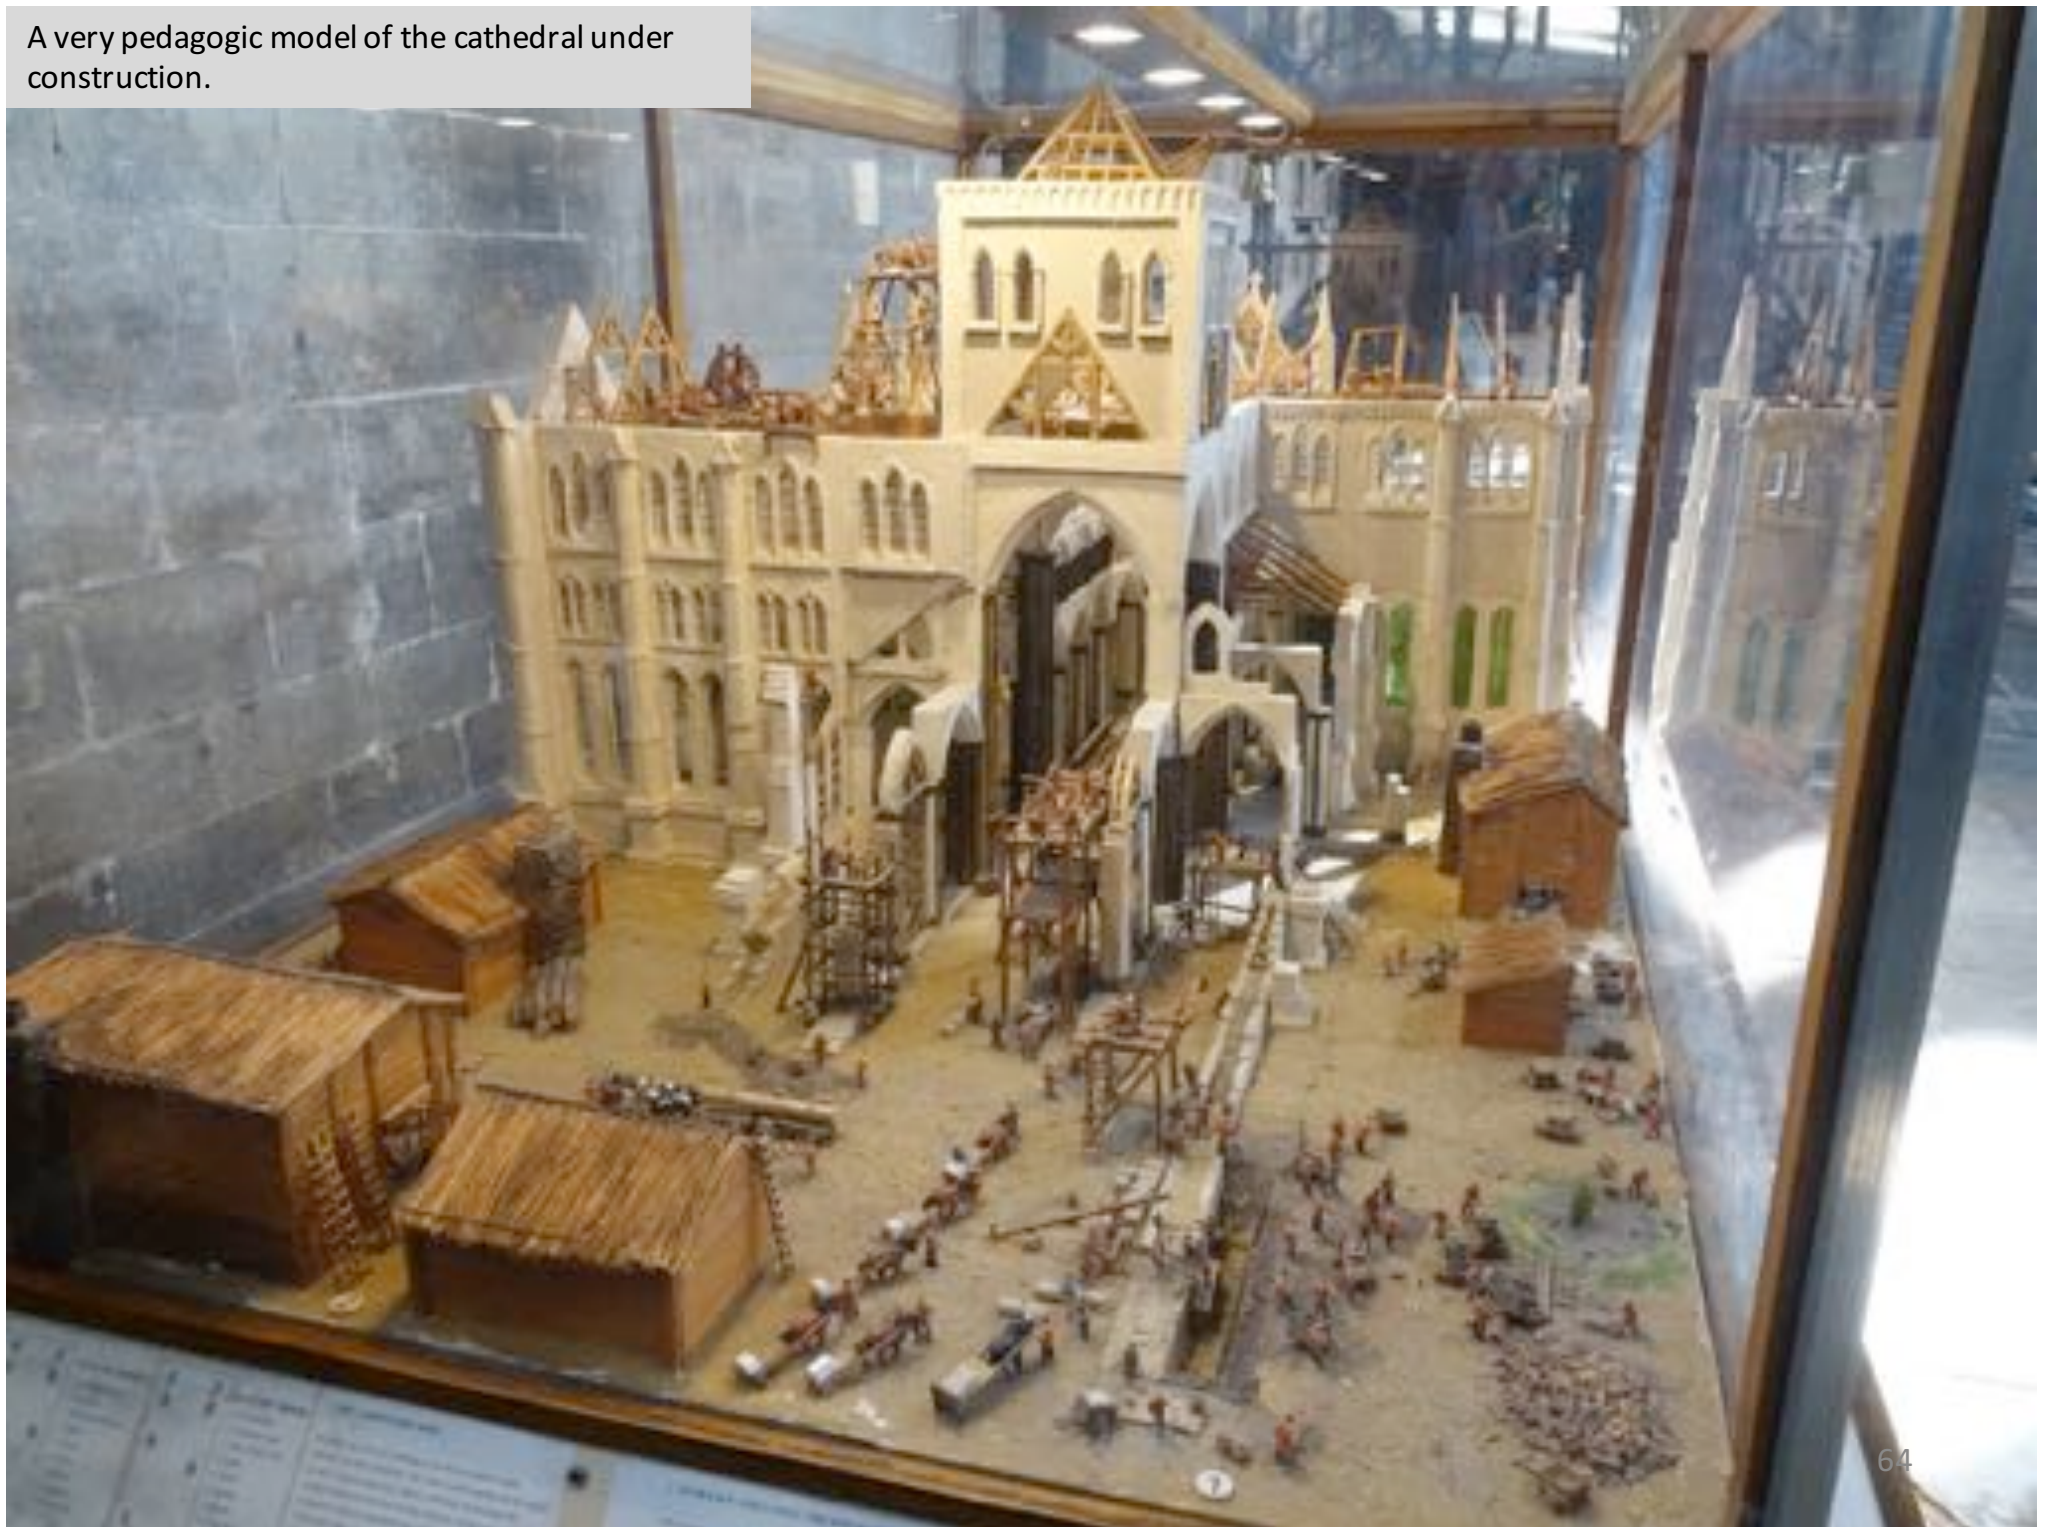
A very pedagogic model of the cathedral under construction.

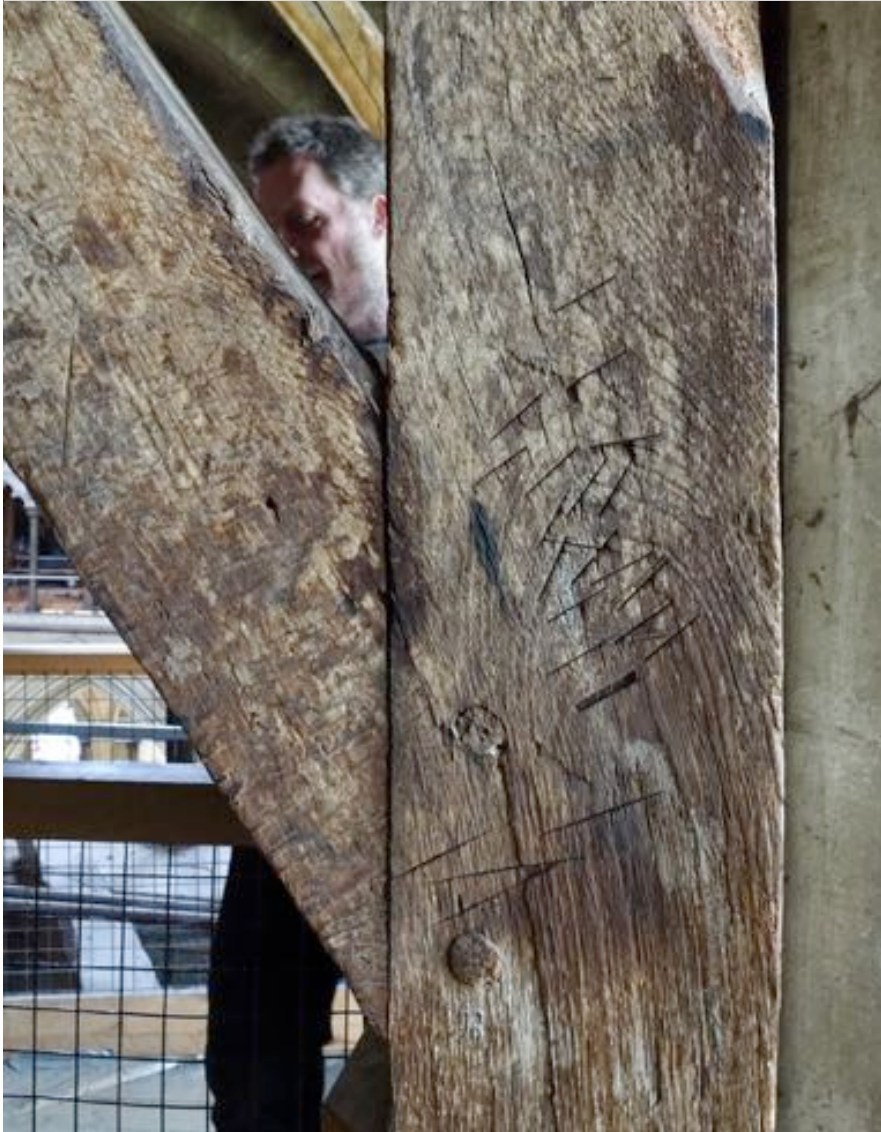
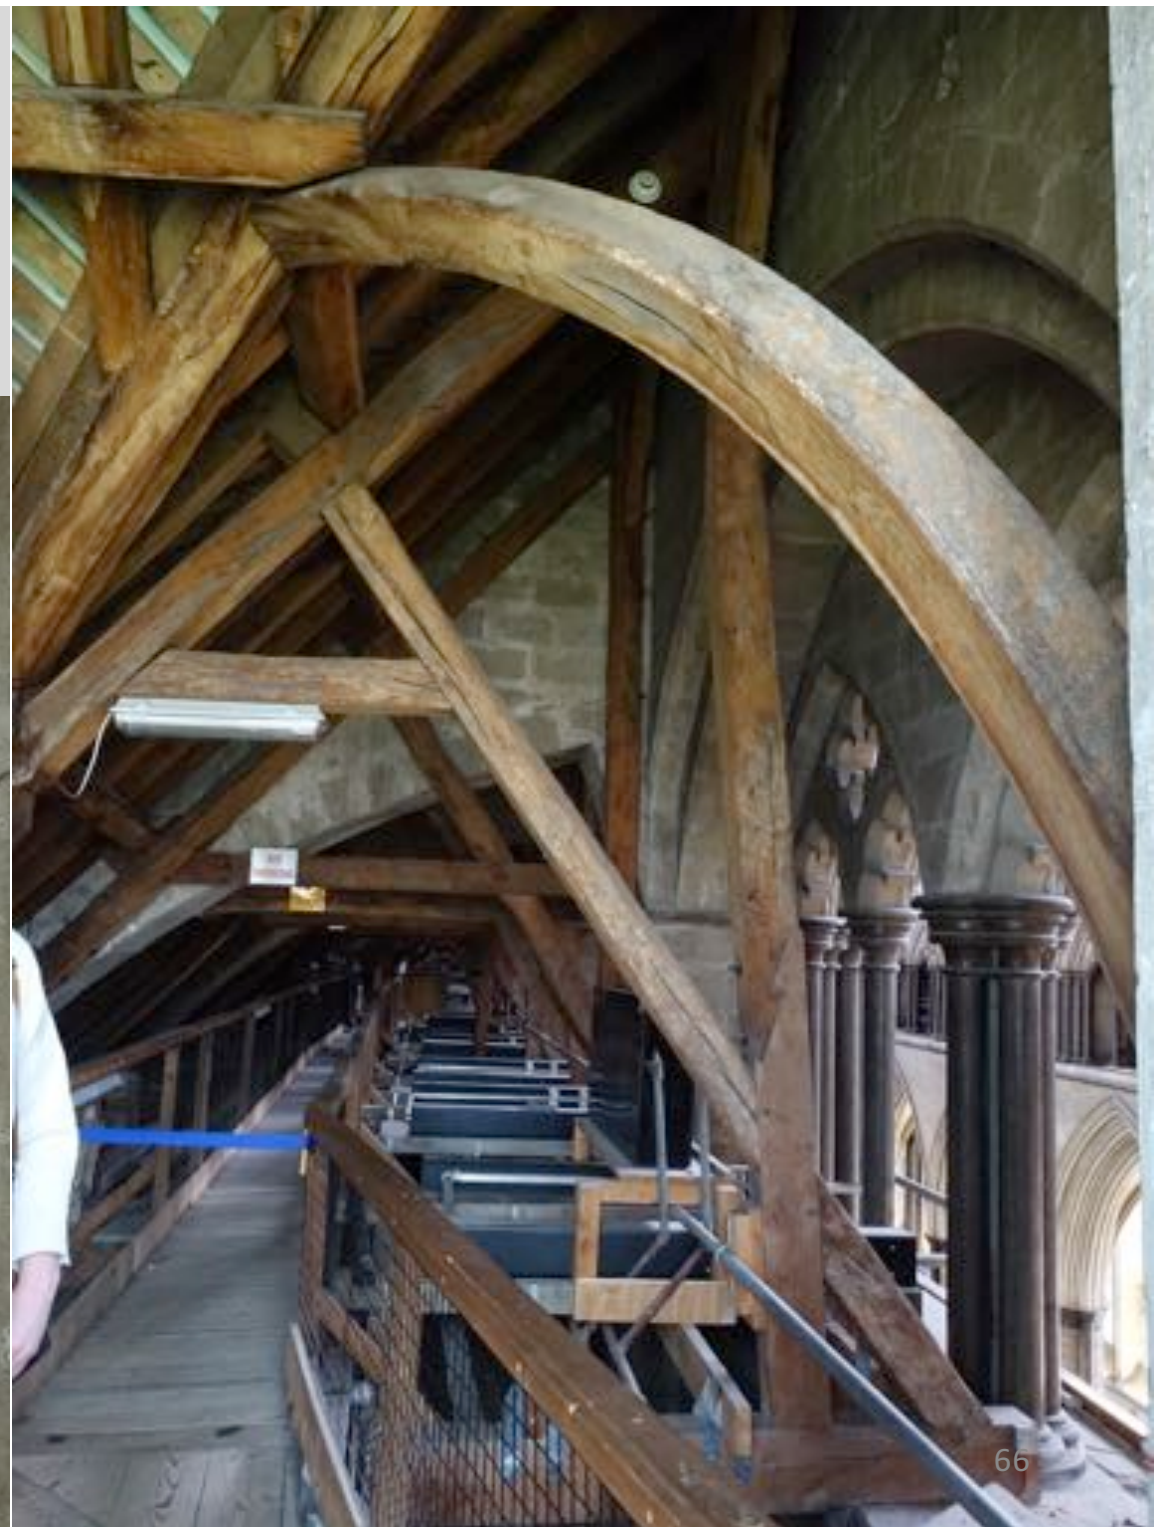
There were lots of graffiti and craftsmens "discussion sketches" on both wood and stone surfaces.

To the right, a curved piece of wood, naturally bent and selected for this specific use.

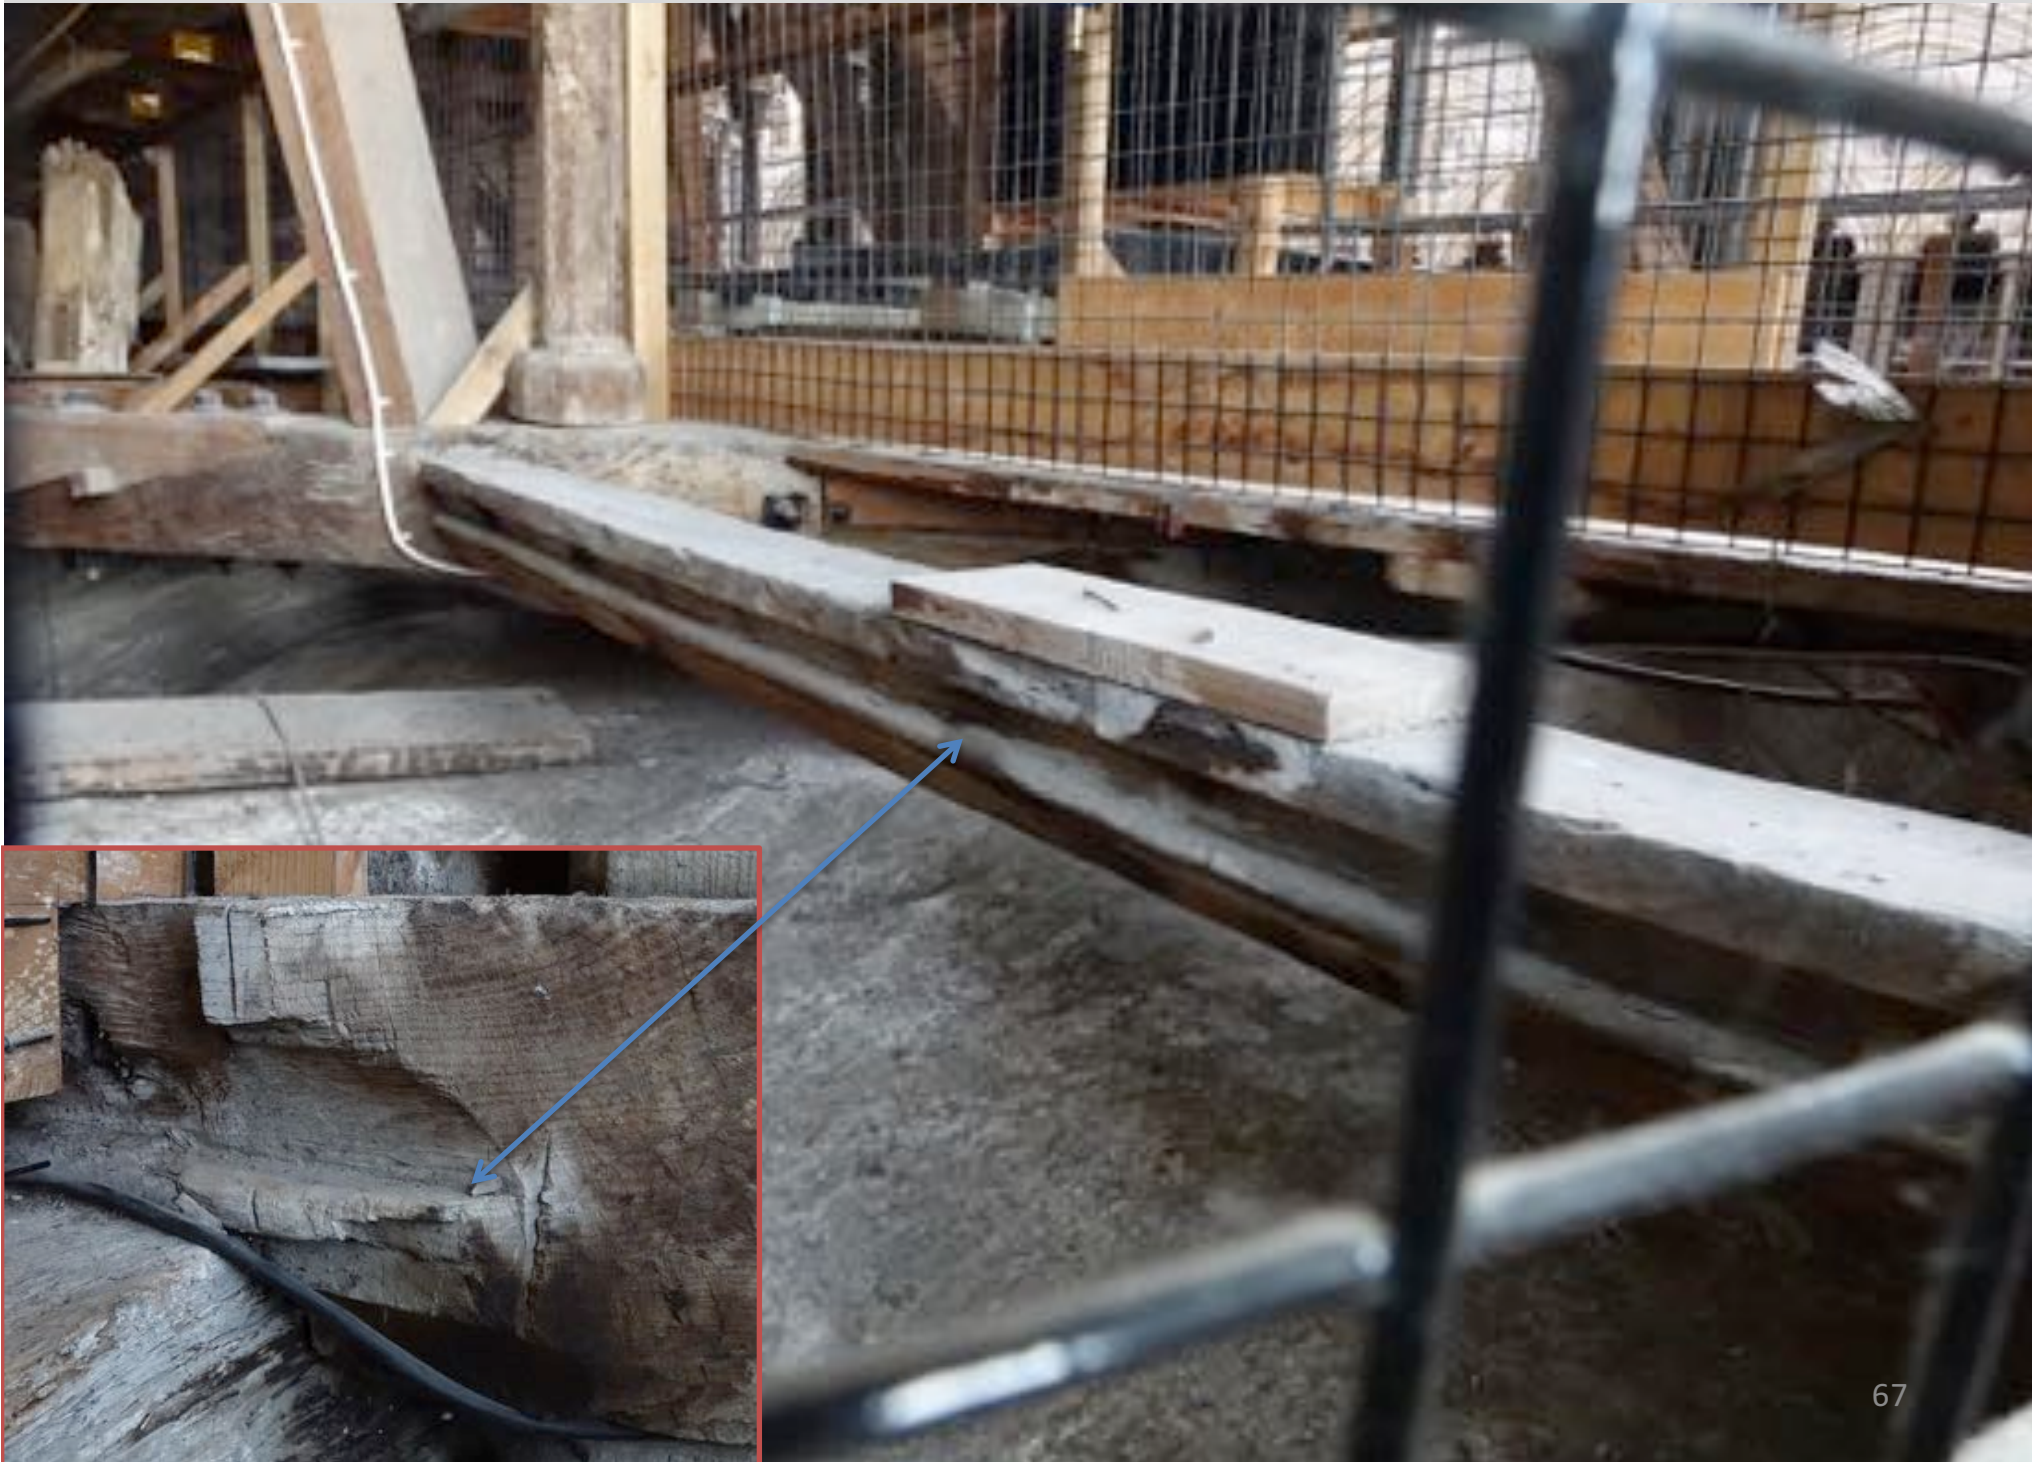
A profiled timber in the northwest corner over the vault.
