Carpentry art, excursion to England

The search for comparison of Scandinavian craftsmanship in medieval English carpentry art

This PM is the result of a carpentry art excursion made by Karl-Magnus Melin and Mattias Hallgren in april 2017. Karl-Magnus works as a carpenter and craft researcher at Knadriks Kulturbbygg, is project leader for the diocese project Historic carpentry art in the diocese of Lund and is a doctoral student at the University of Gothenburg.

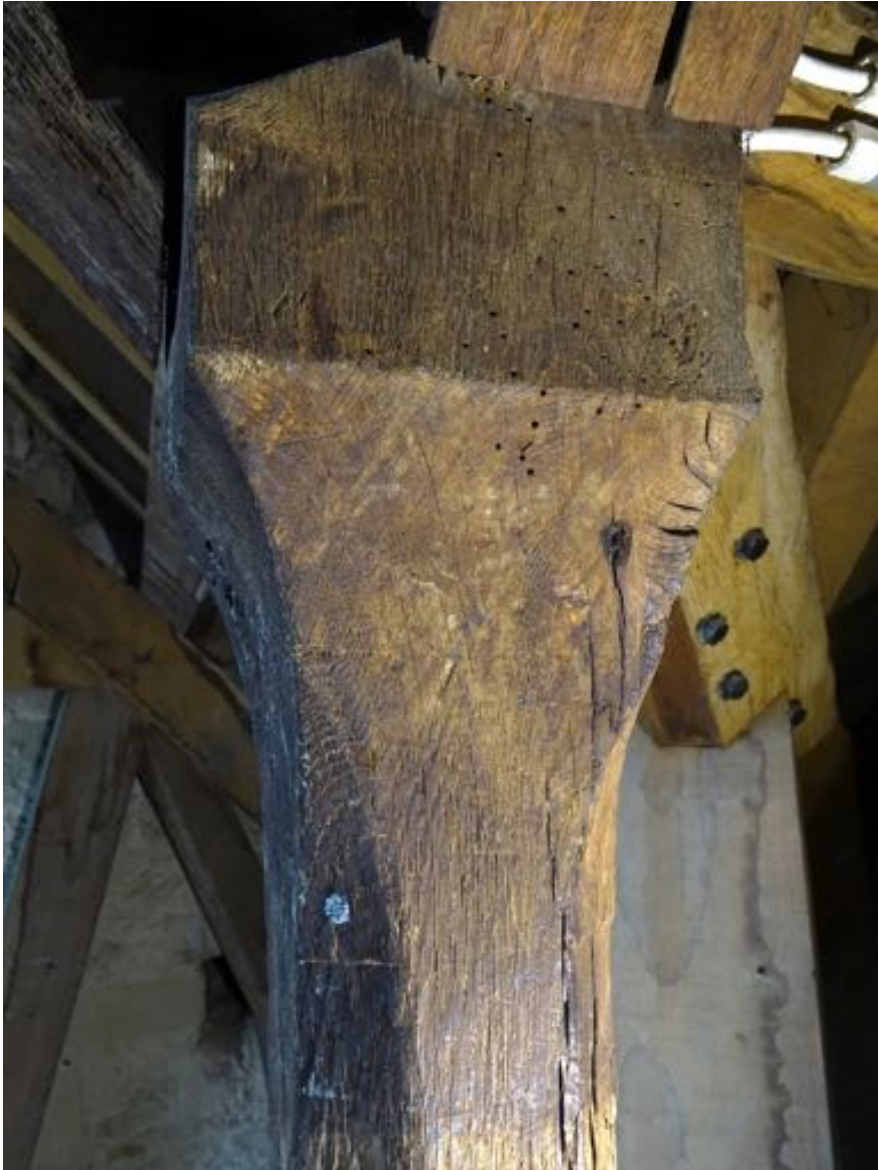
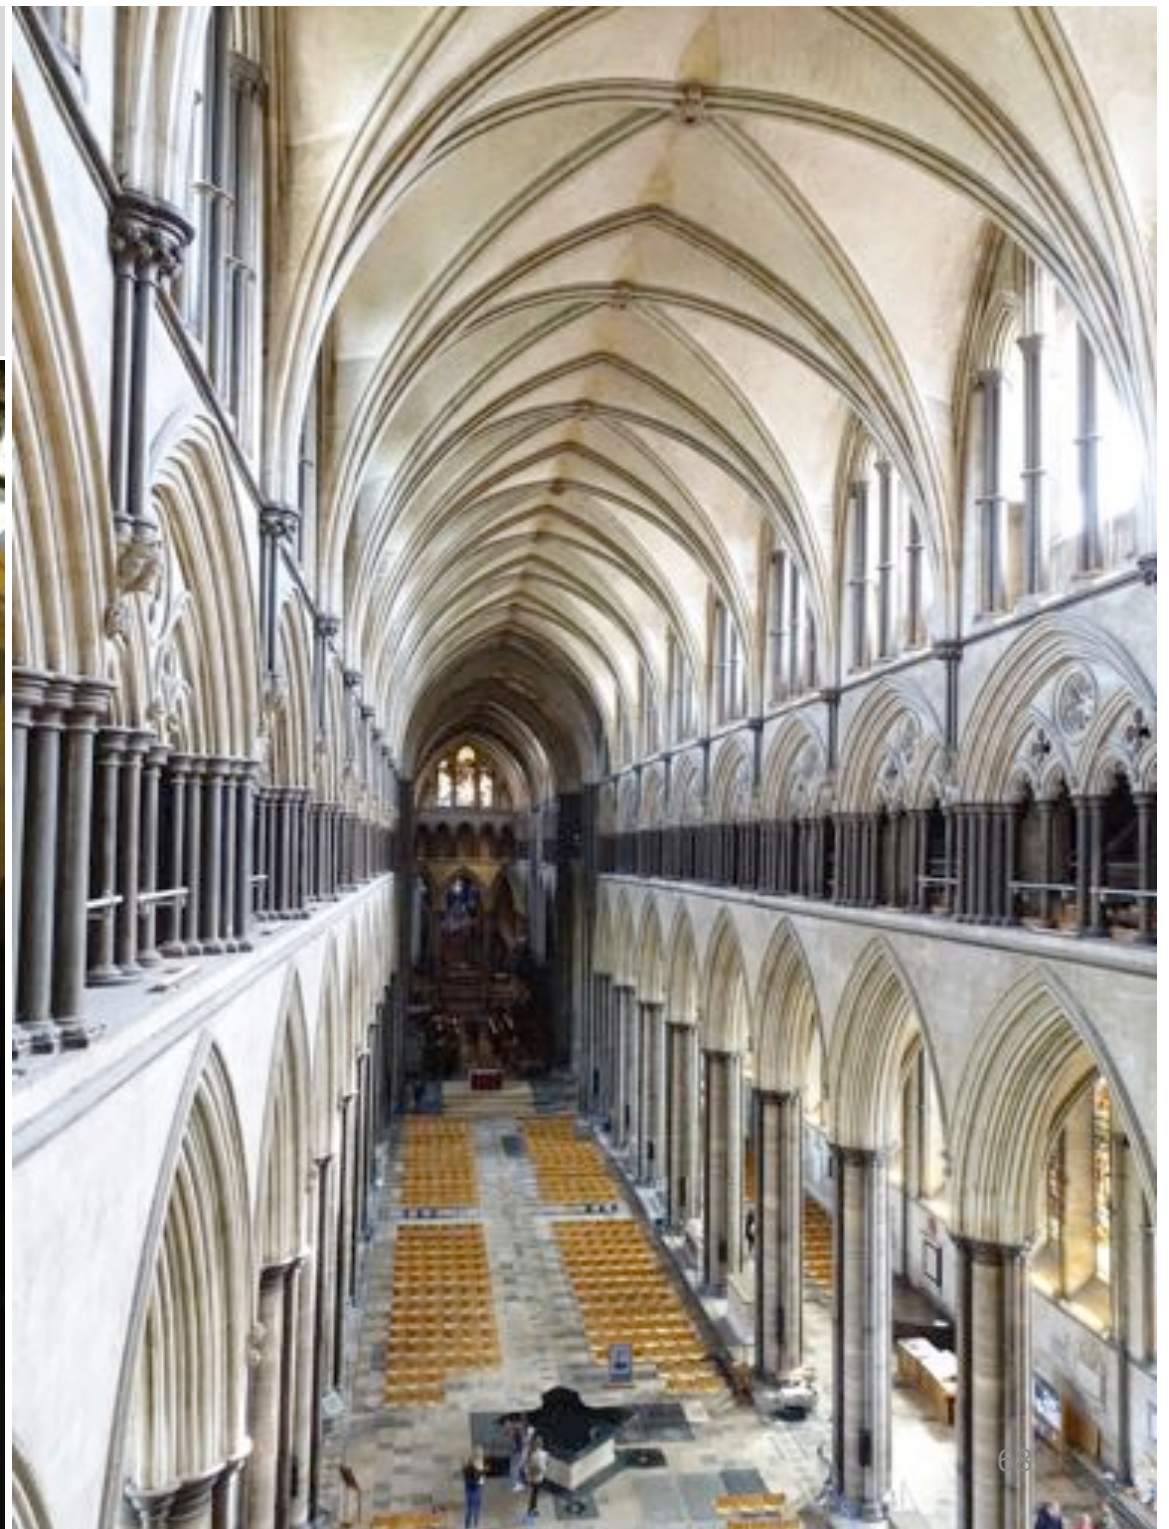
Some of the posts were nicely shaped and it was still possible to see the guiding lines scribed on the surface.

To the right, the nave seen from west.

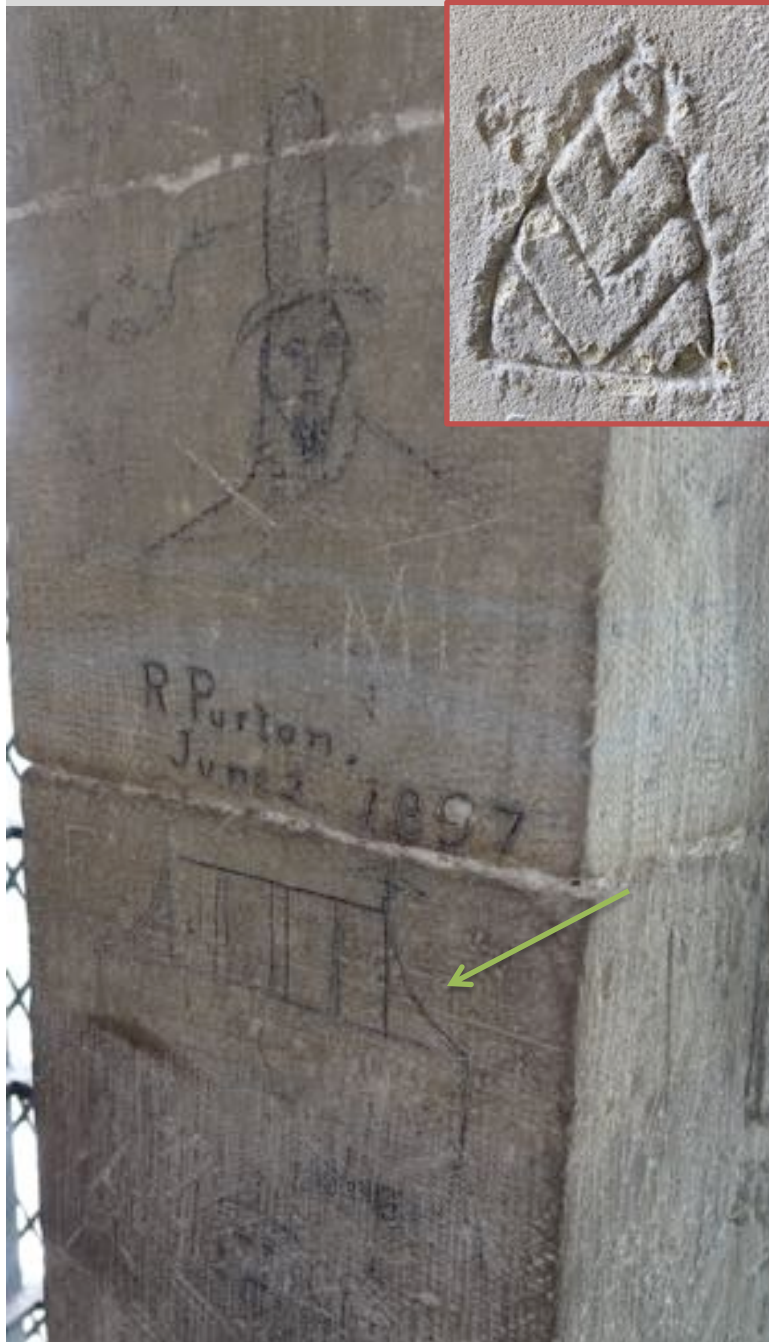
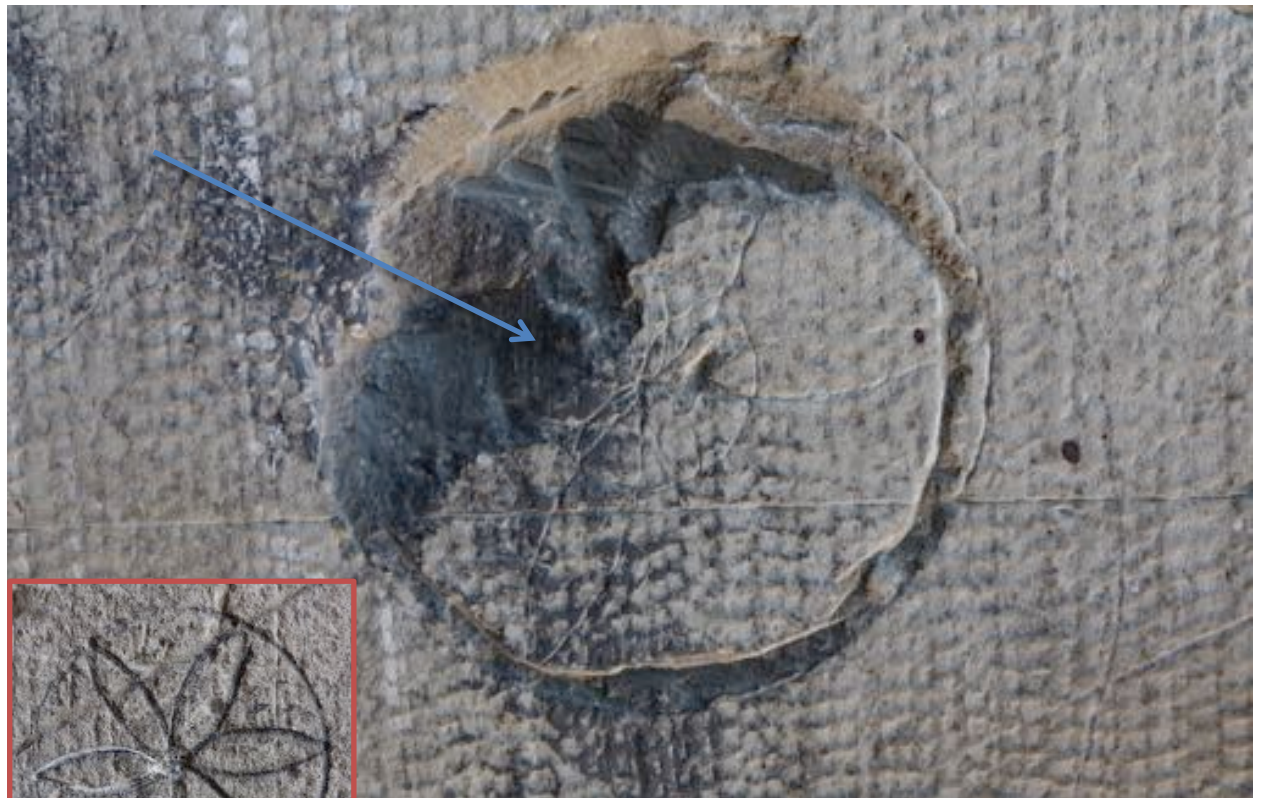
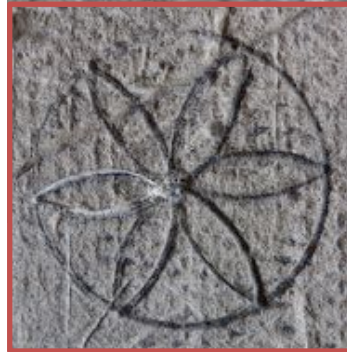
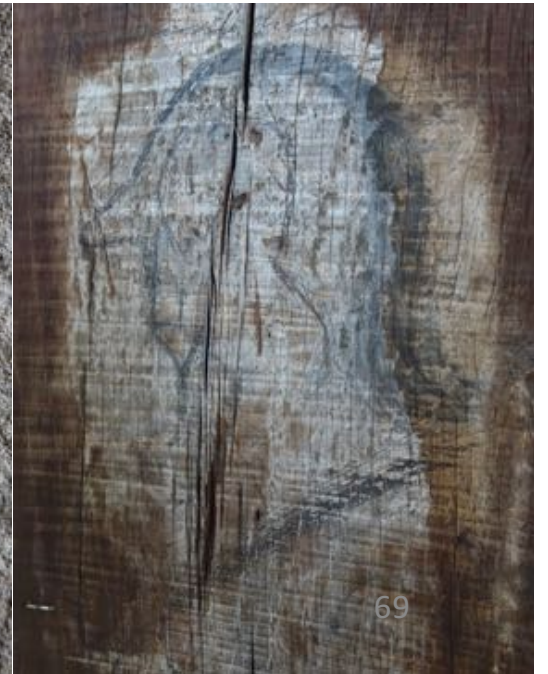
Graffiti and a daisywheel flower and a roof constructions scribed on the stone walls.

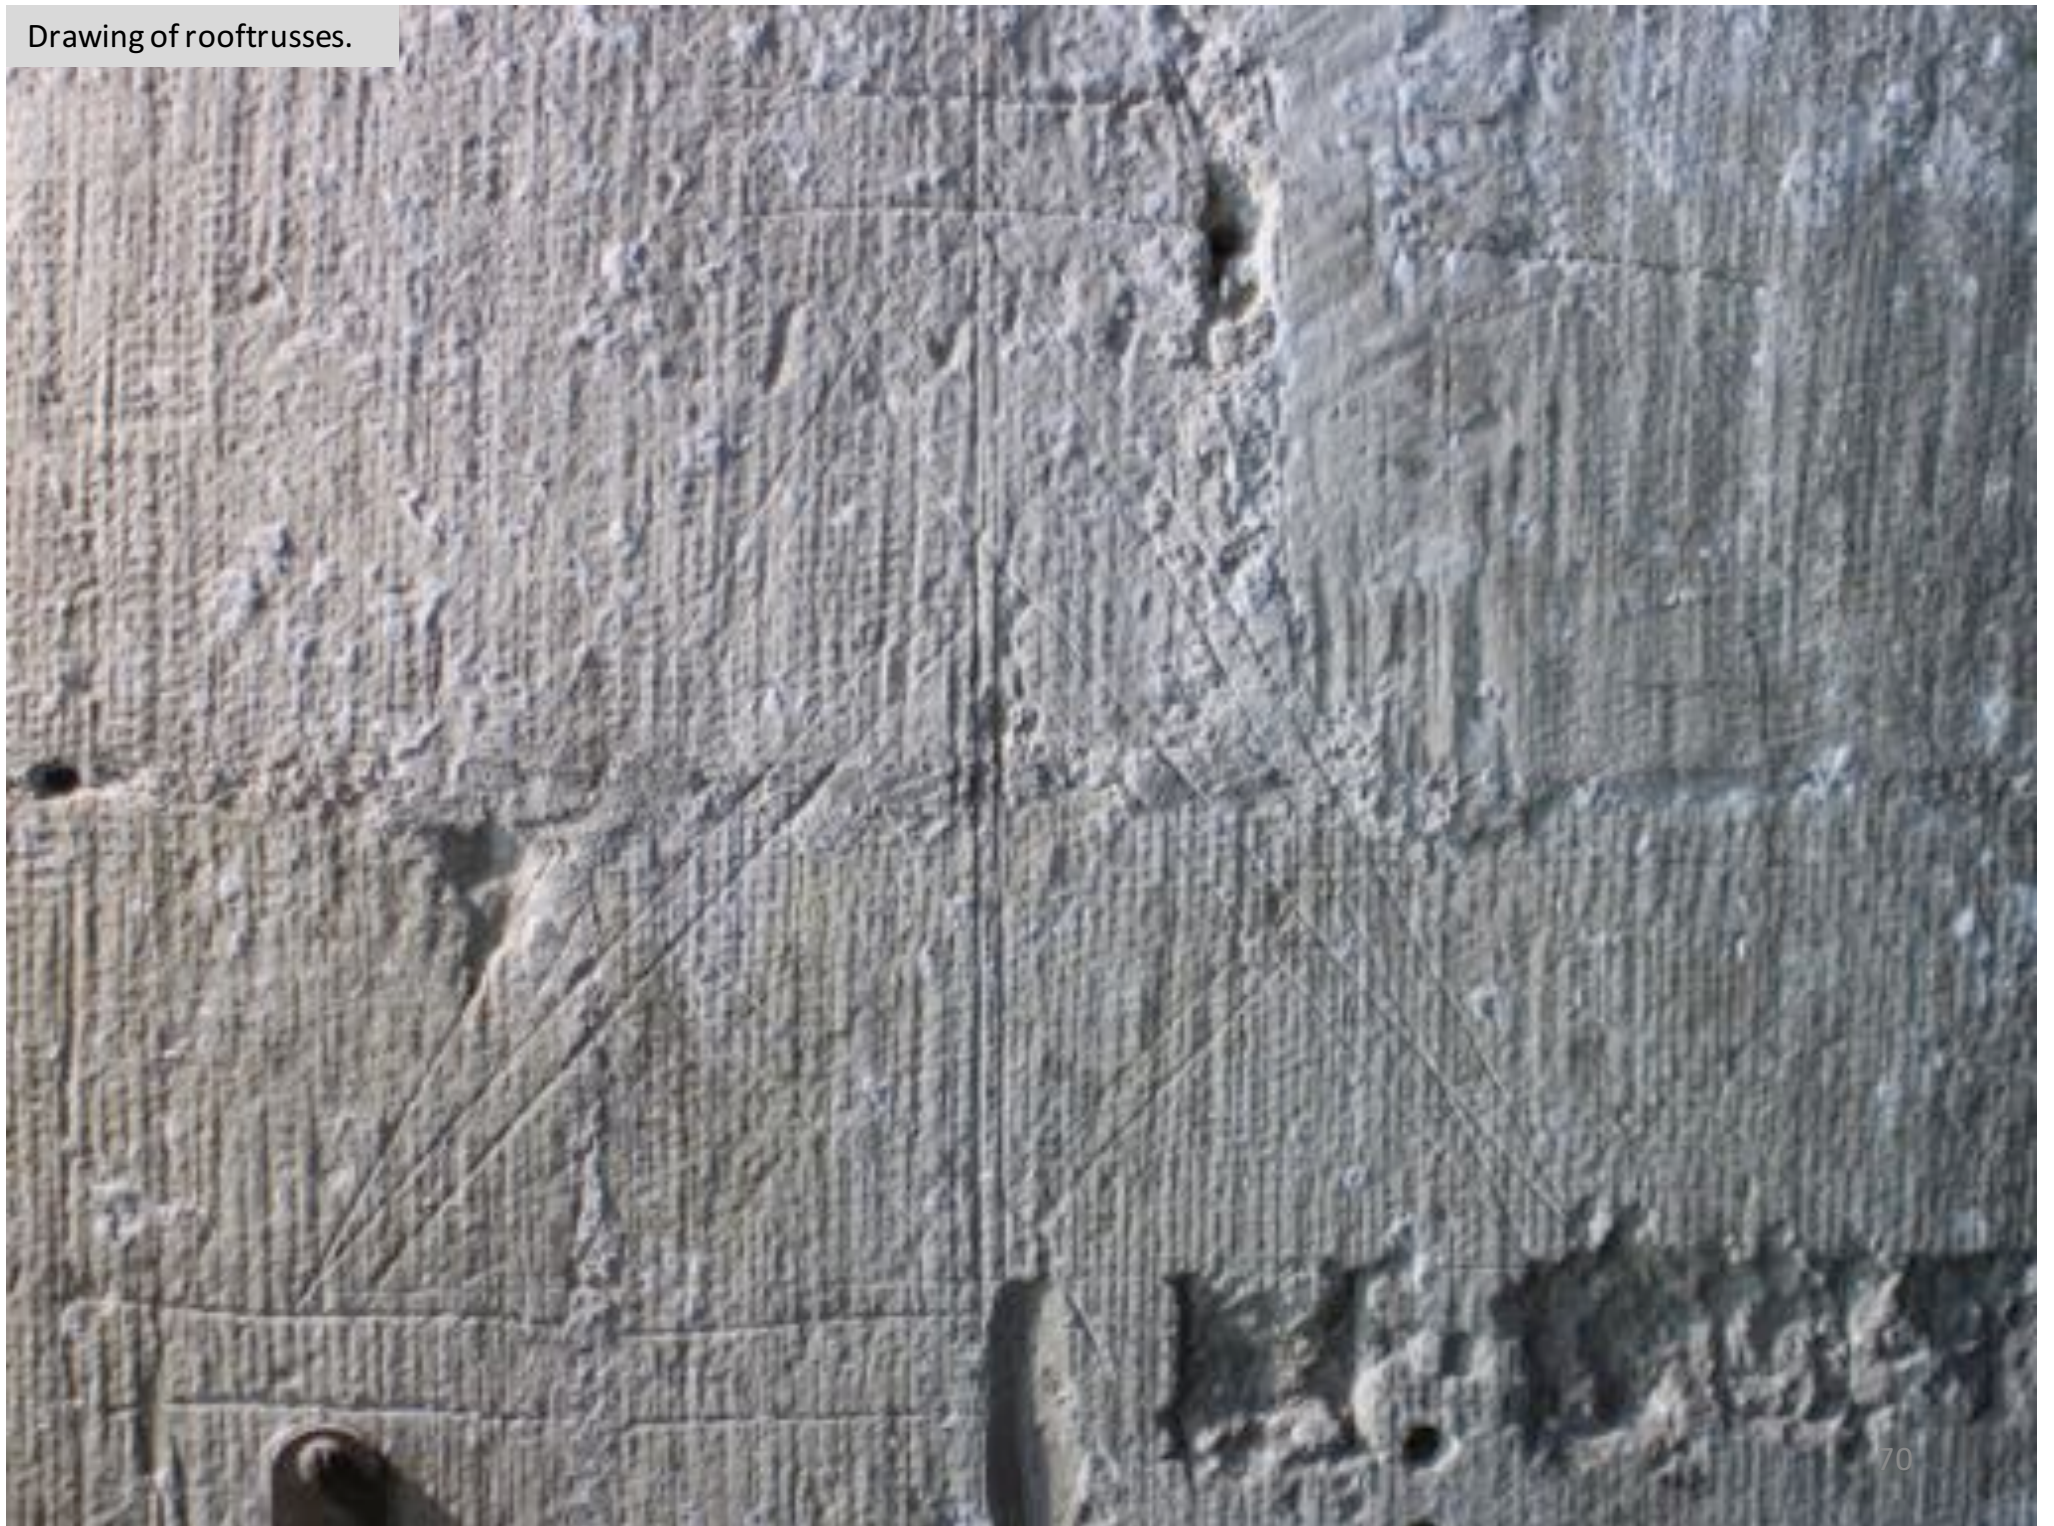
Drawing of rooftrusses.

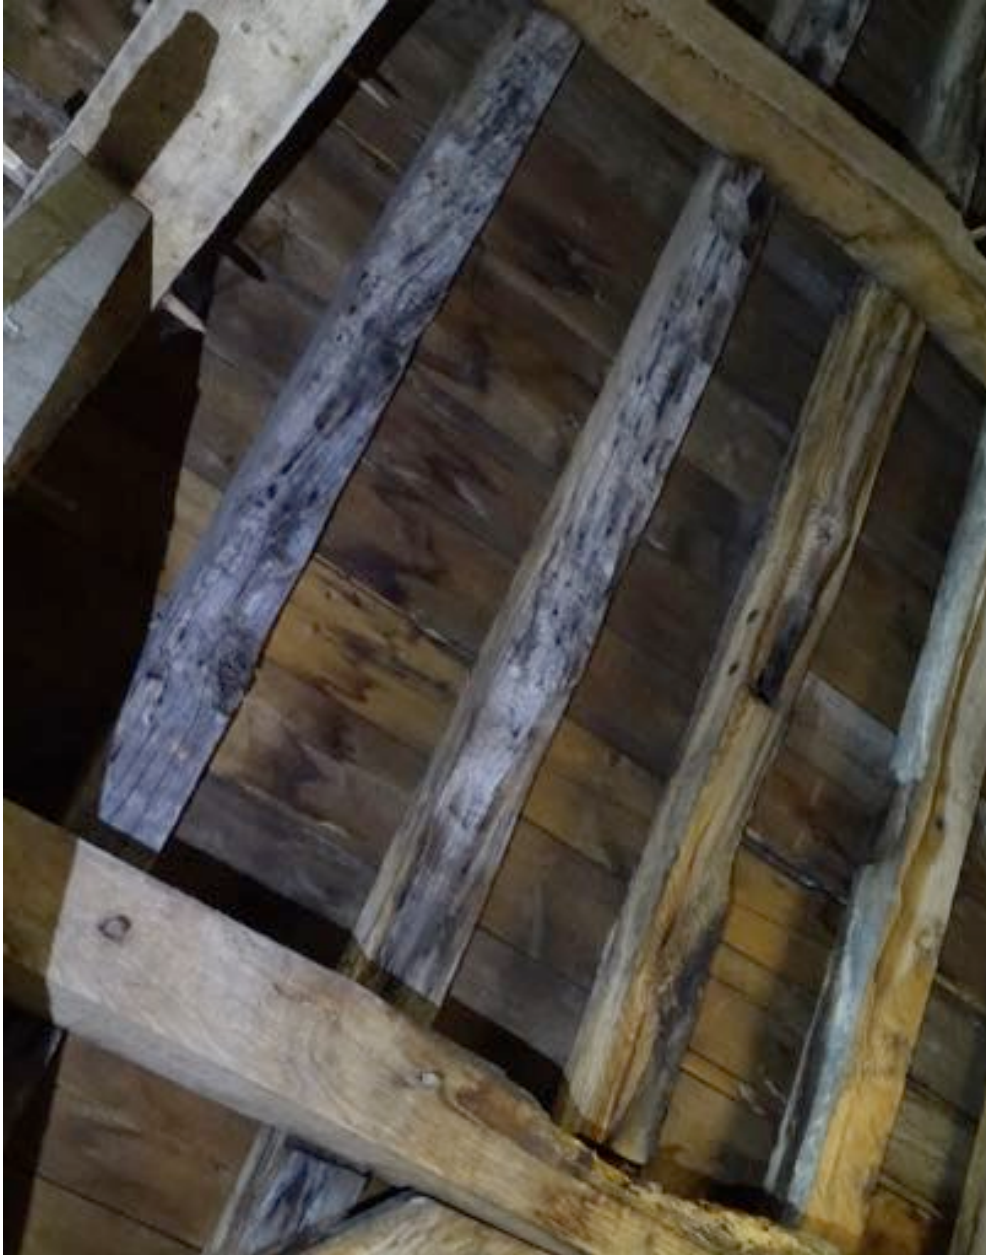
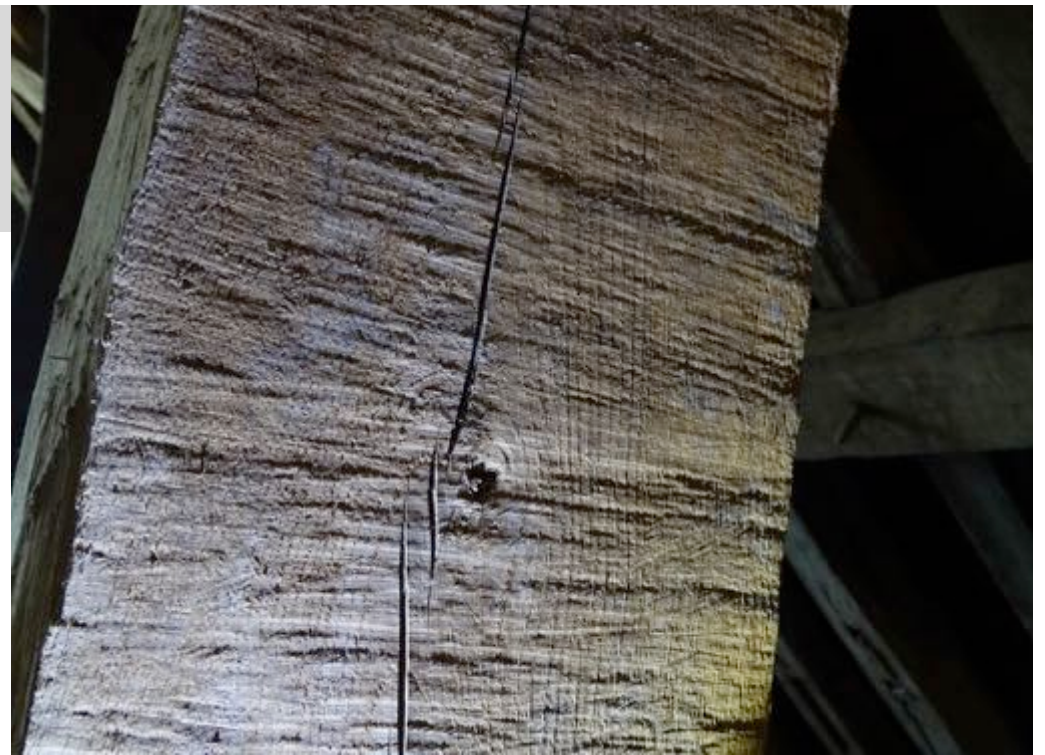
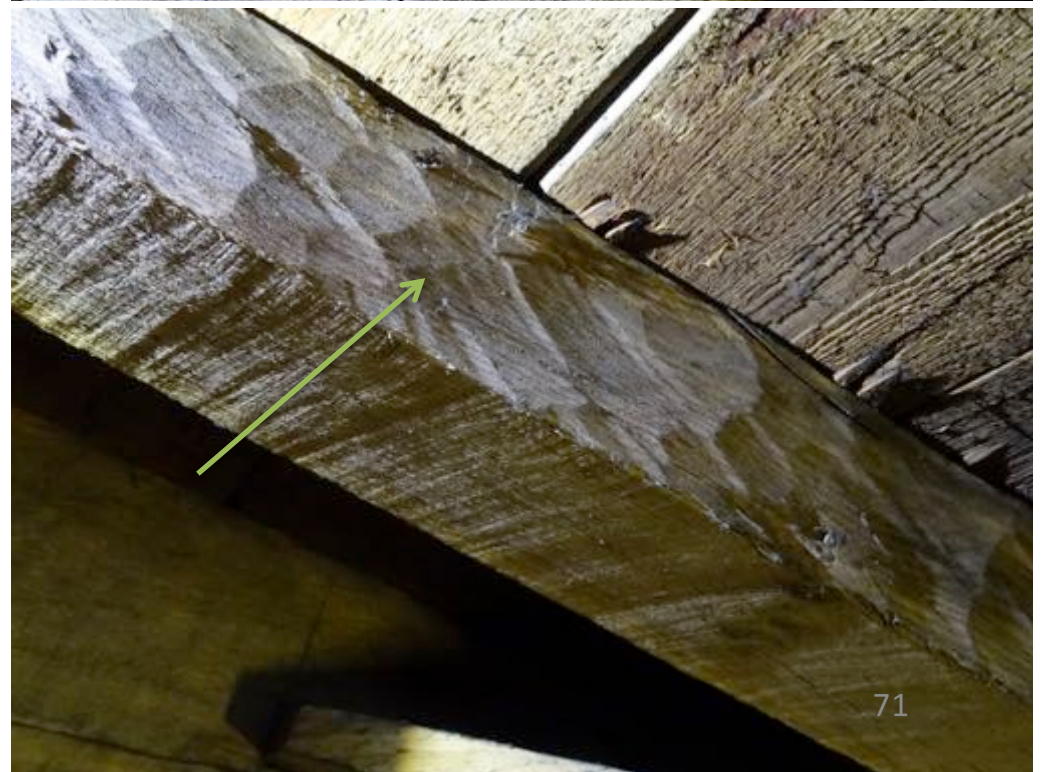
There are lots of reused timber in the roof over the Salisbury nave. Some of the wood have been hewed into square blocks and then sawn in half with a pitsaw. Some of the beams have a cutting pattern that are similar to swedish medieval timber, with a smaller axe diagonally along the fibers.

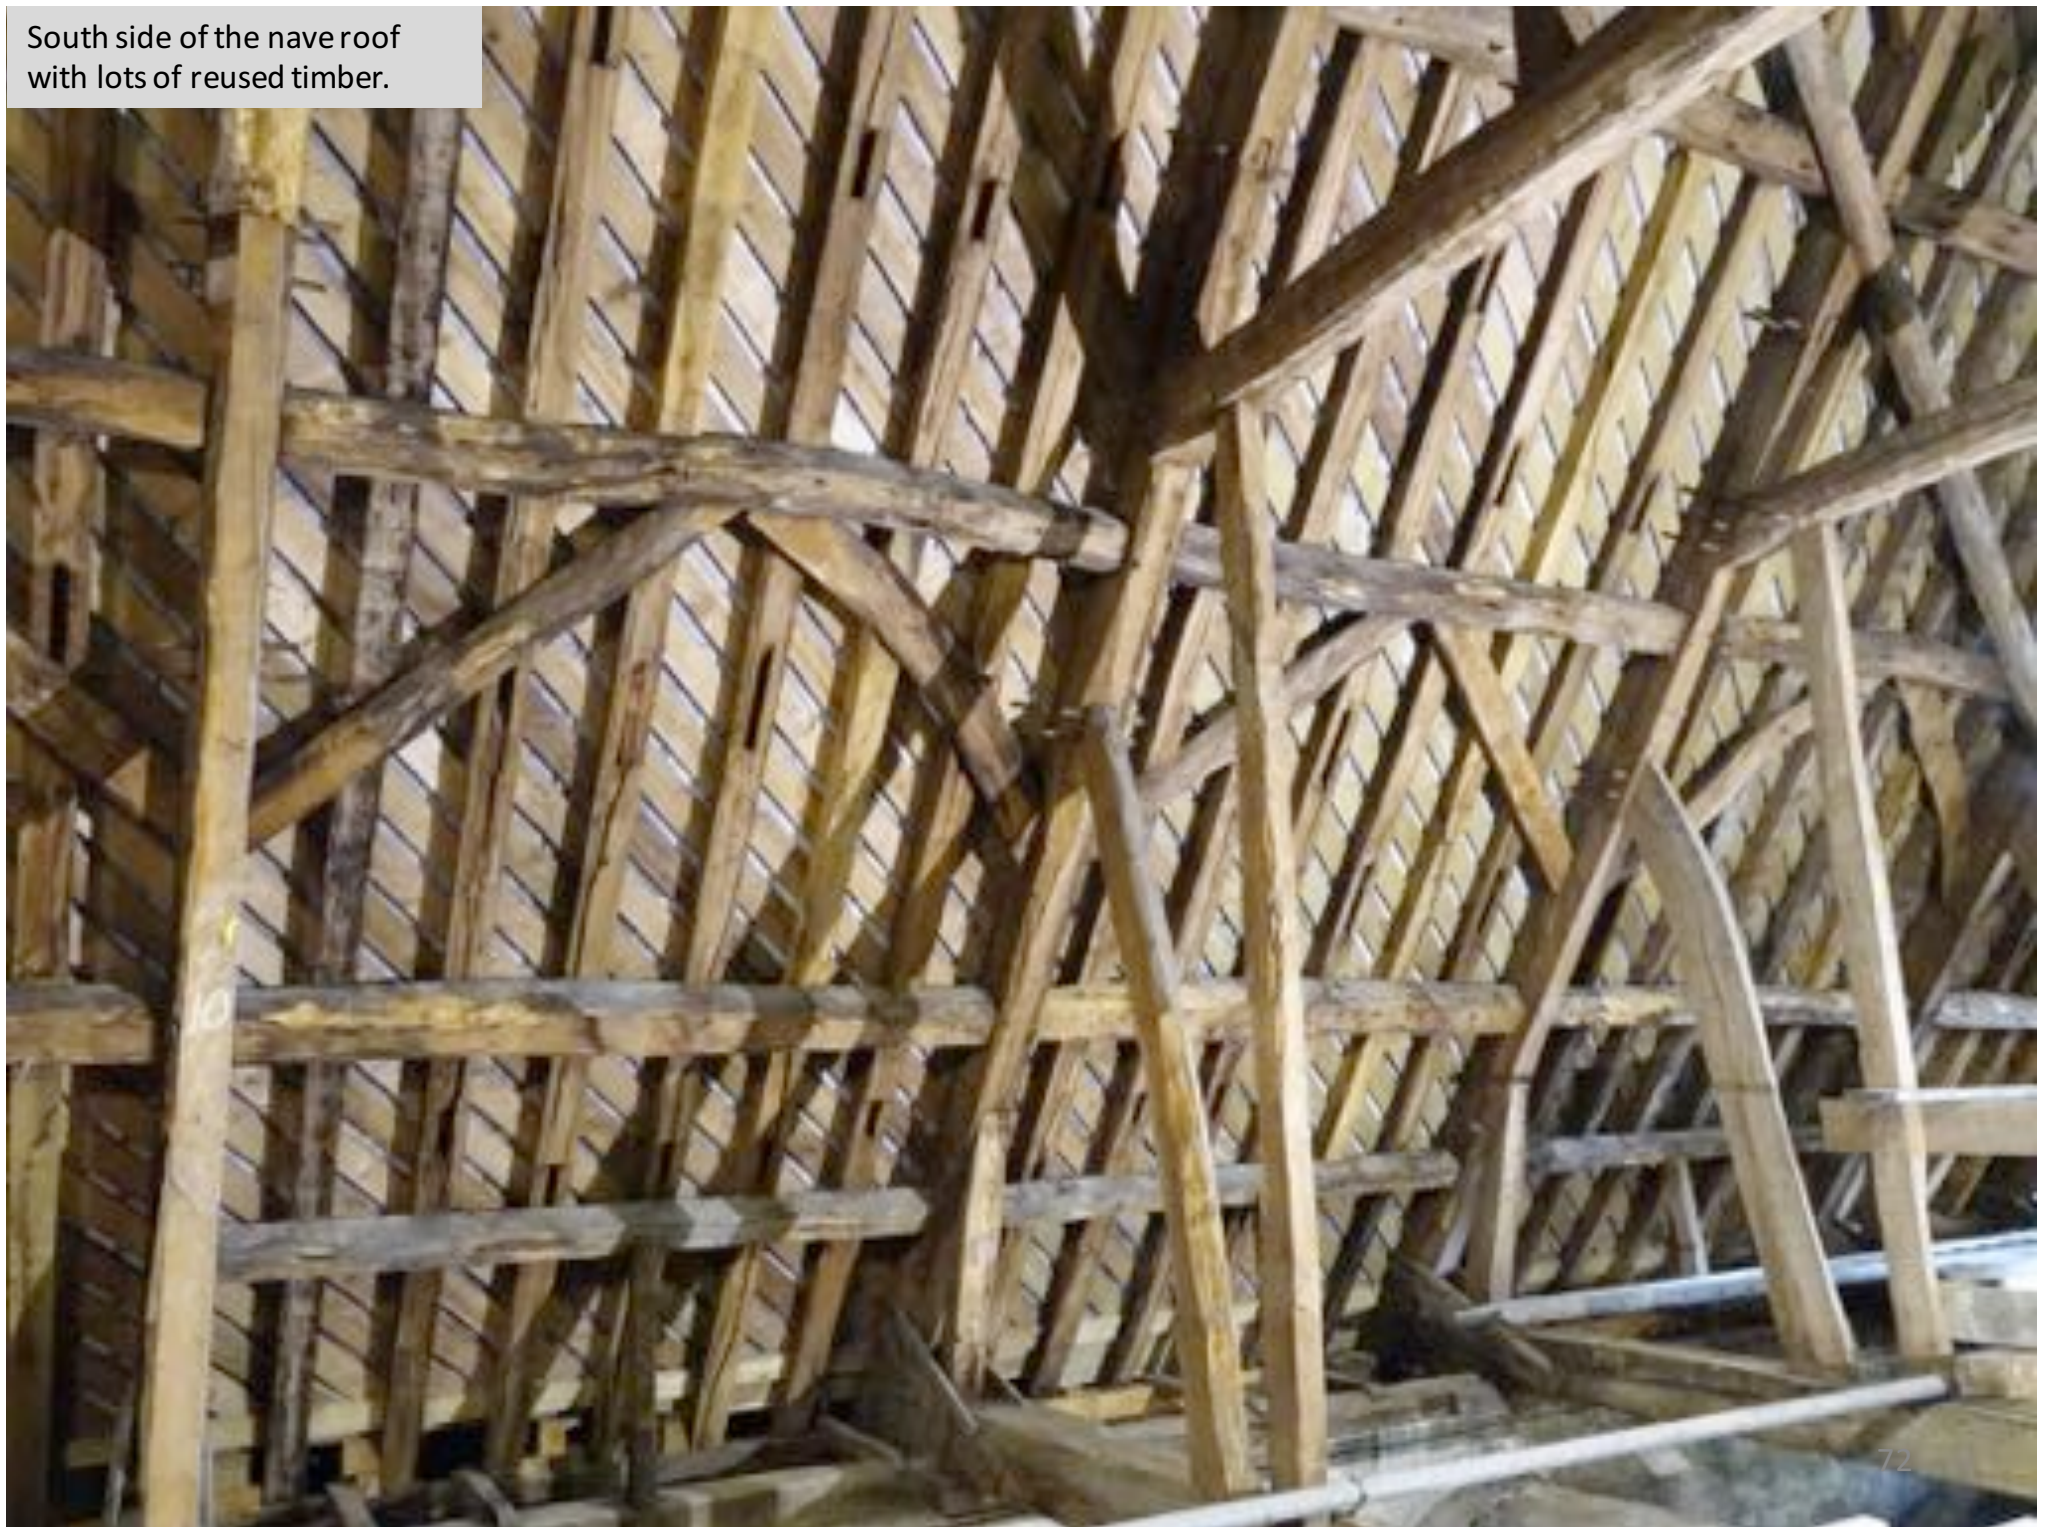
South side of the nave roof
with lots of reused timber.

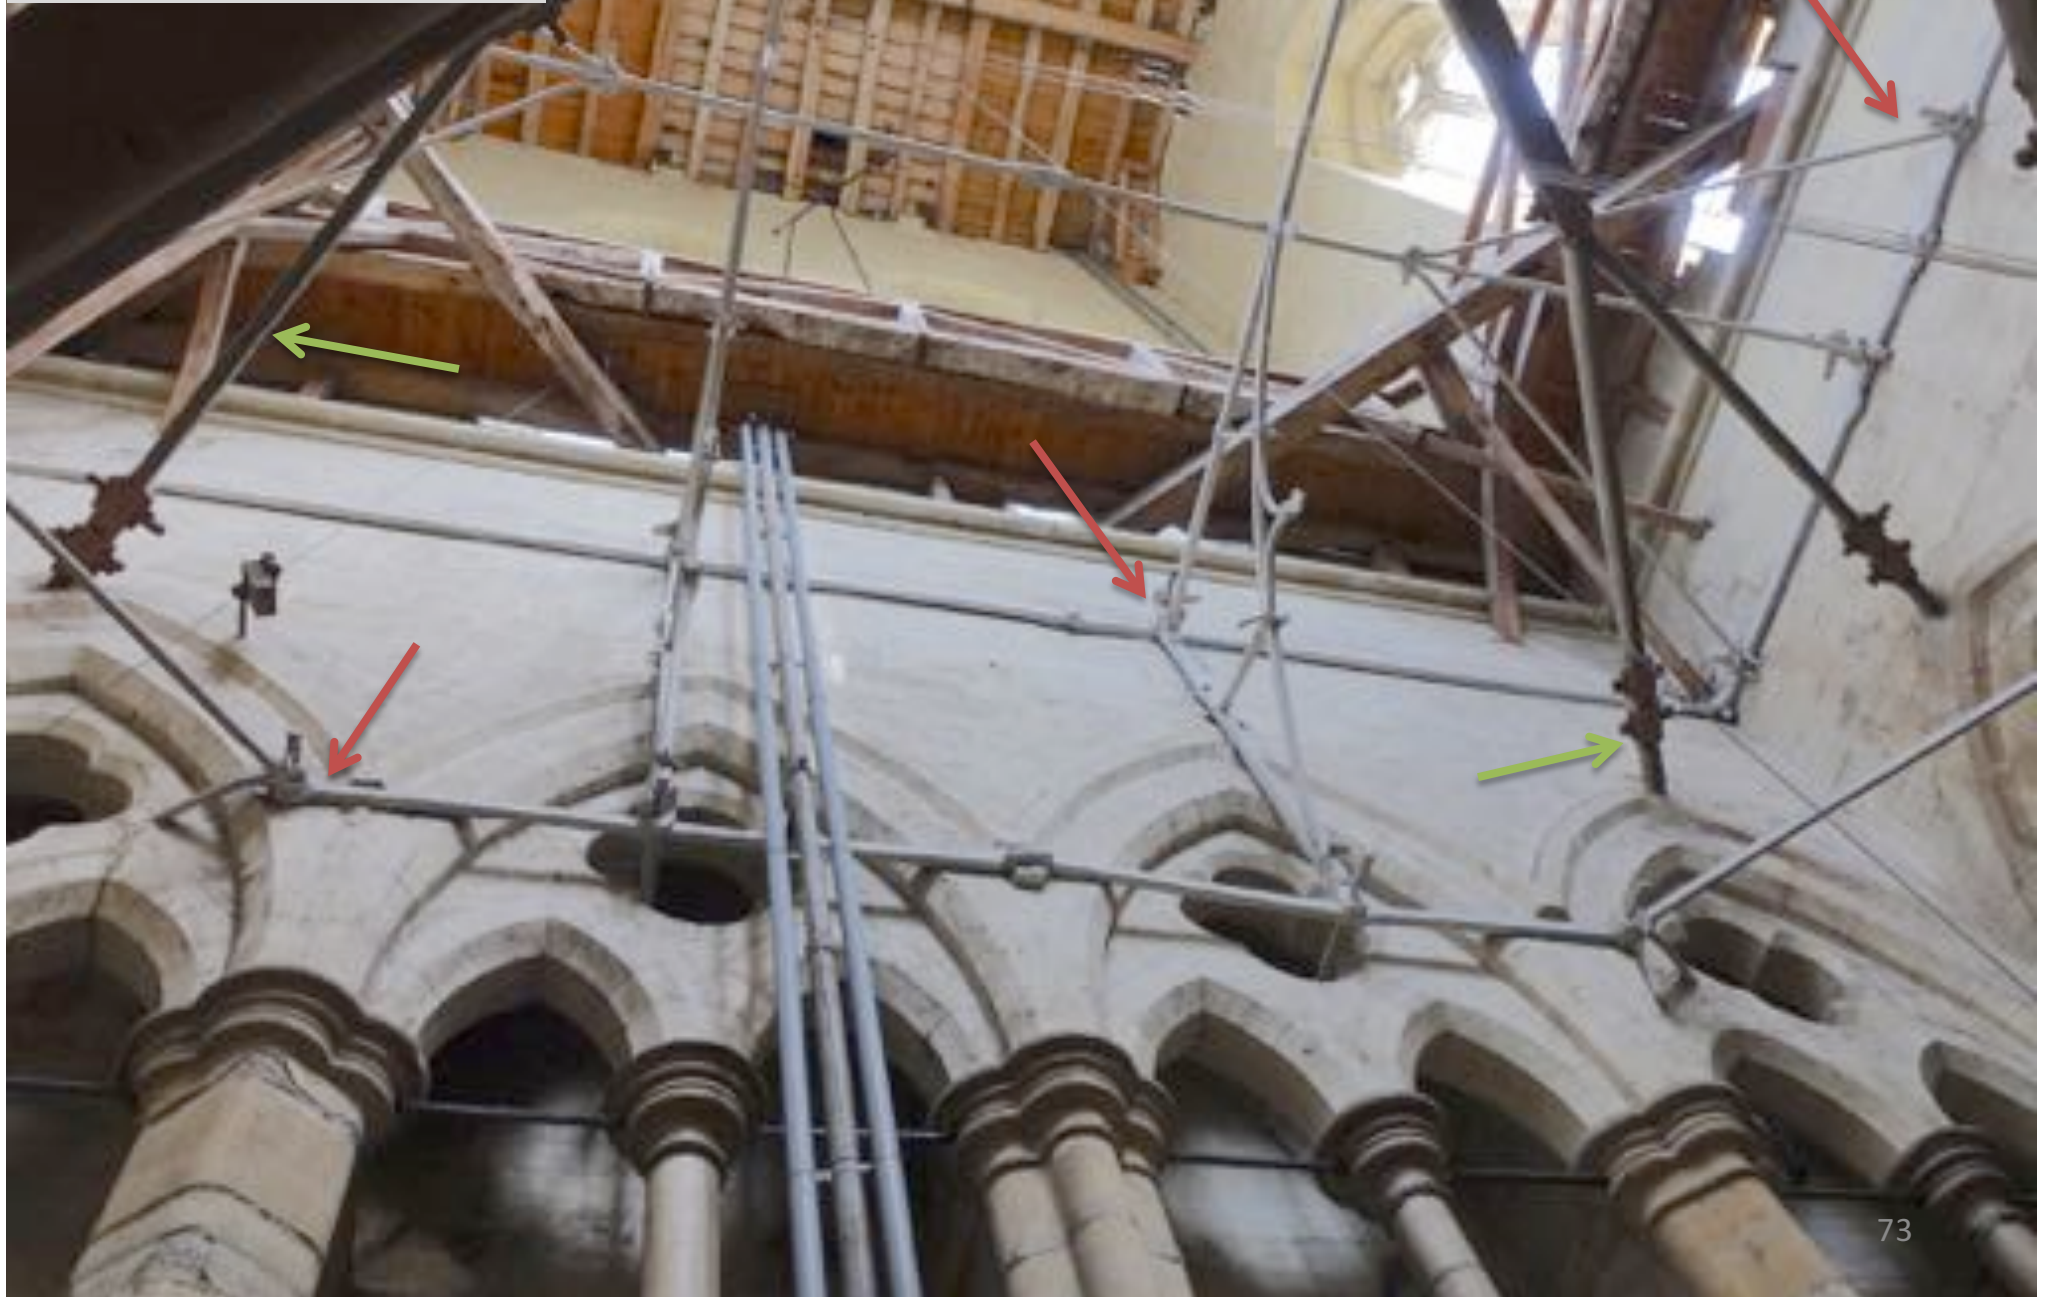
Medieval ironwork in Salisbury tower approximately made in 1250 in white paint. Complementary ironwork from modern times in grey.

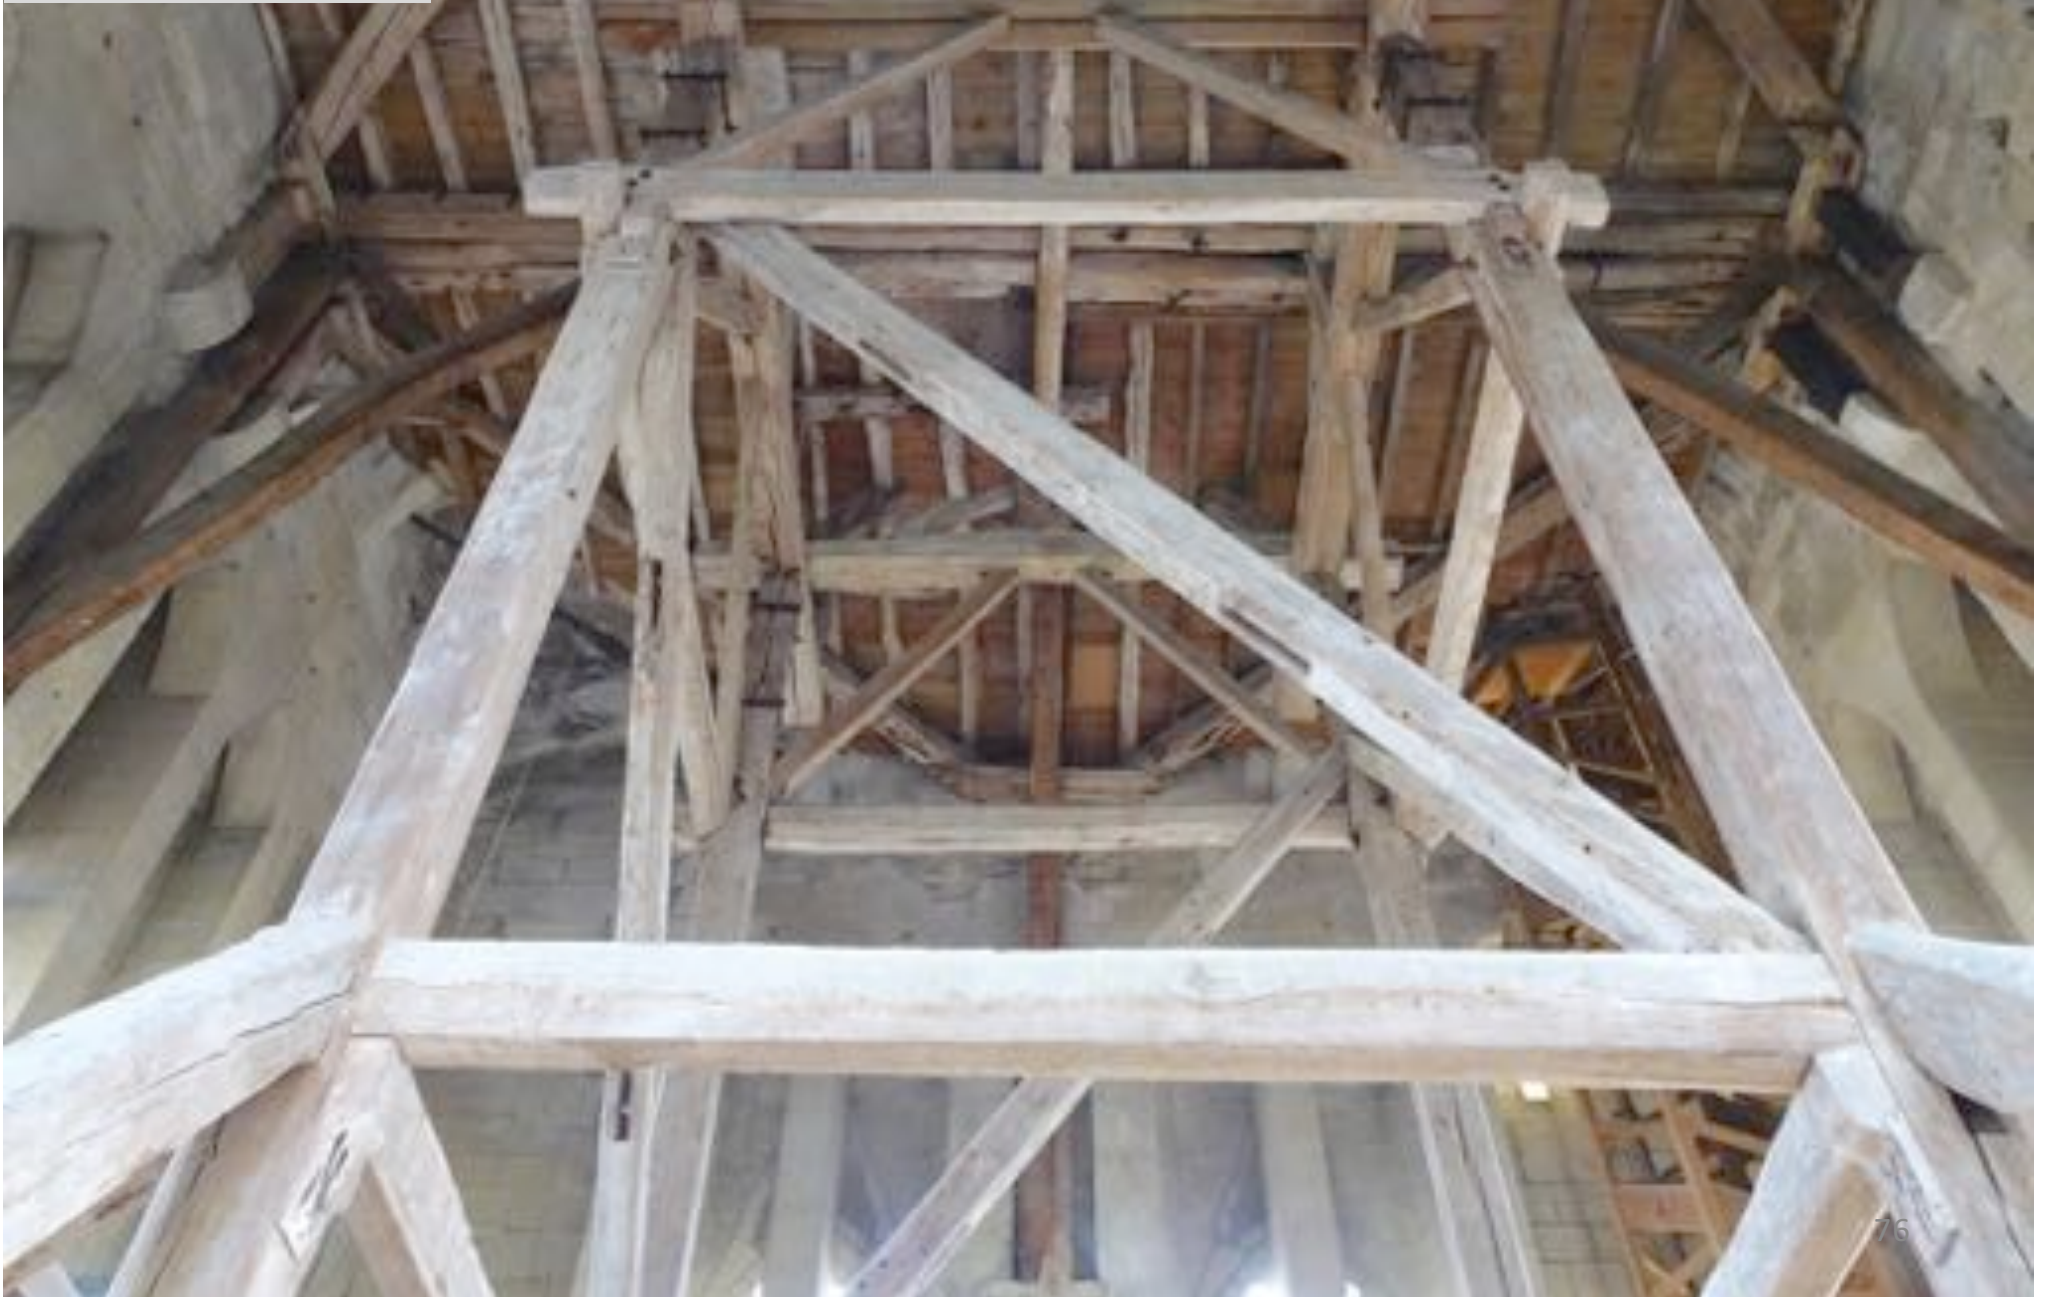
The scaffolding from the 14th century left standing inside the tower. Built of a mix of new and reused timber.

We visited the spire but it was not possible for us to climb up in the scaffolding because of security reasons. We could see that the scaffolding had many reused timbers, something the results of the dendrochronological analysis confirm.

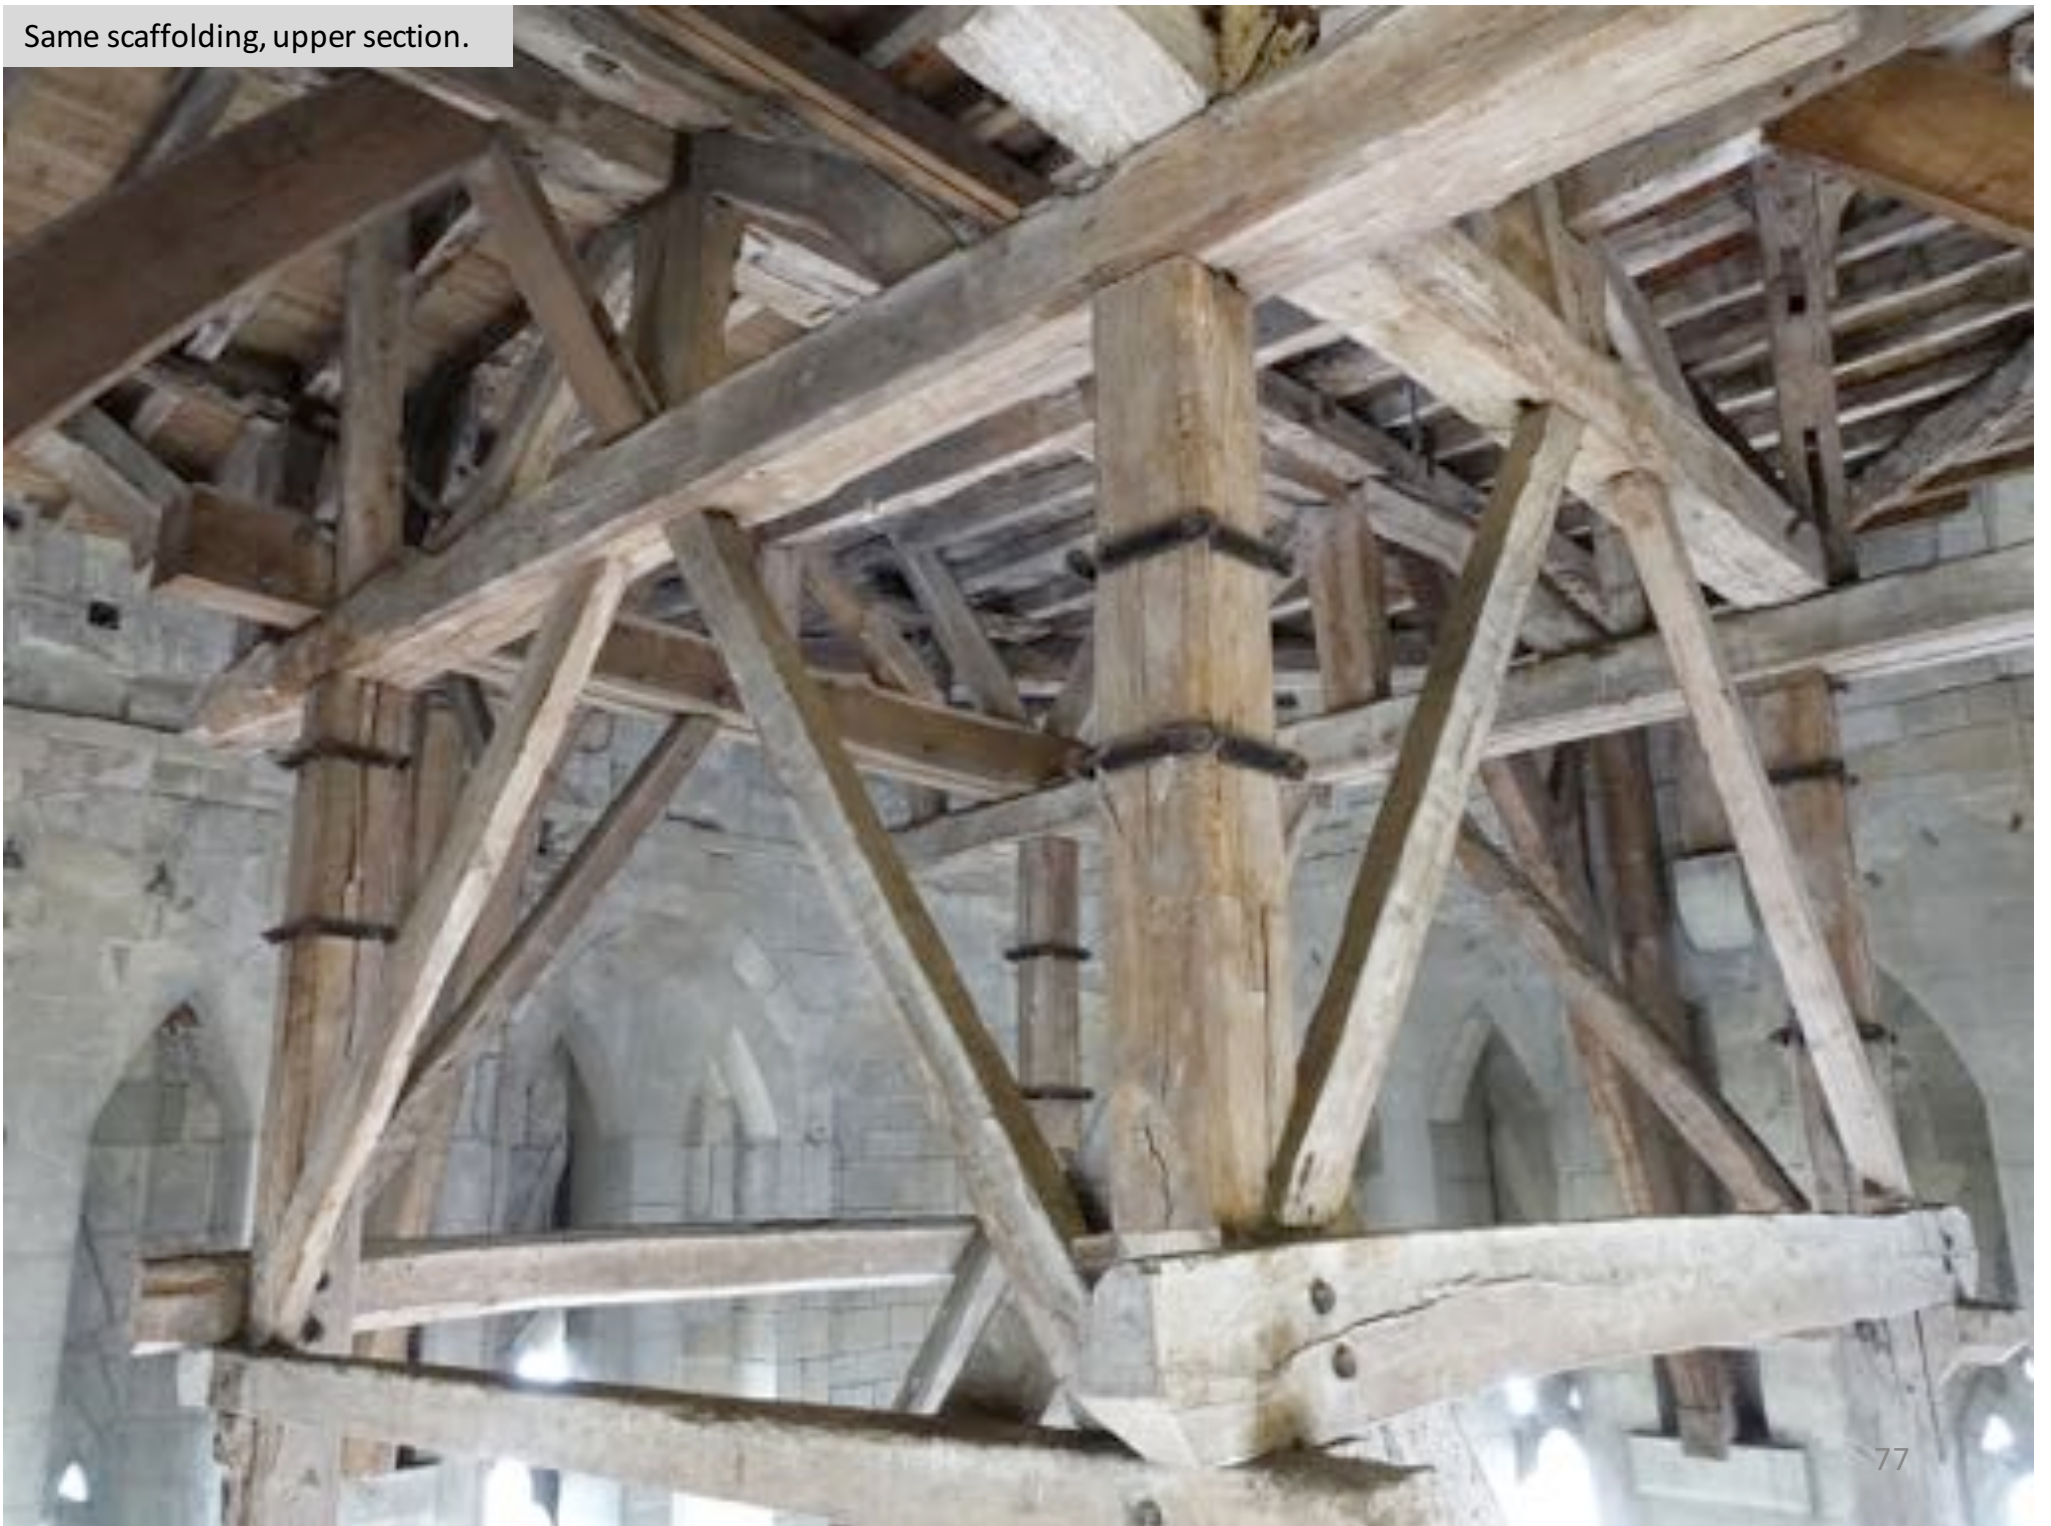
Same scaffolding, upper section.
