Carpentry art, excursion to England

The search for comparison of Scandinavian craftsmanship in medieval English carpentry art

This PM is the result of a carpentry art excursion made by Karl-Magnus Melin and Mattias Hallgren in april 2017. Karl-Magnus works as a carpenter and craft researcher at Knadriks Kulturbbygg, is project leader for the diocese project Historic carpentry art in the diocese of Lund and is a doctoral student at the University of Gothenburg.

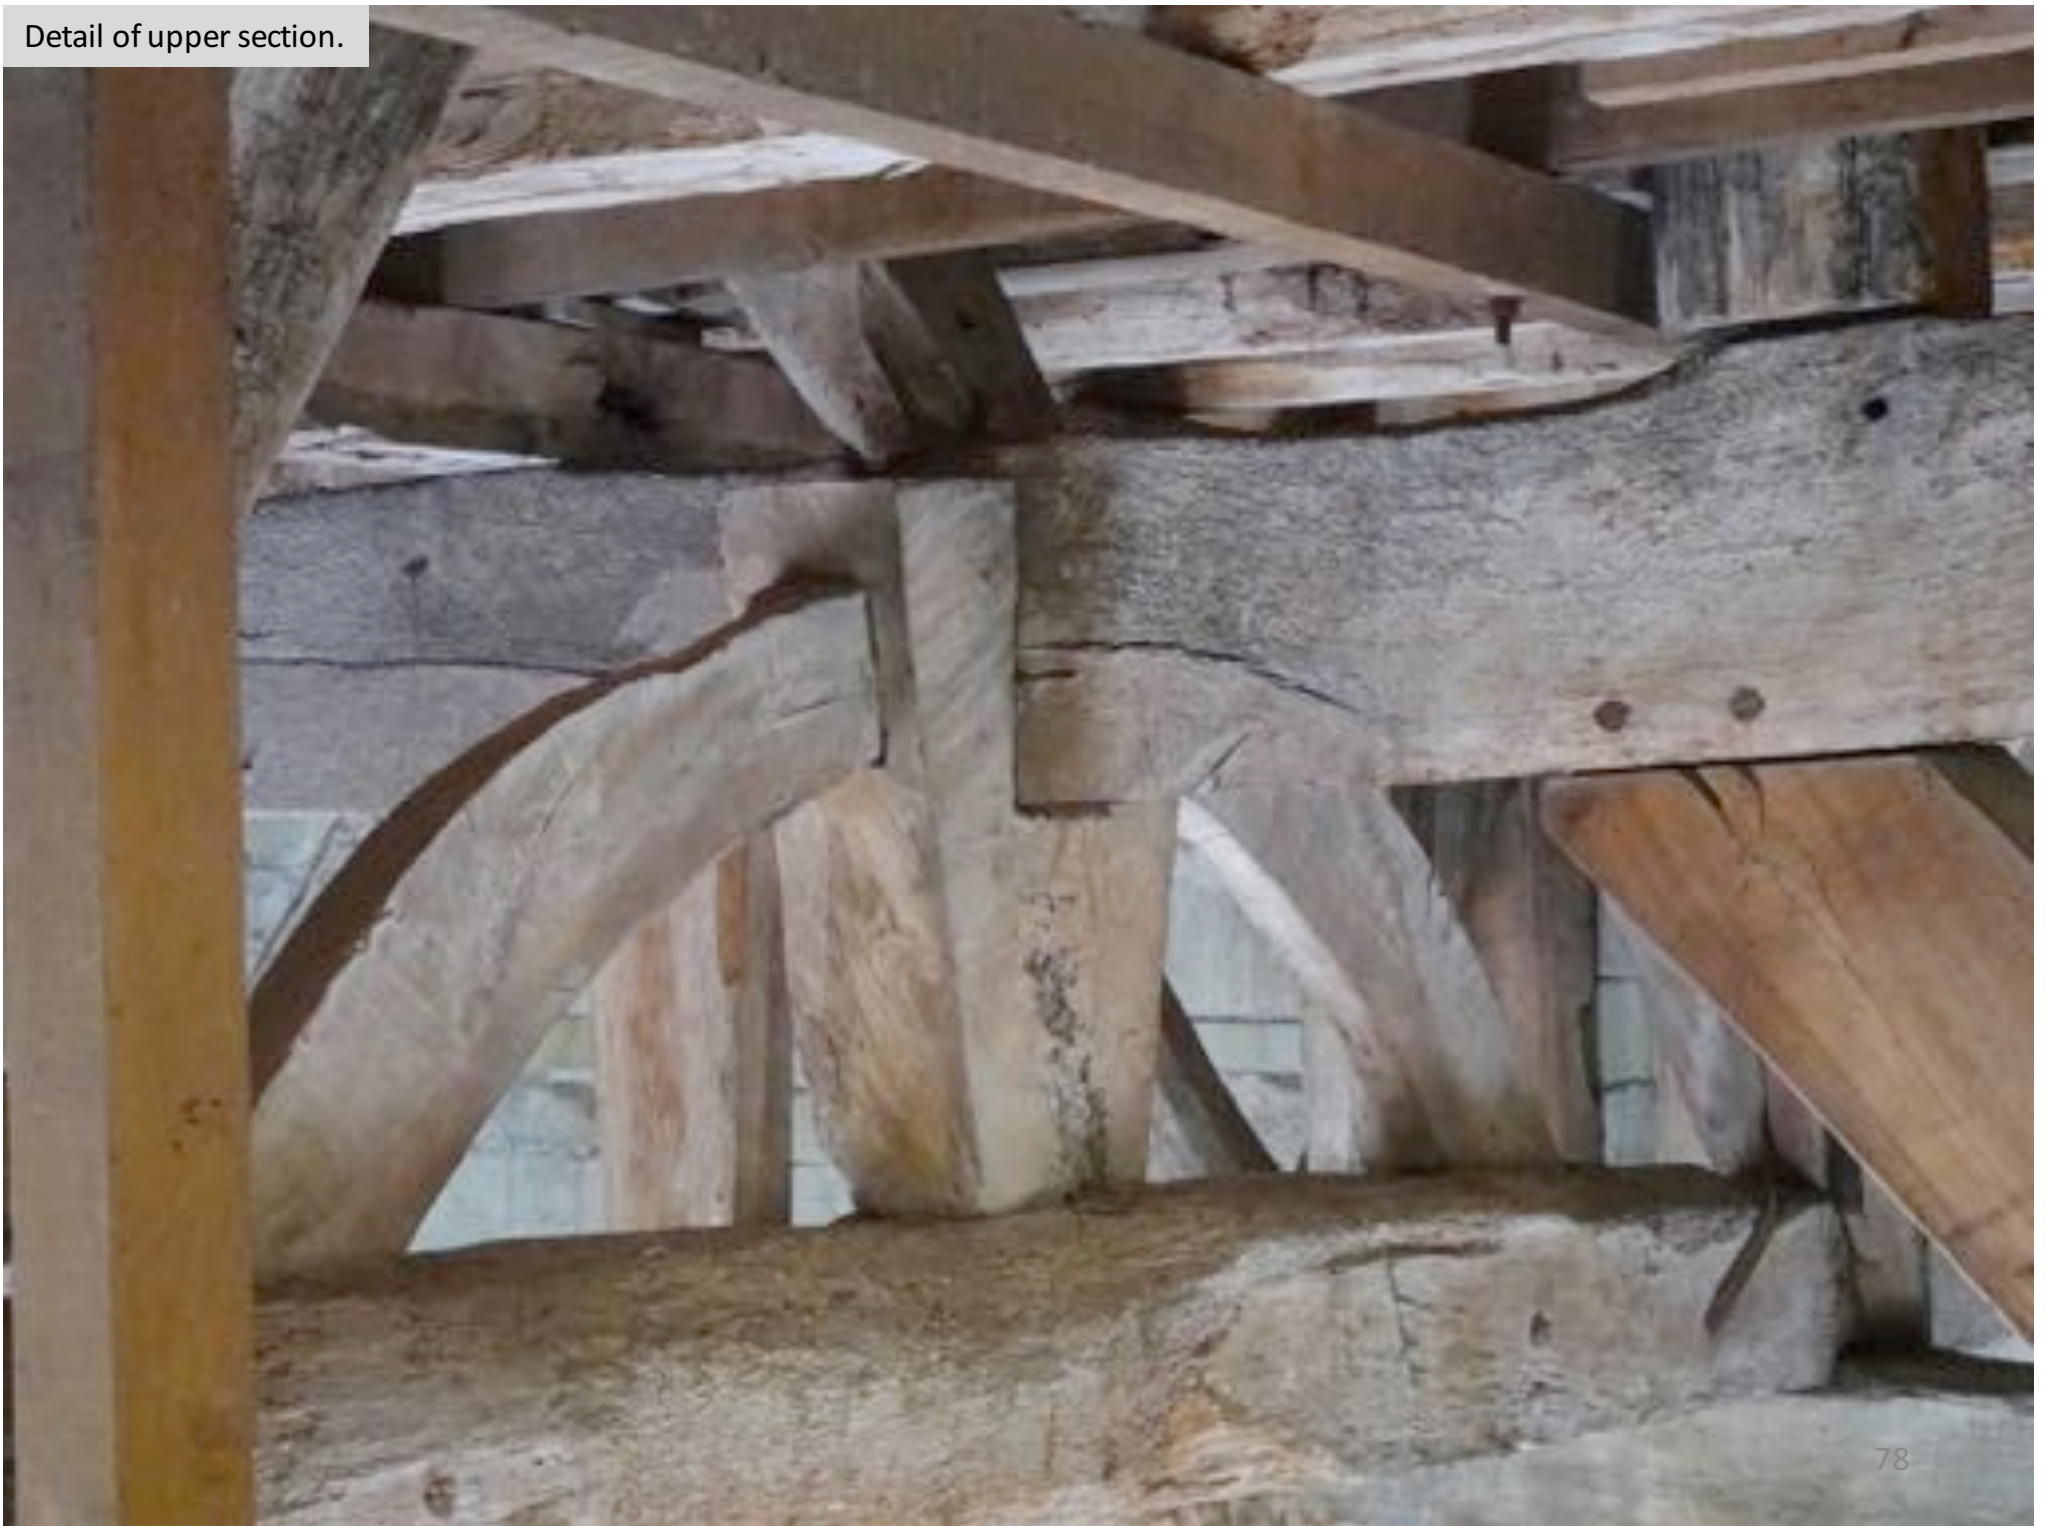
Detail of upper section.

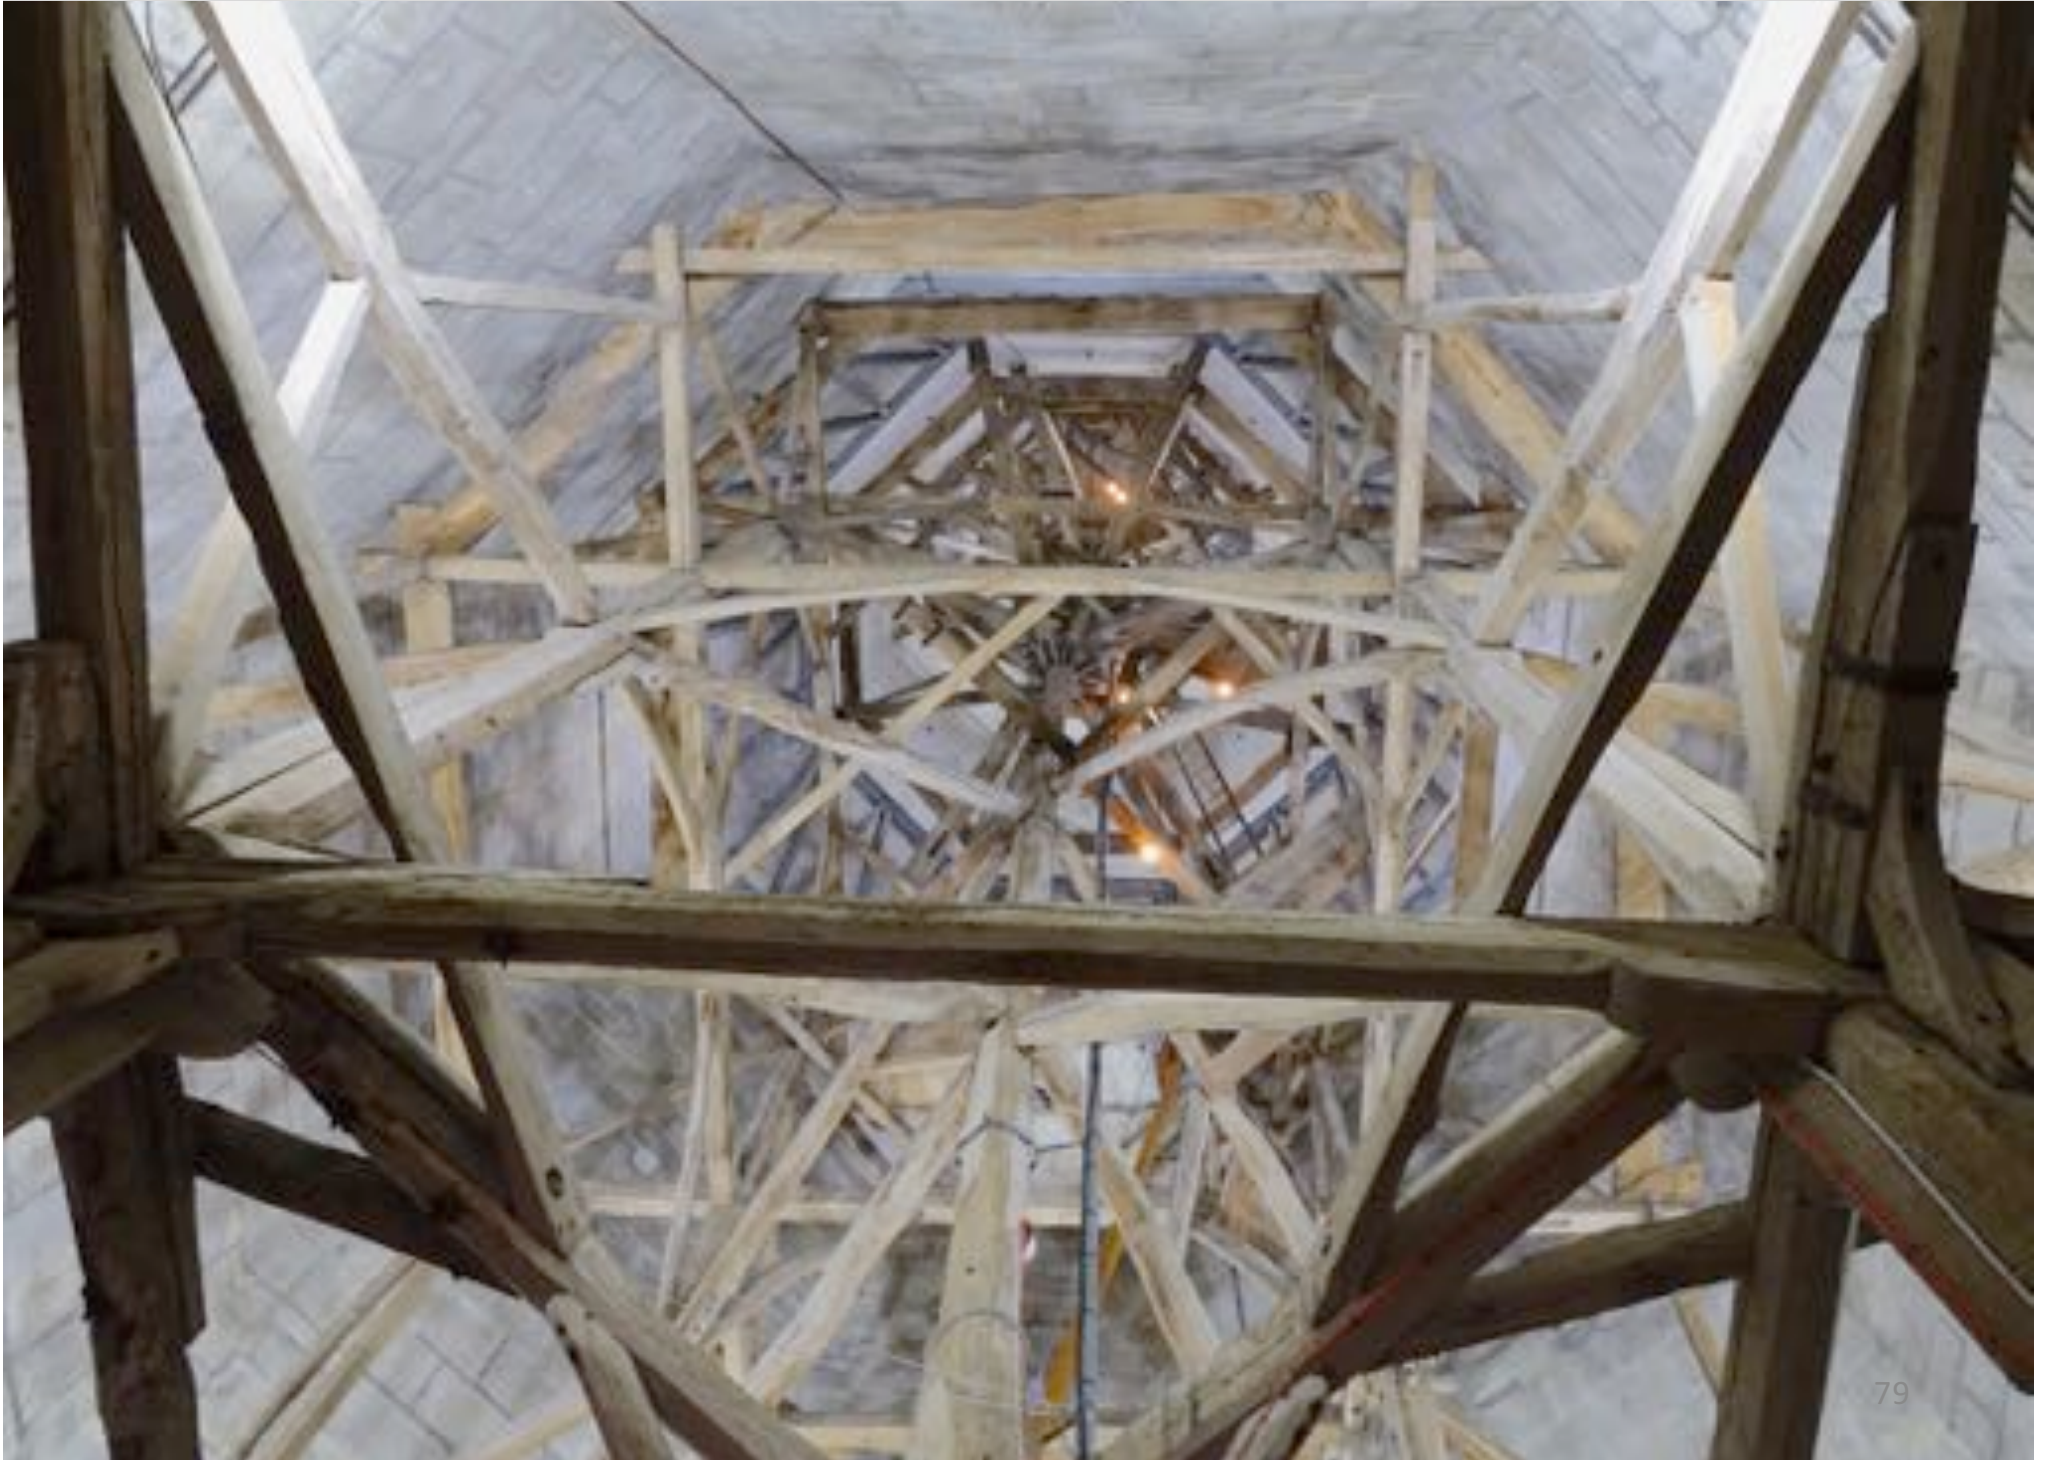
Scaffolding inside the stone spire. Some wood is changed in modern time.

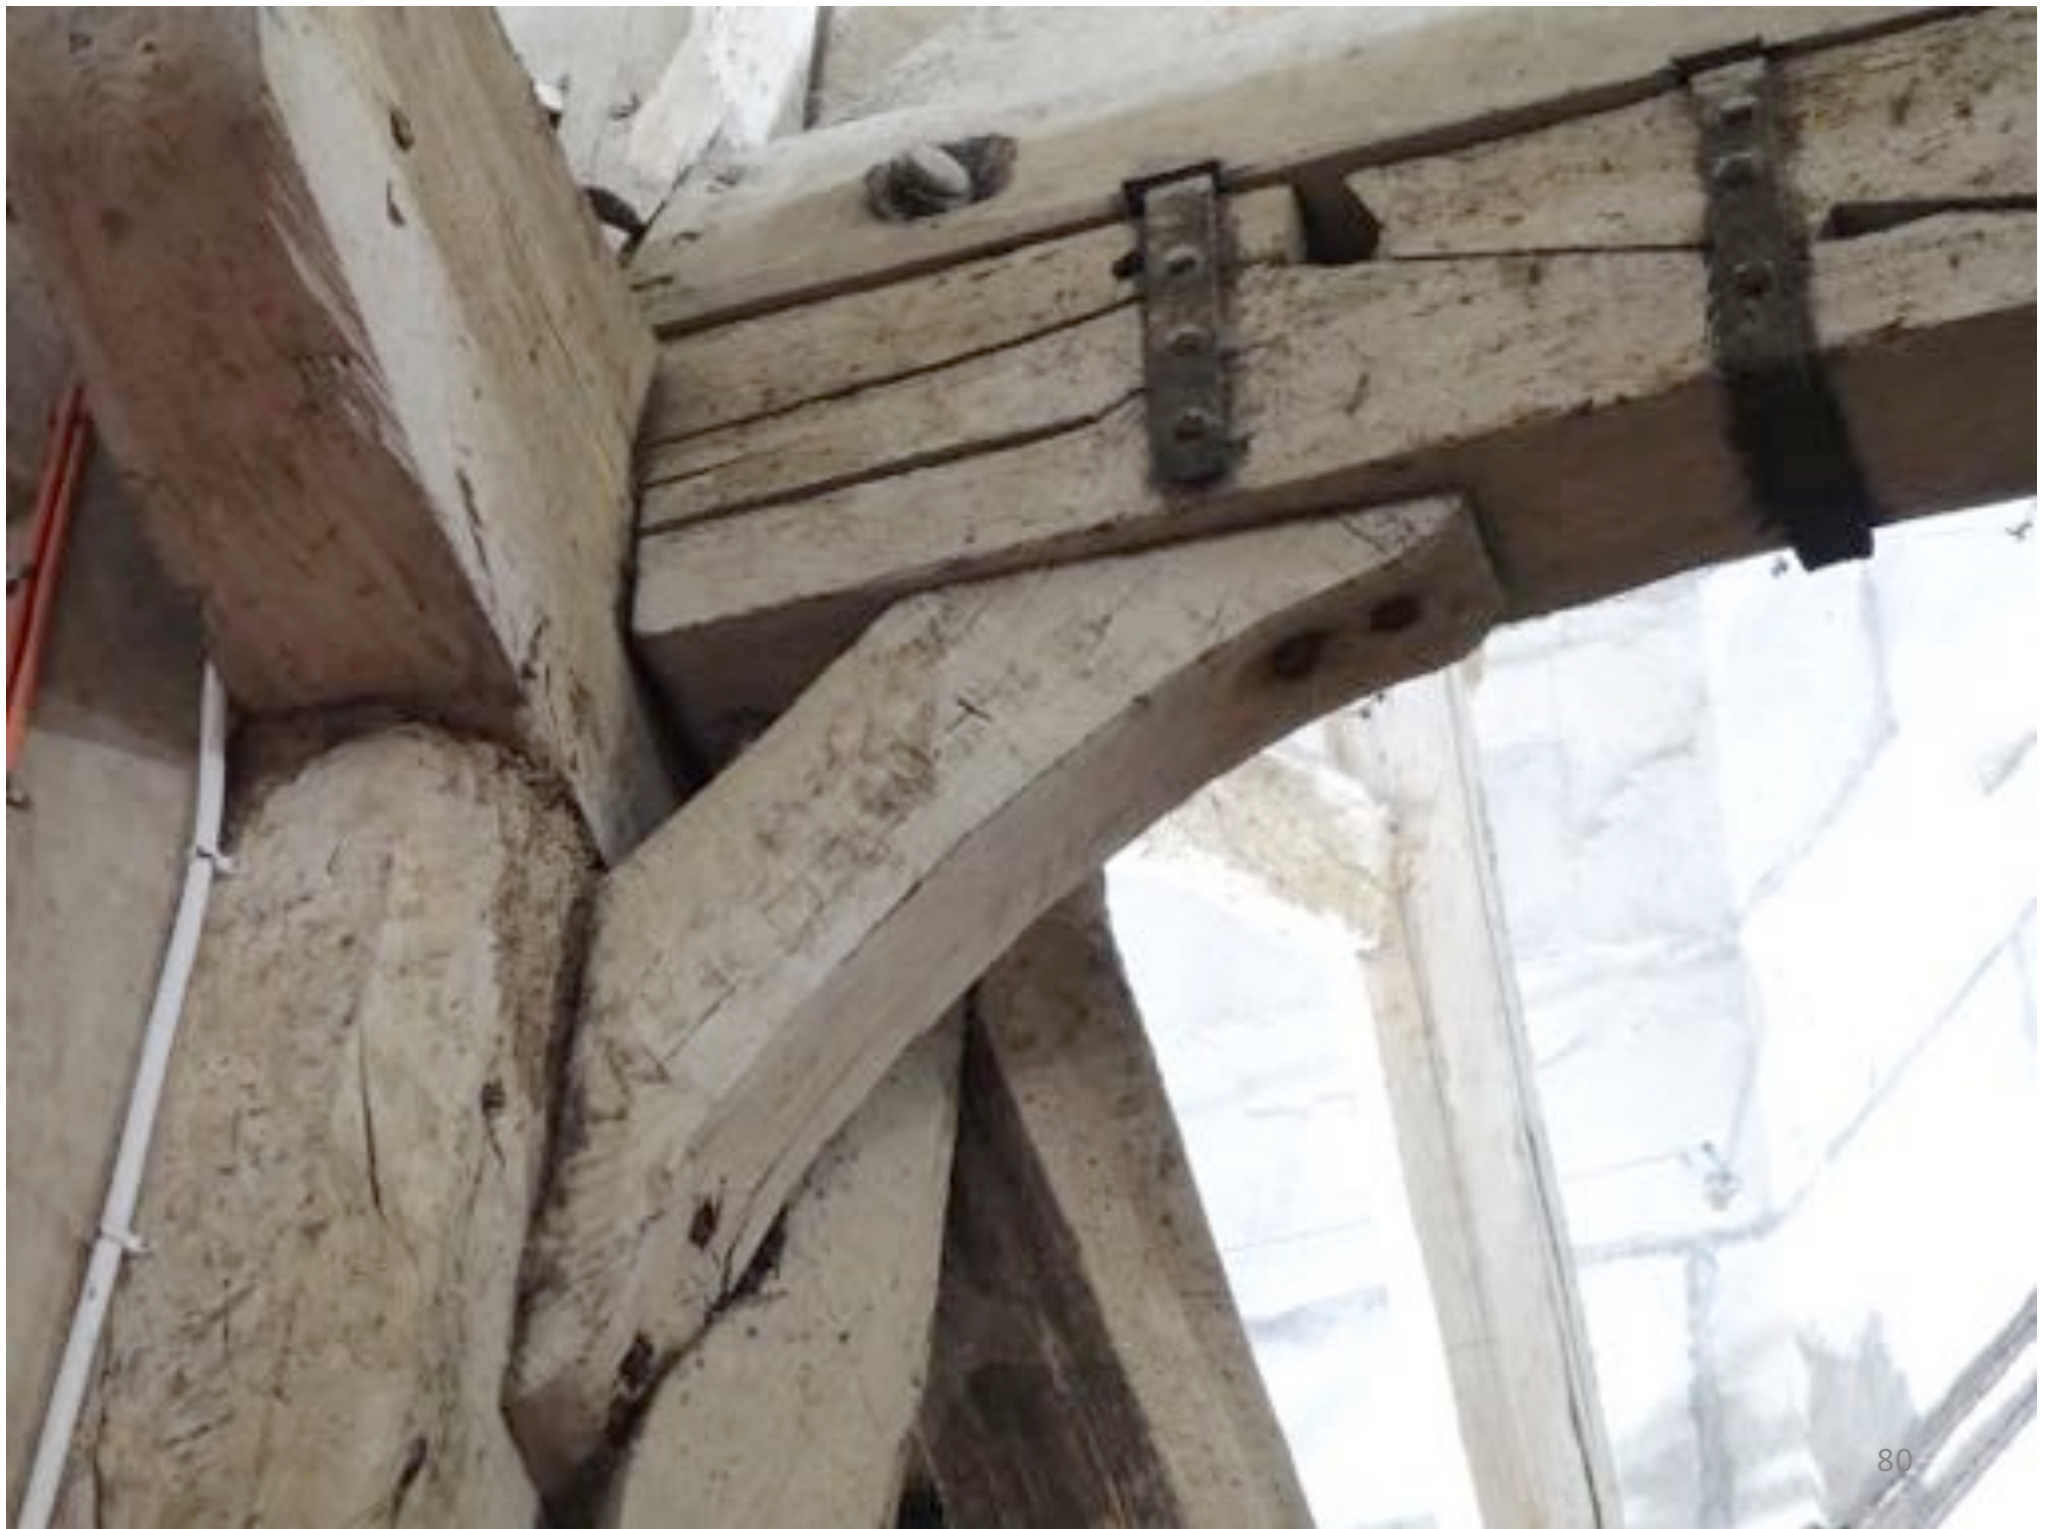
In the tower, the medieval windlass is still in function. It is tested yearly for winching down injured people at emergencies.

To the right, a drawing of the spire and the scaffolding inside.

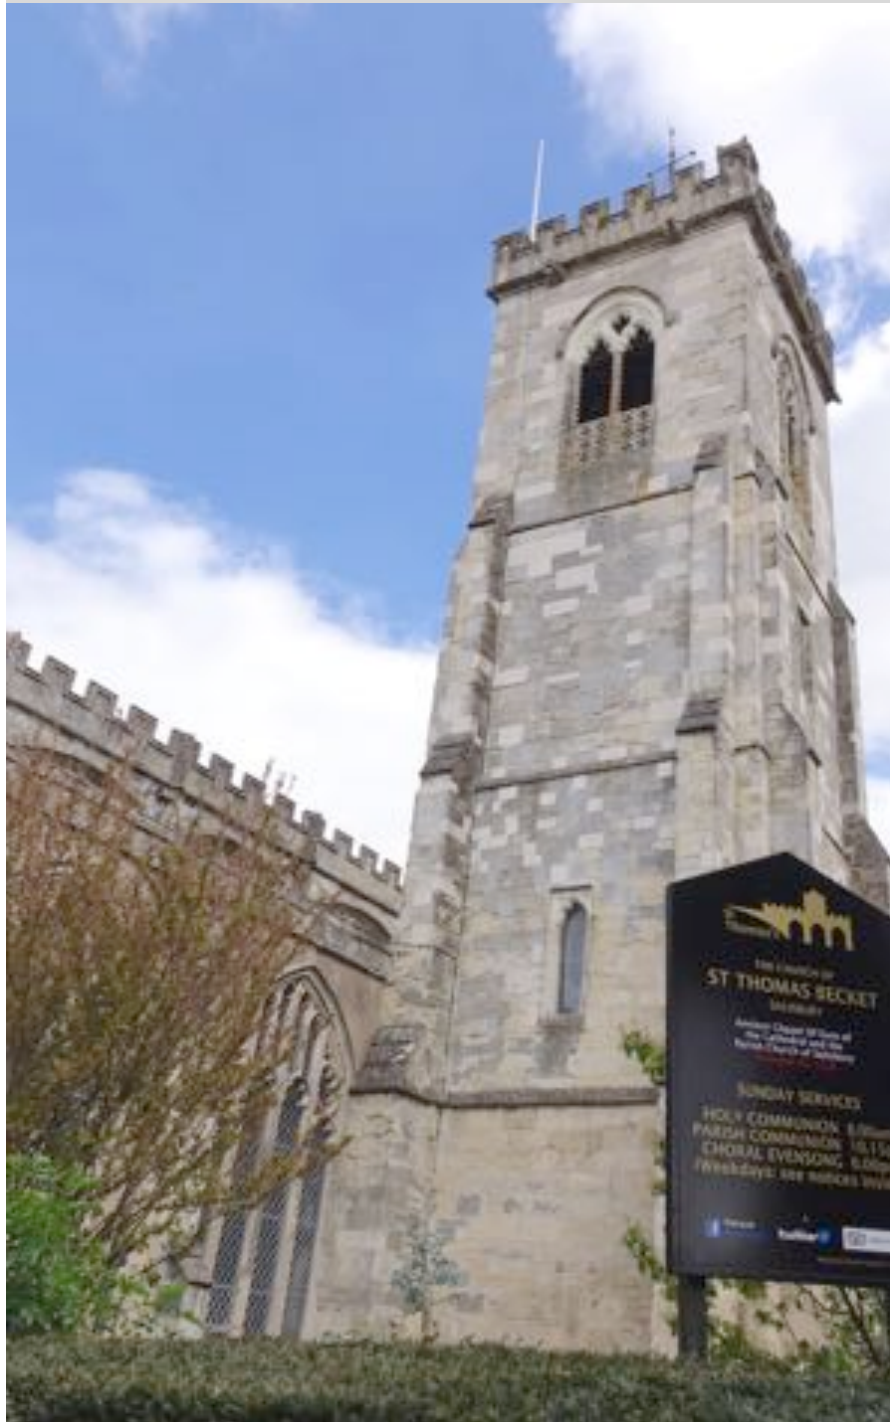
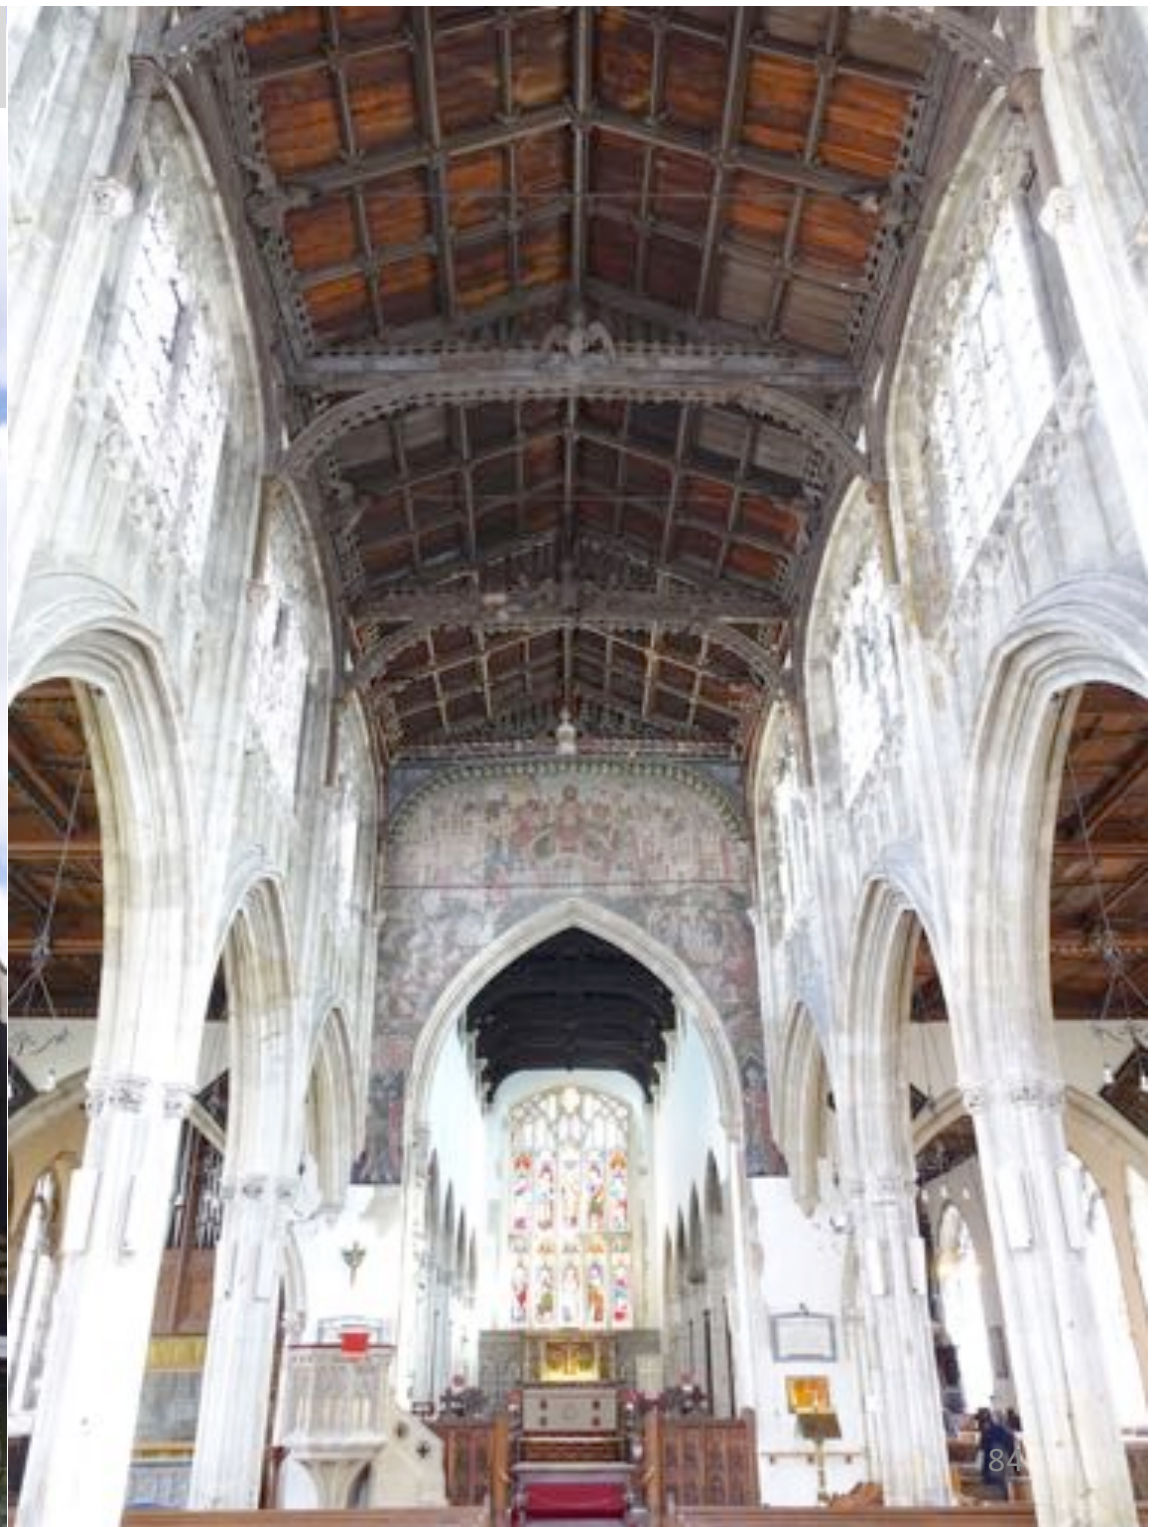
After the cathedral, we went to St Thomas Becket church, 15th century, in Salisbury with a wooden panel roof.

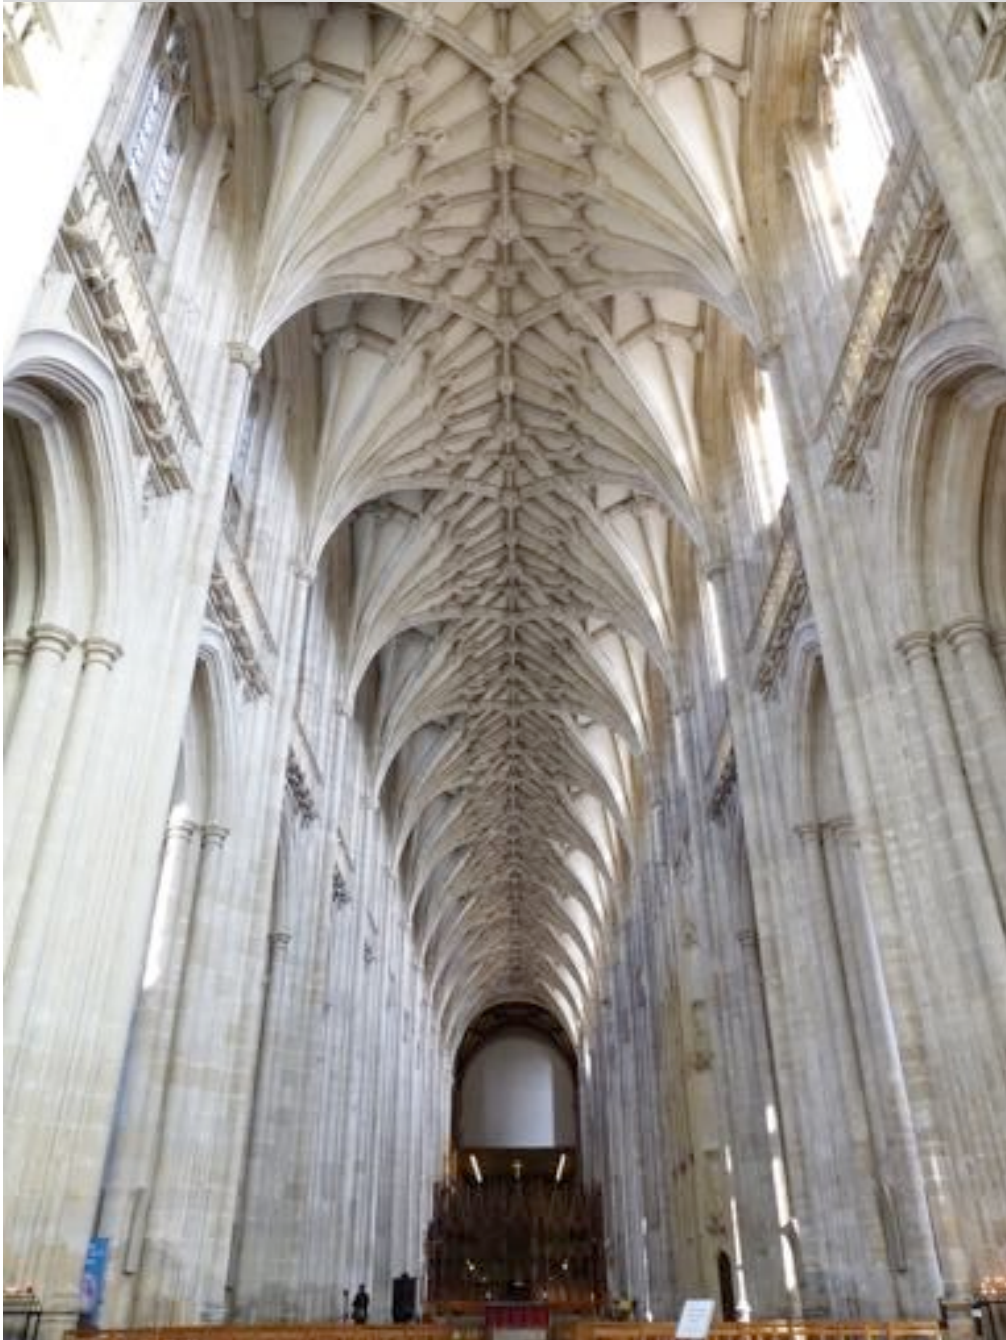
To the left, the vault in Winchester nave.
To the right, the wooden cassette roof from the 13th century.

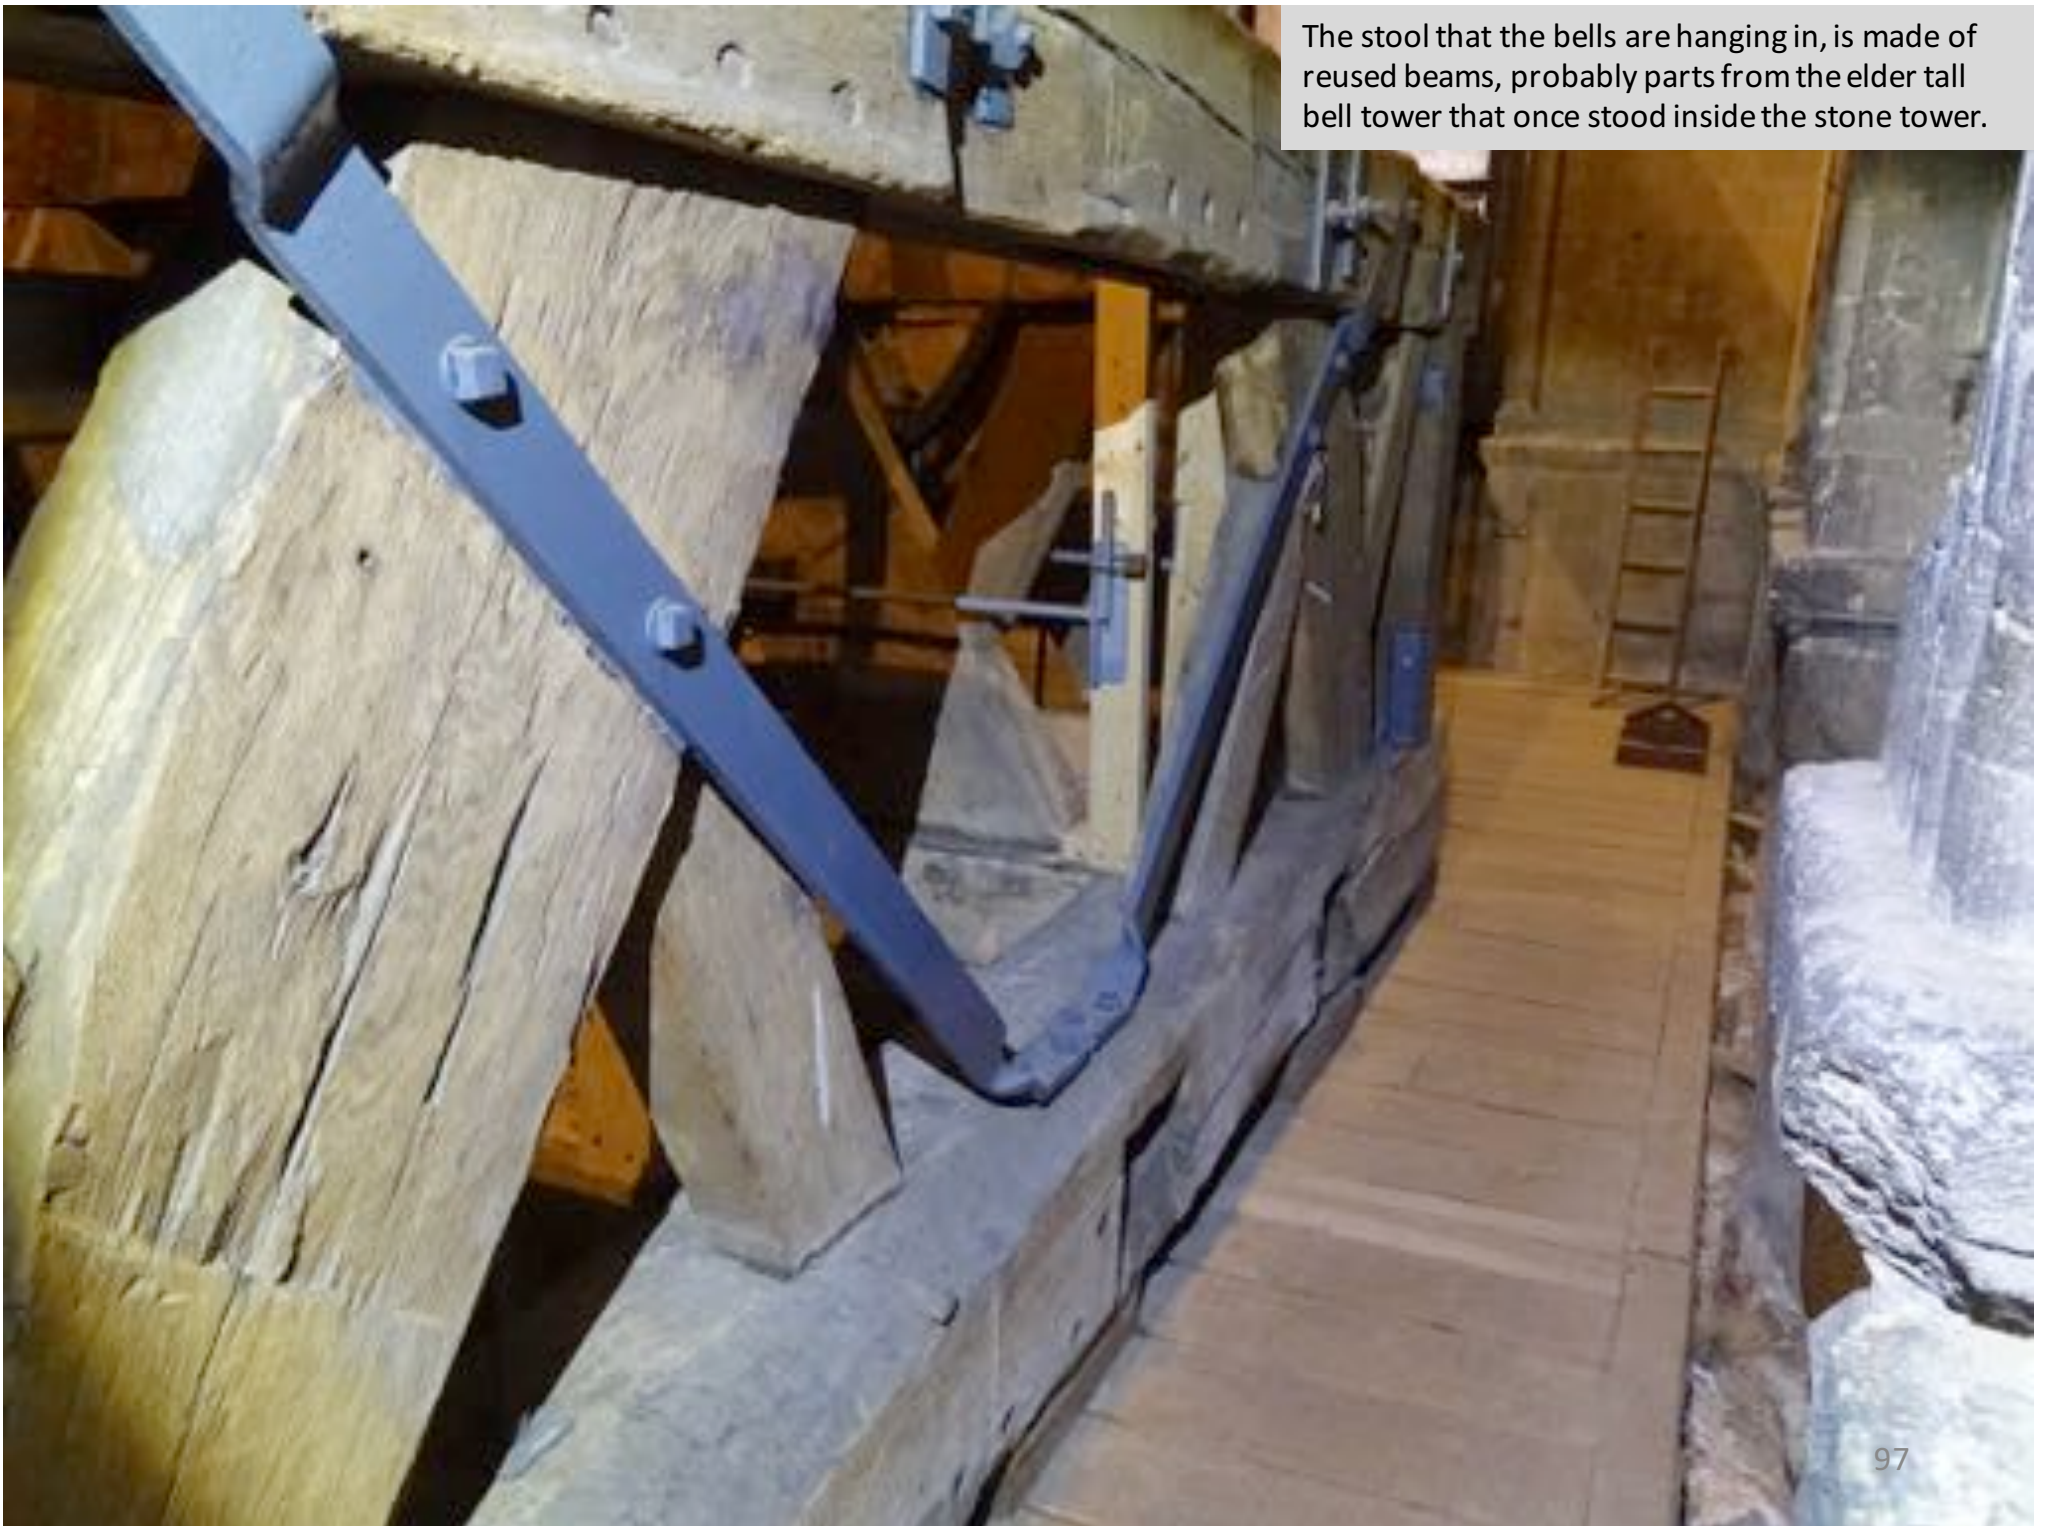
The stool that the bells are hanging in, is made of reused beams, probably parts from the elder tall bell tower that once stood inside the stone tower.

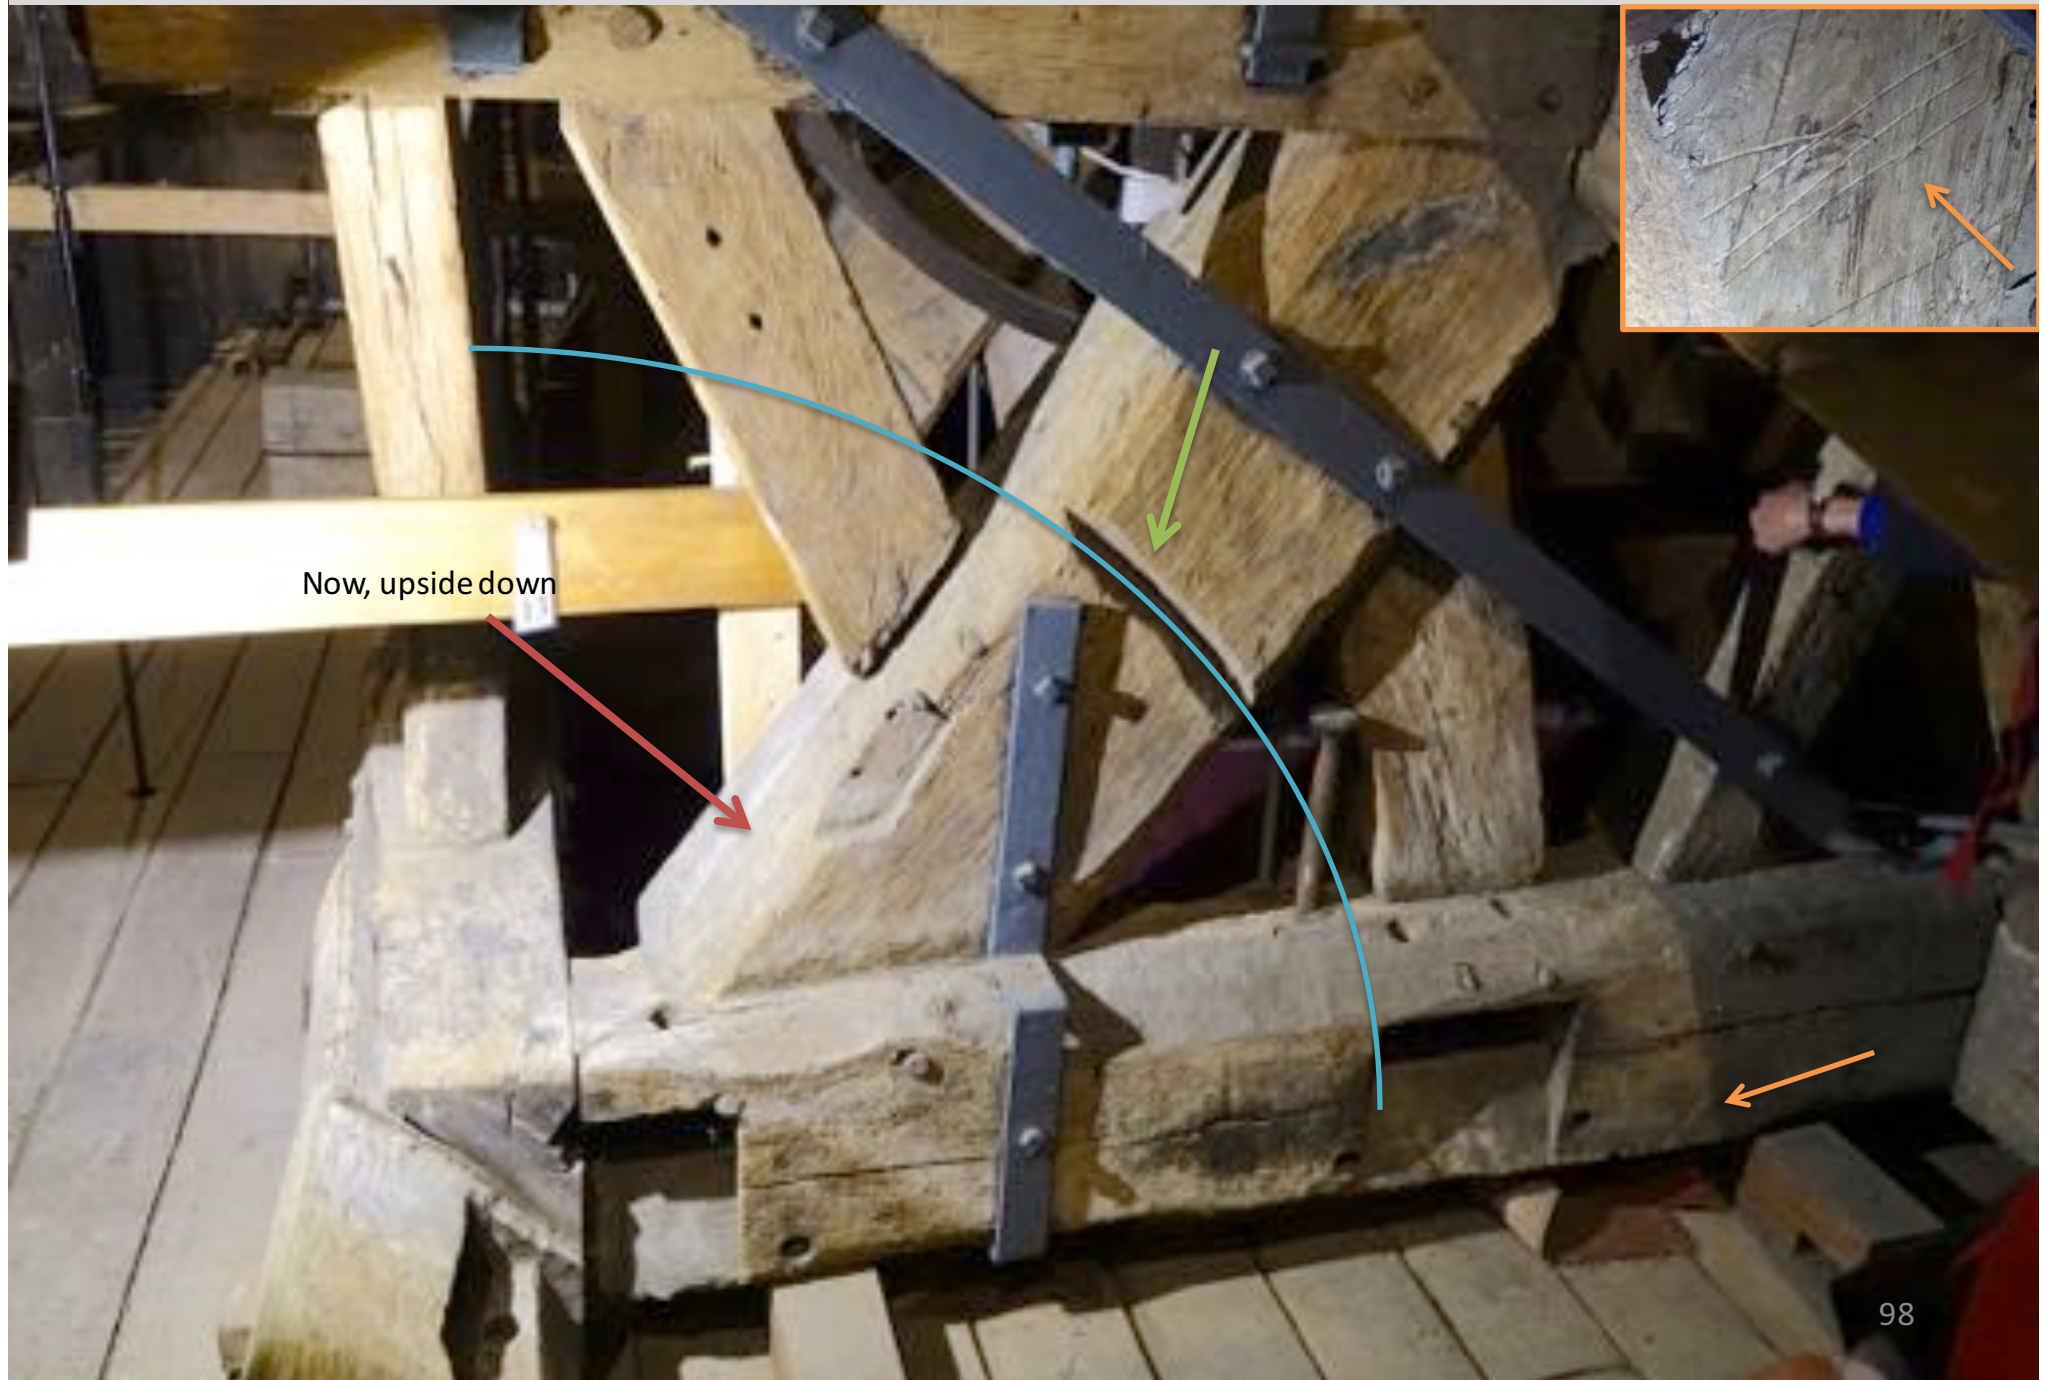
There are deep cuttings for the swinging bells in the former bell beam (now upside down). Markings for assembly, resembling runes, can be seen here and there. It would be possible to figure out how the standing bell tower looked like, by making a deeper examination and drawings of all the parts. Making a digital or a scale model of it could give a better understanding. We visited similar belltowers in Liege, Belgium, in 2016.

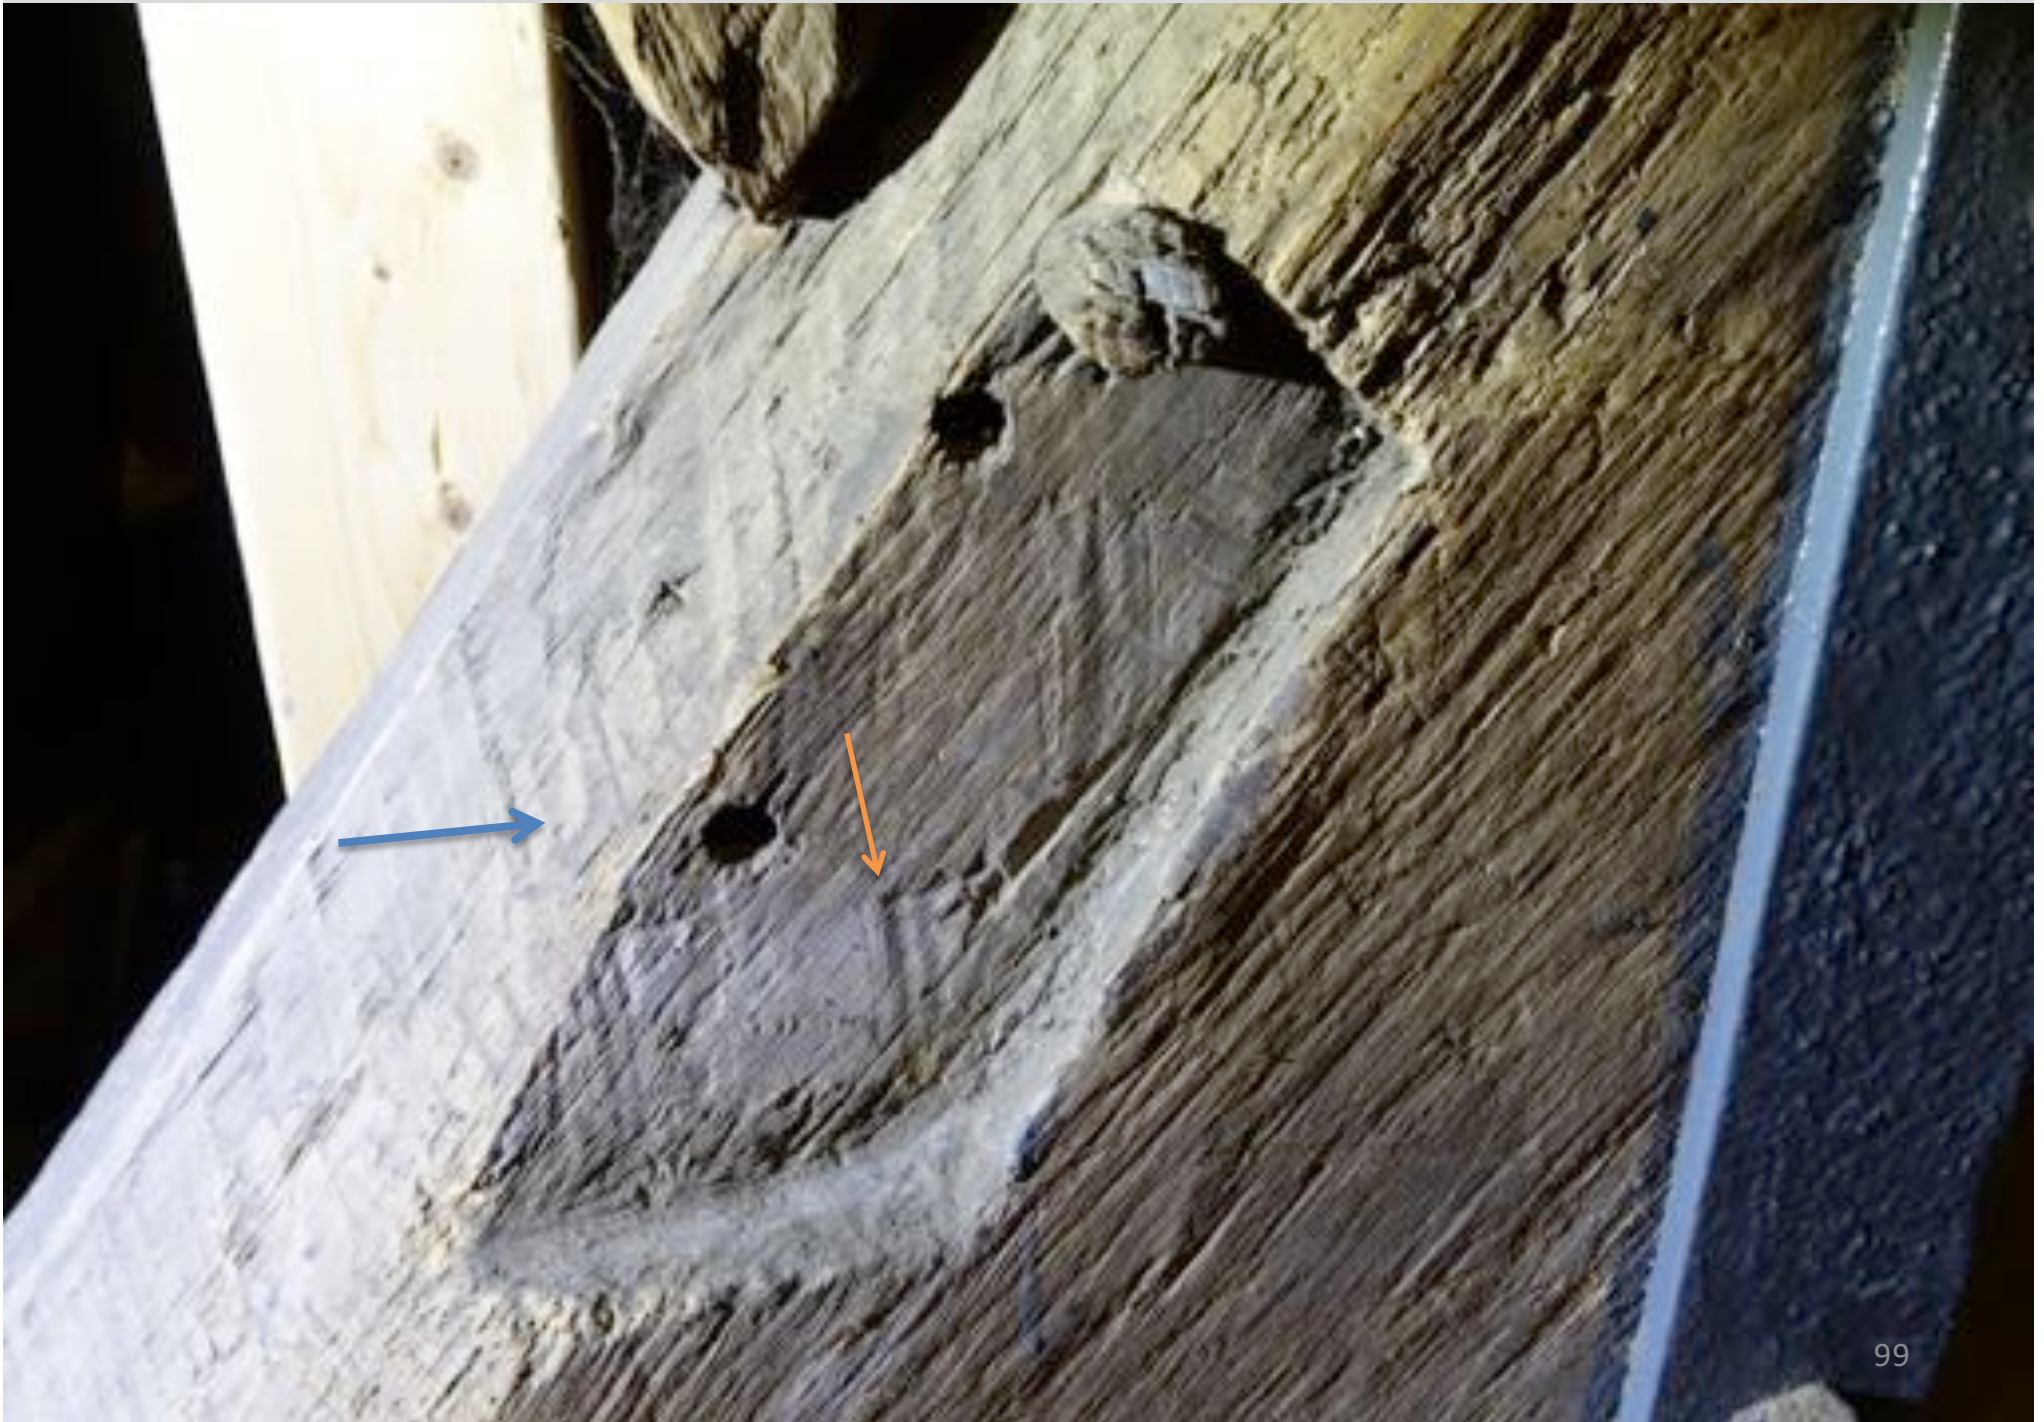
In one open notch from the former bell tower, there are toolmarks **from a chisel** the carpenter used. There are many cutting marks from **cutting off the bark** on the round surface of the beam.
