Carpentry art, excursion to England

The search for comparison of Scandinavian craftsmanship in medieval English carpentry art

This PM is the result of a carpentry art excursion made by Karl-Magnus Melin and Mattias Hallgren in april 2017. Karl-Magnus works as a carpenter and craft researcher at Knadriks Kulturbbygg, is project leader for the diocese project Historic carpentry art in the diocese of Lund and is a doctoral student at the University of Gothenburg.

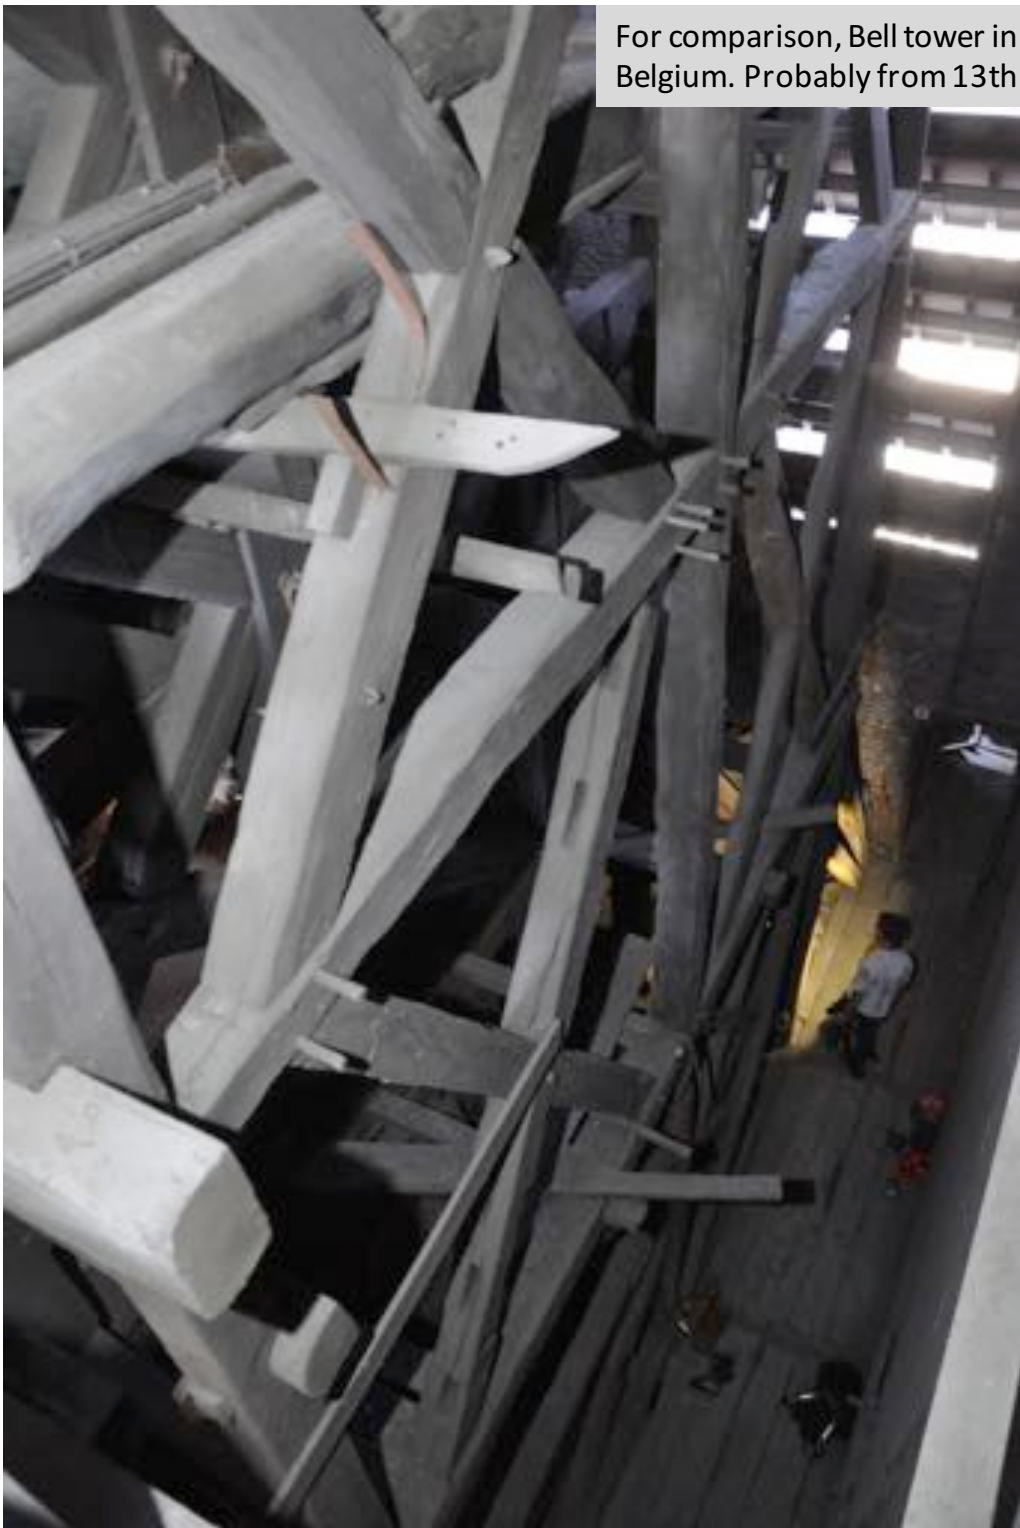
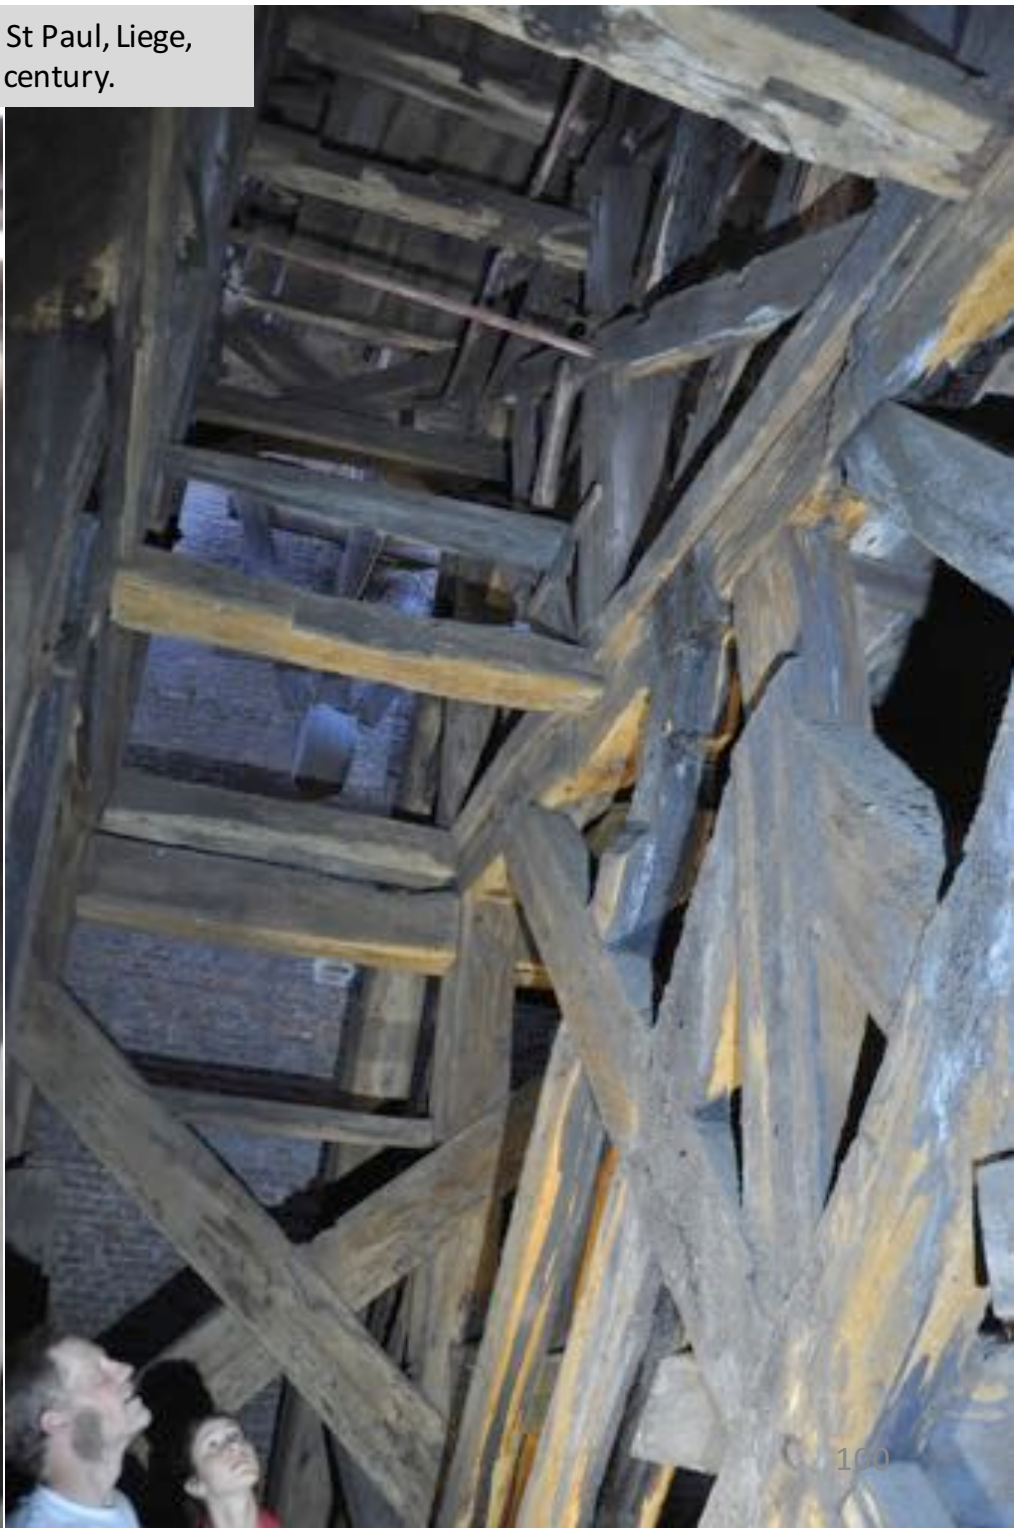
For comparison, Bell tower in St Paul, Liege, Belgium. Probably from 13th century.

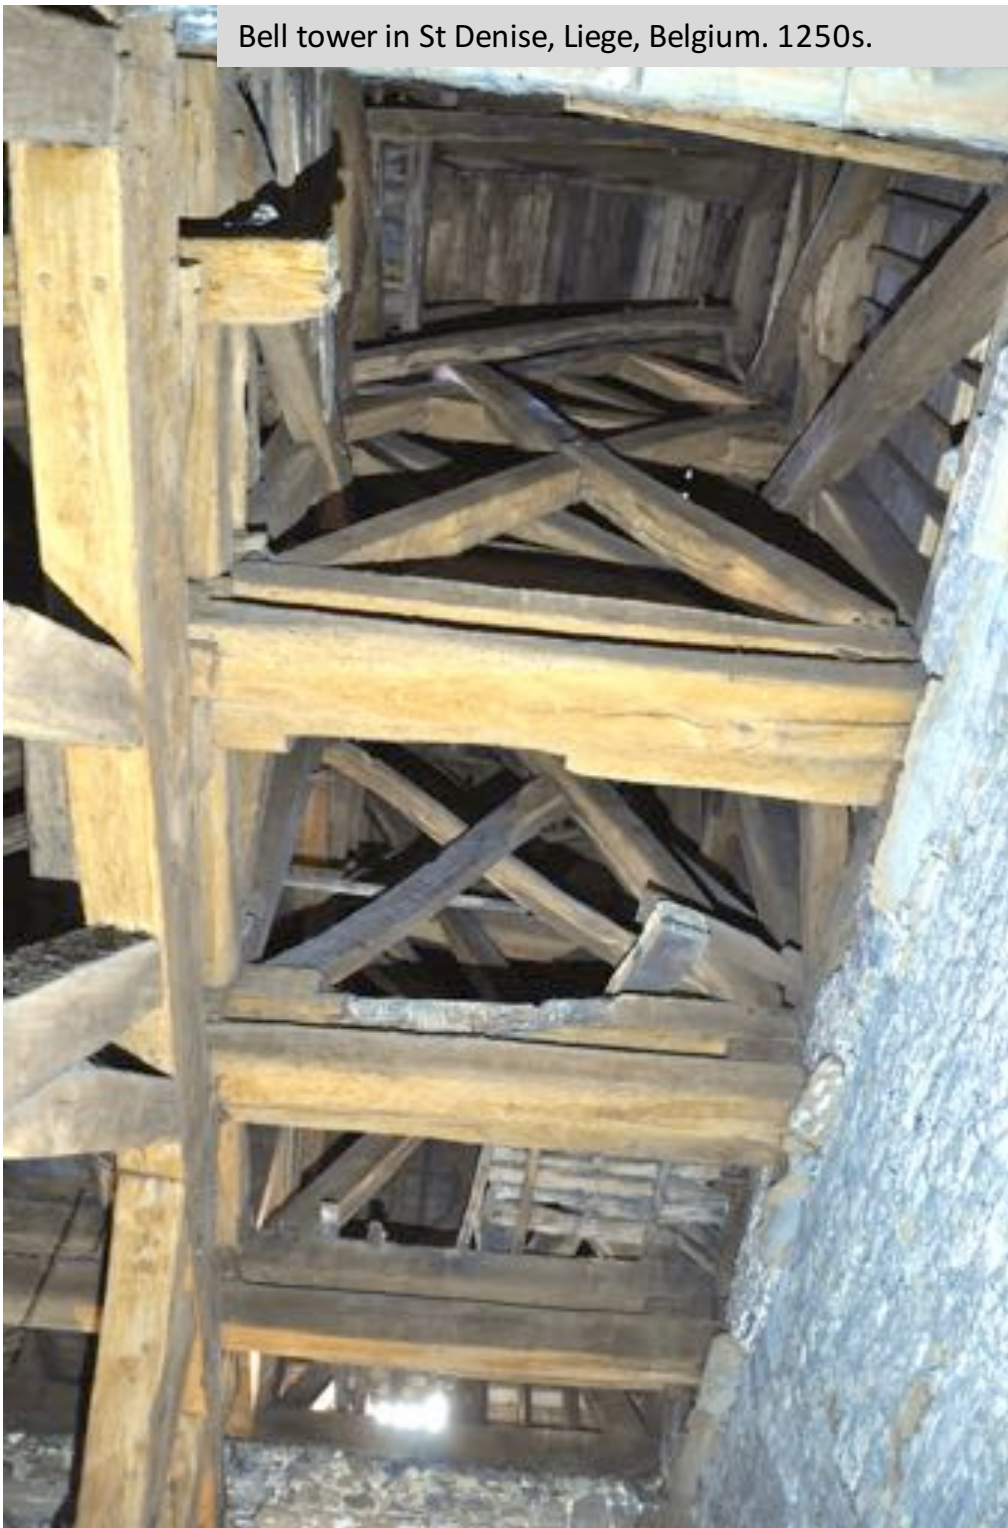
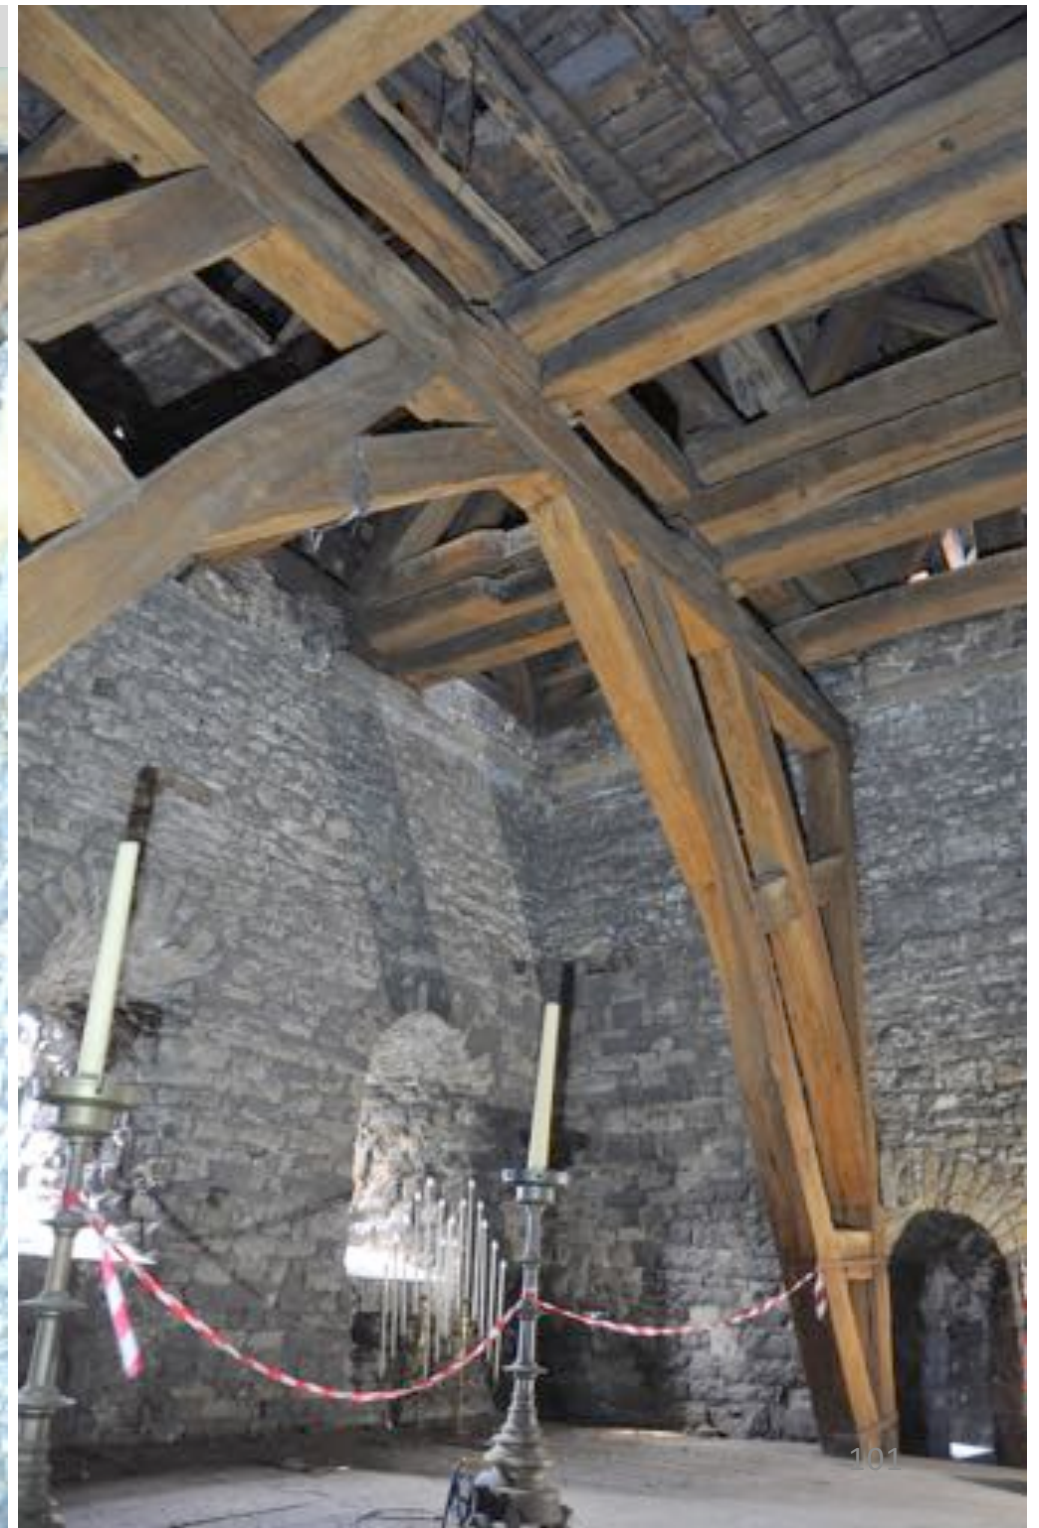
Bell tower in St Denise, Liege, Belgium. 1250s.

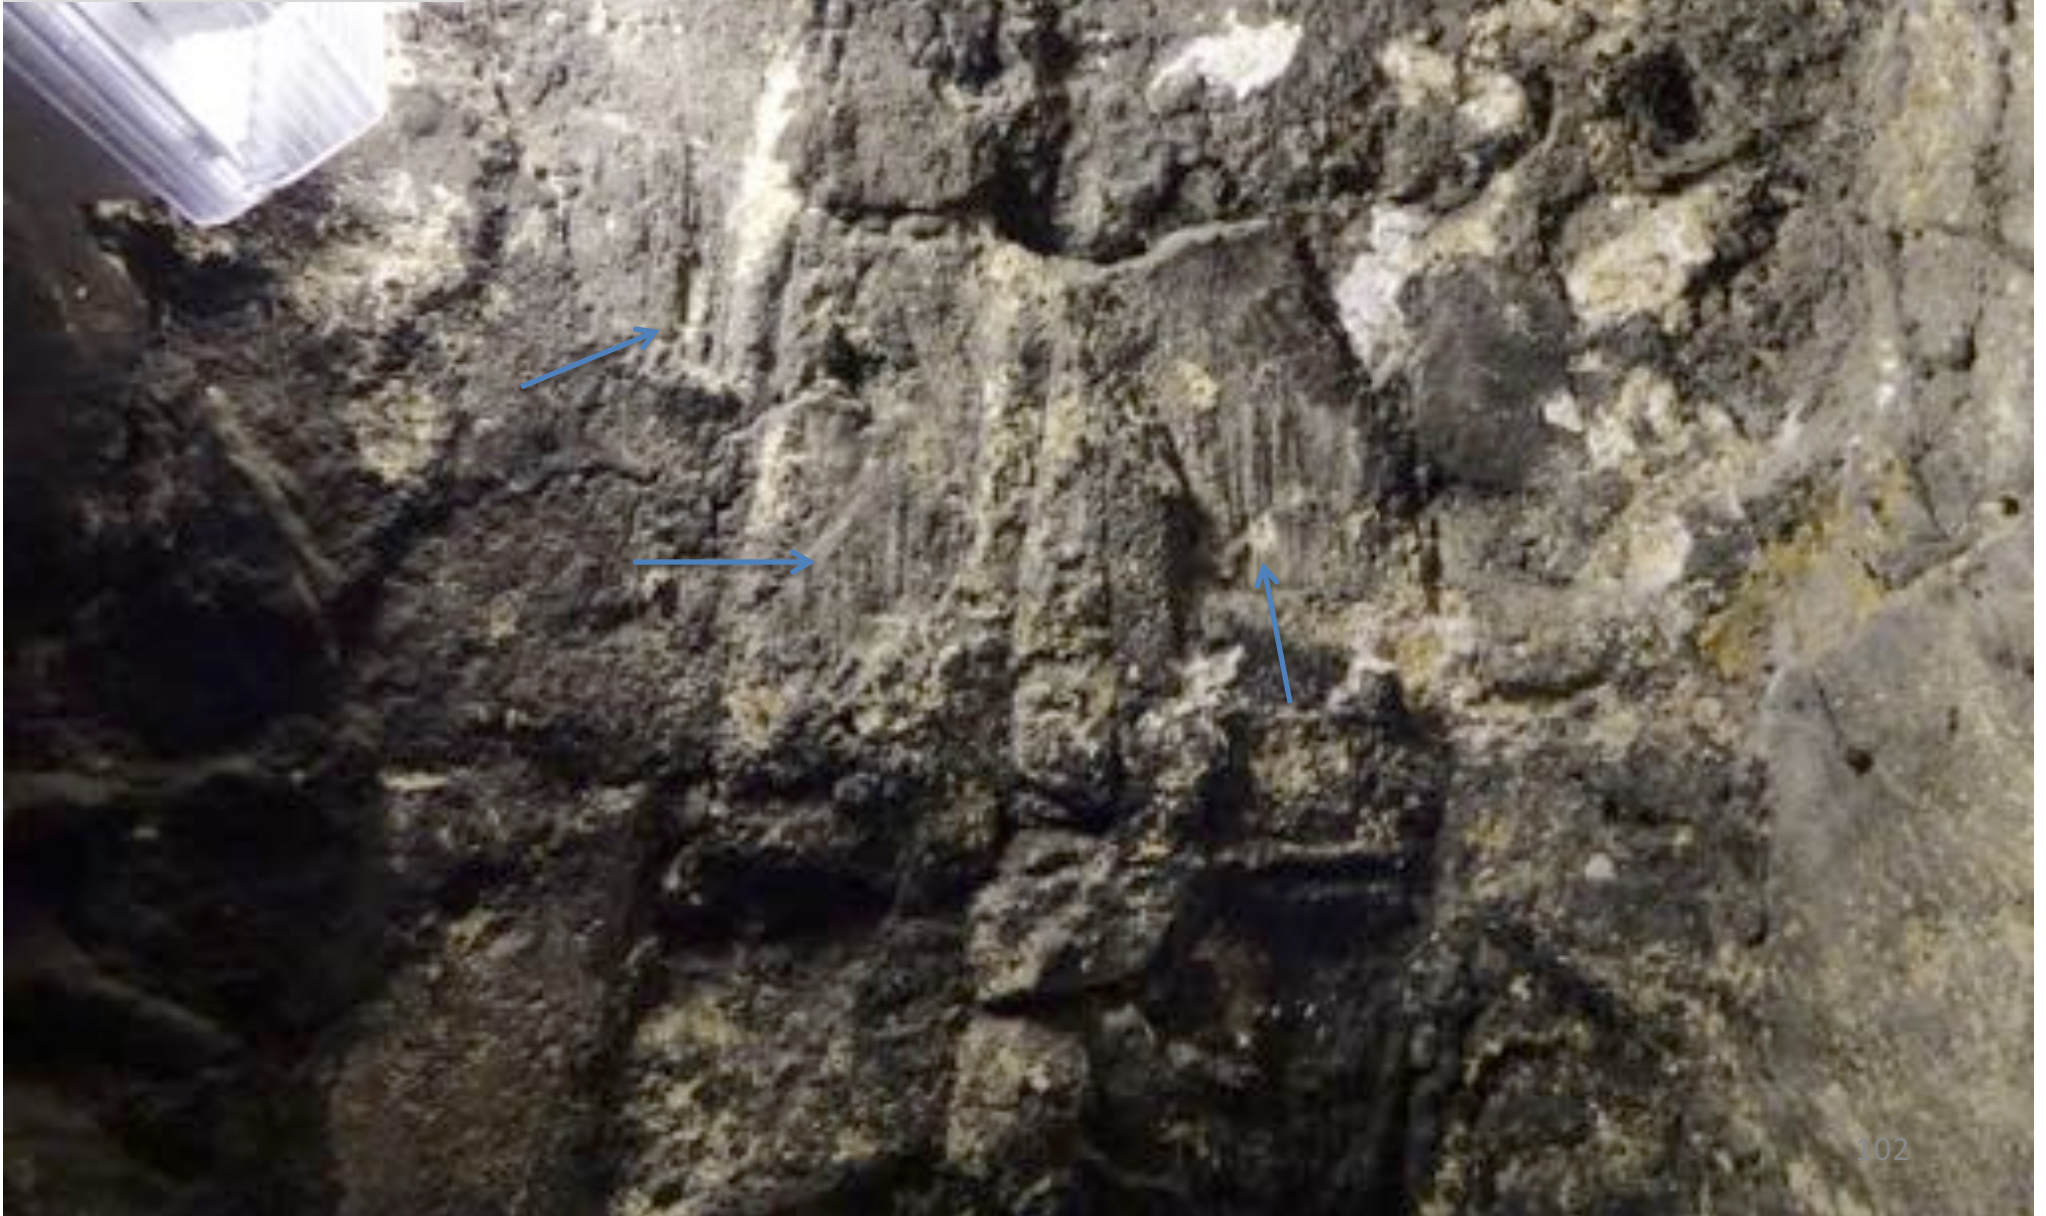
In the roof of the stairway, in the tower of Winchester cathedral, there are marks from the molding planks that show they were **cleaved**, not sawn.

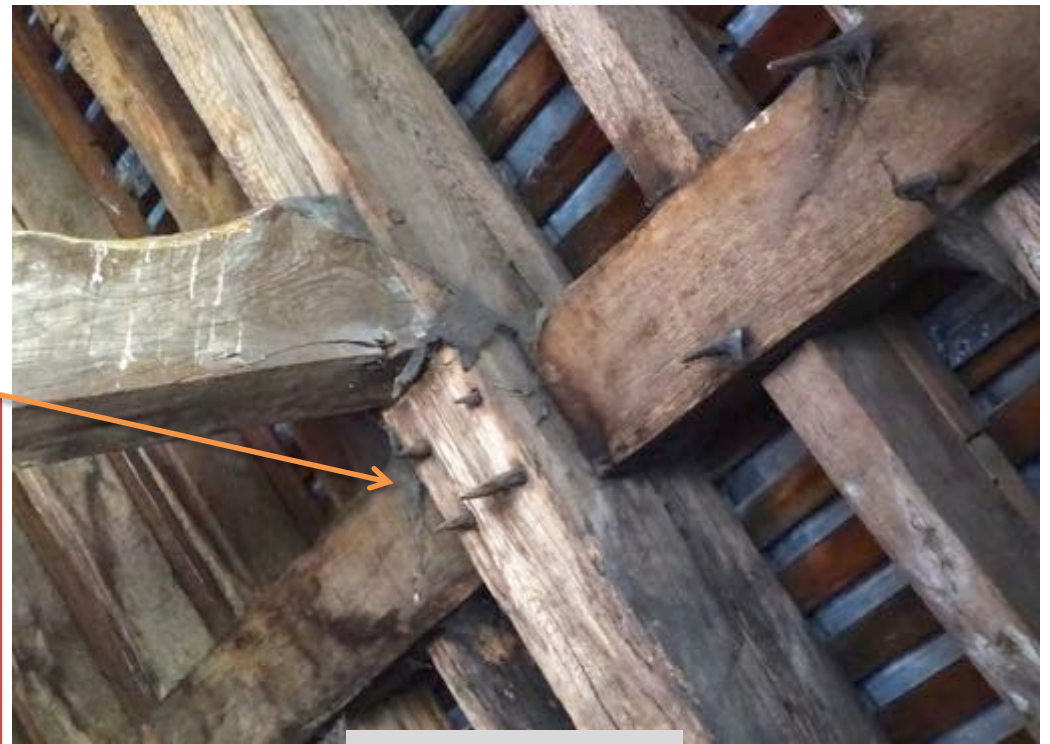
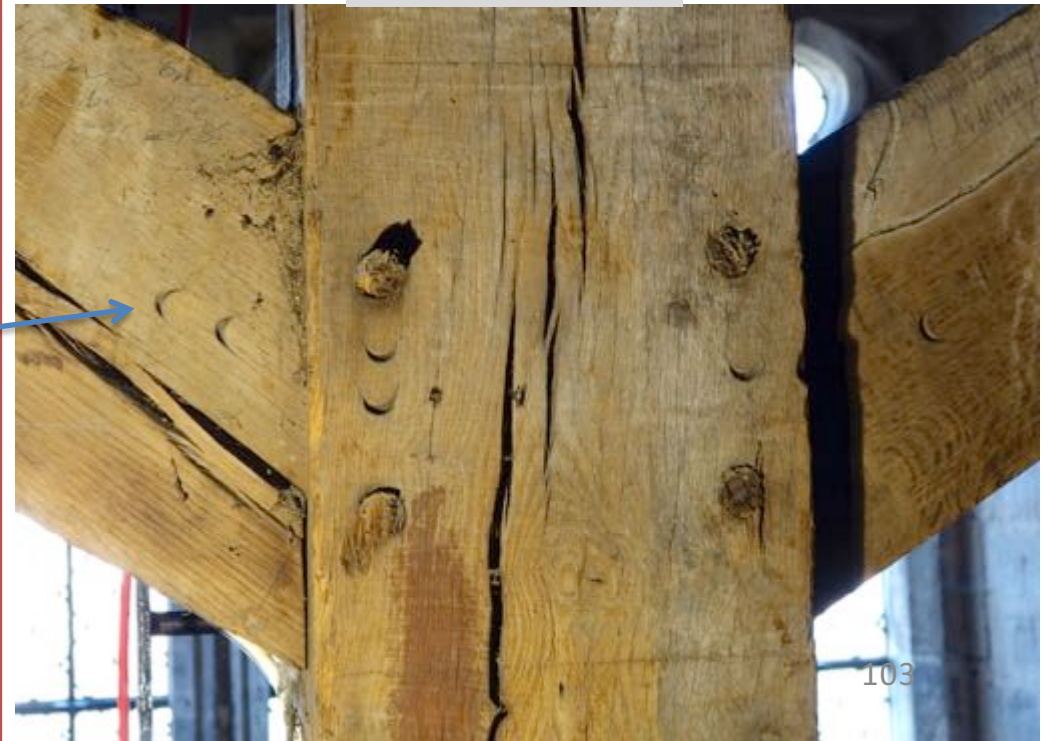
The roof construction over the nave in Winchester cathedral has been rebuilt several times and therefore it is a mix of all kinds of timber, new and reused. The western part should have been rebuilt after a fire in the 17th century. The carpentry, [assembly marks](#) and "vampirepegs" is very similar to what we see in Sweden from this time.

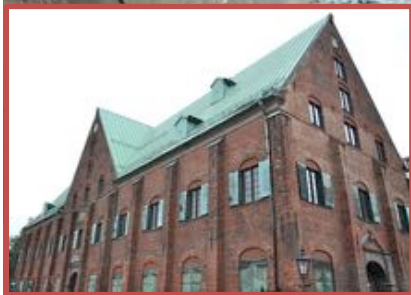
Kronhuset in Gothenburg, Sweden, built in 1654.

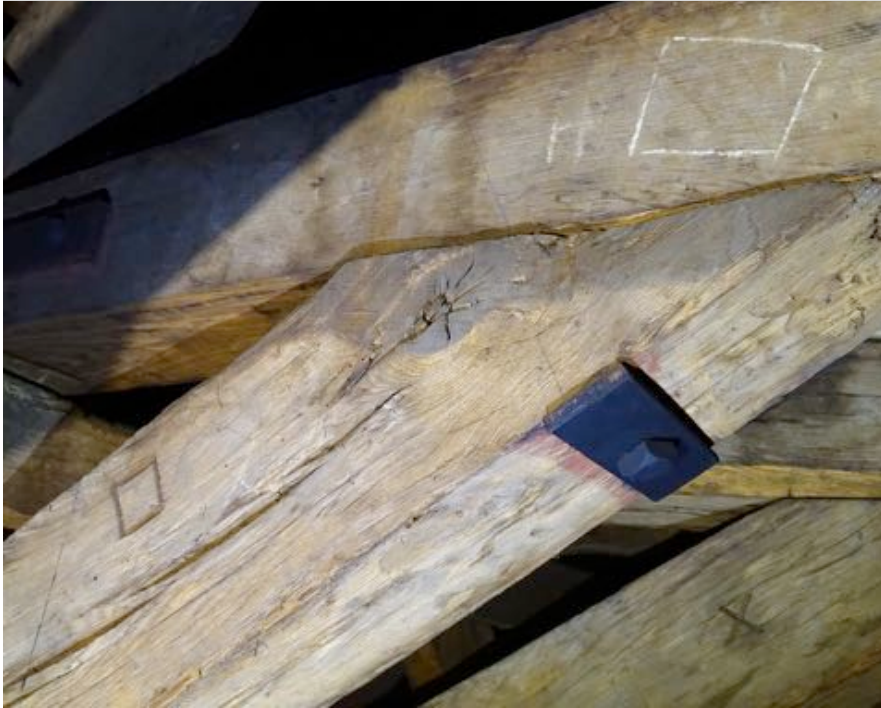
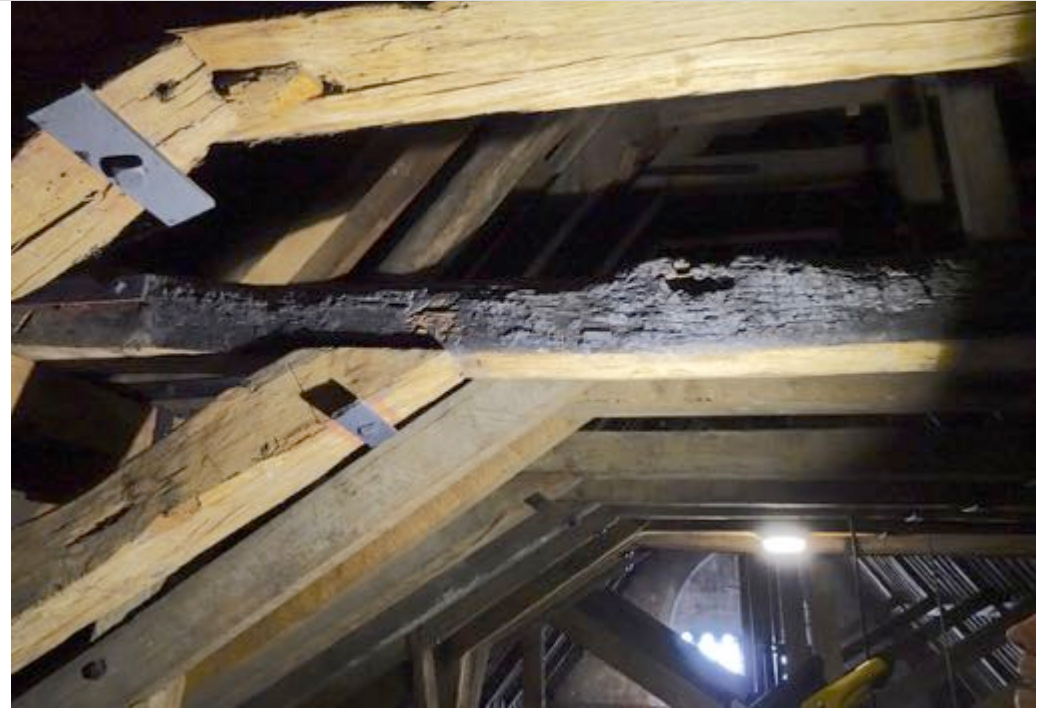
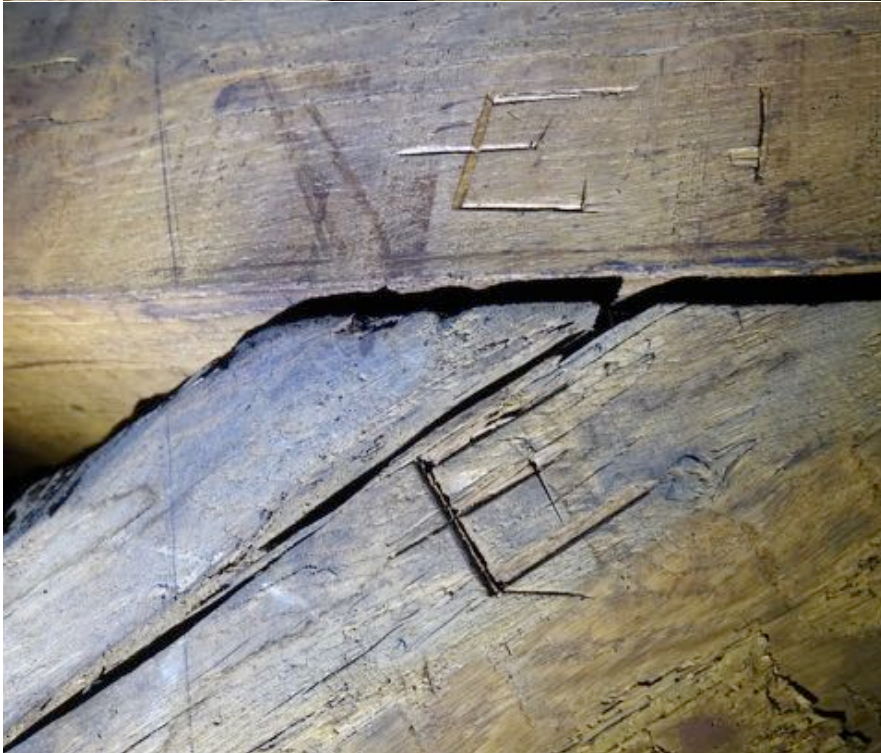
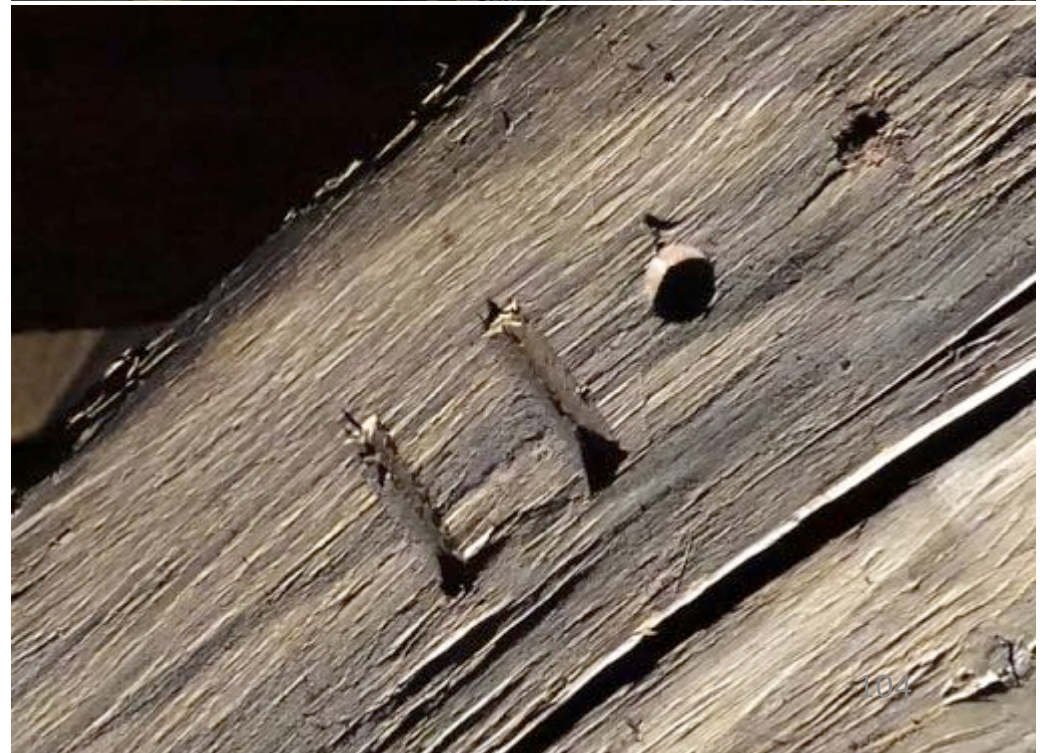
Some interesting assembly marks on the naves roof construction. There is also one beam that is half burnt off.

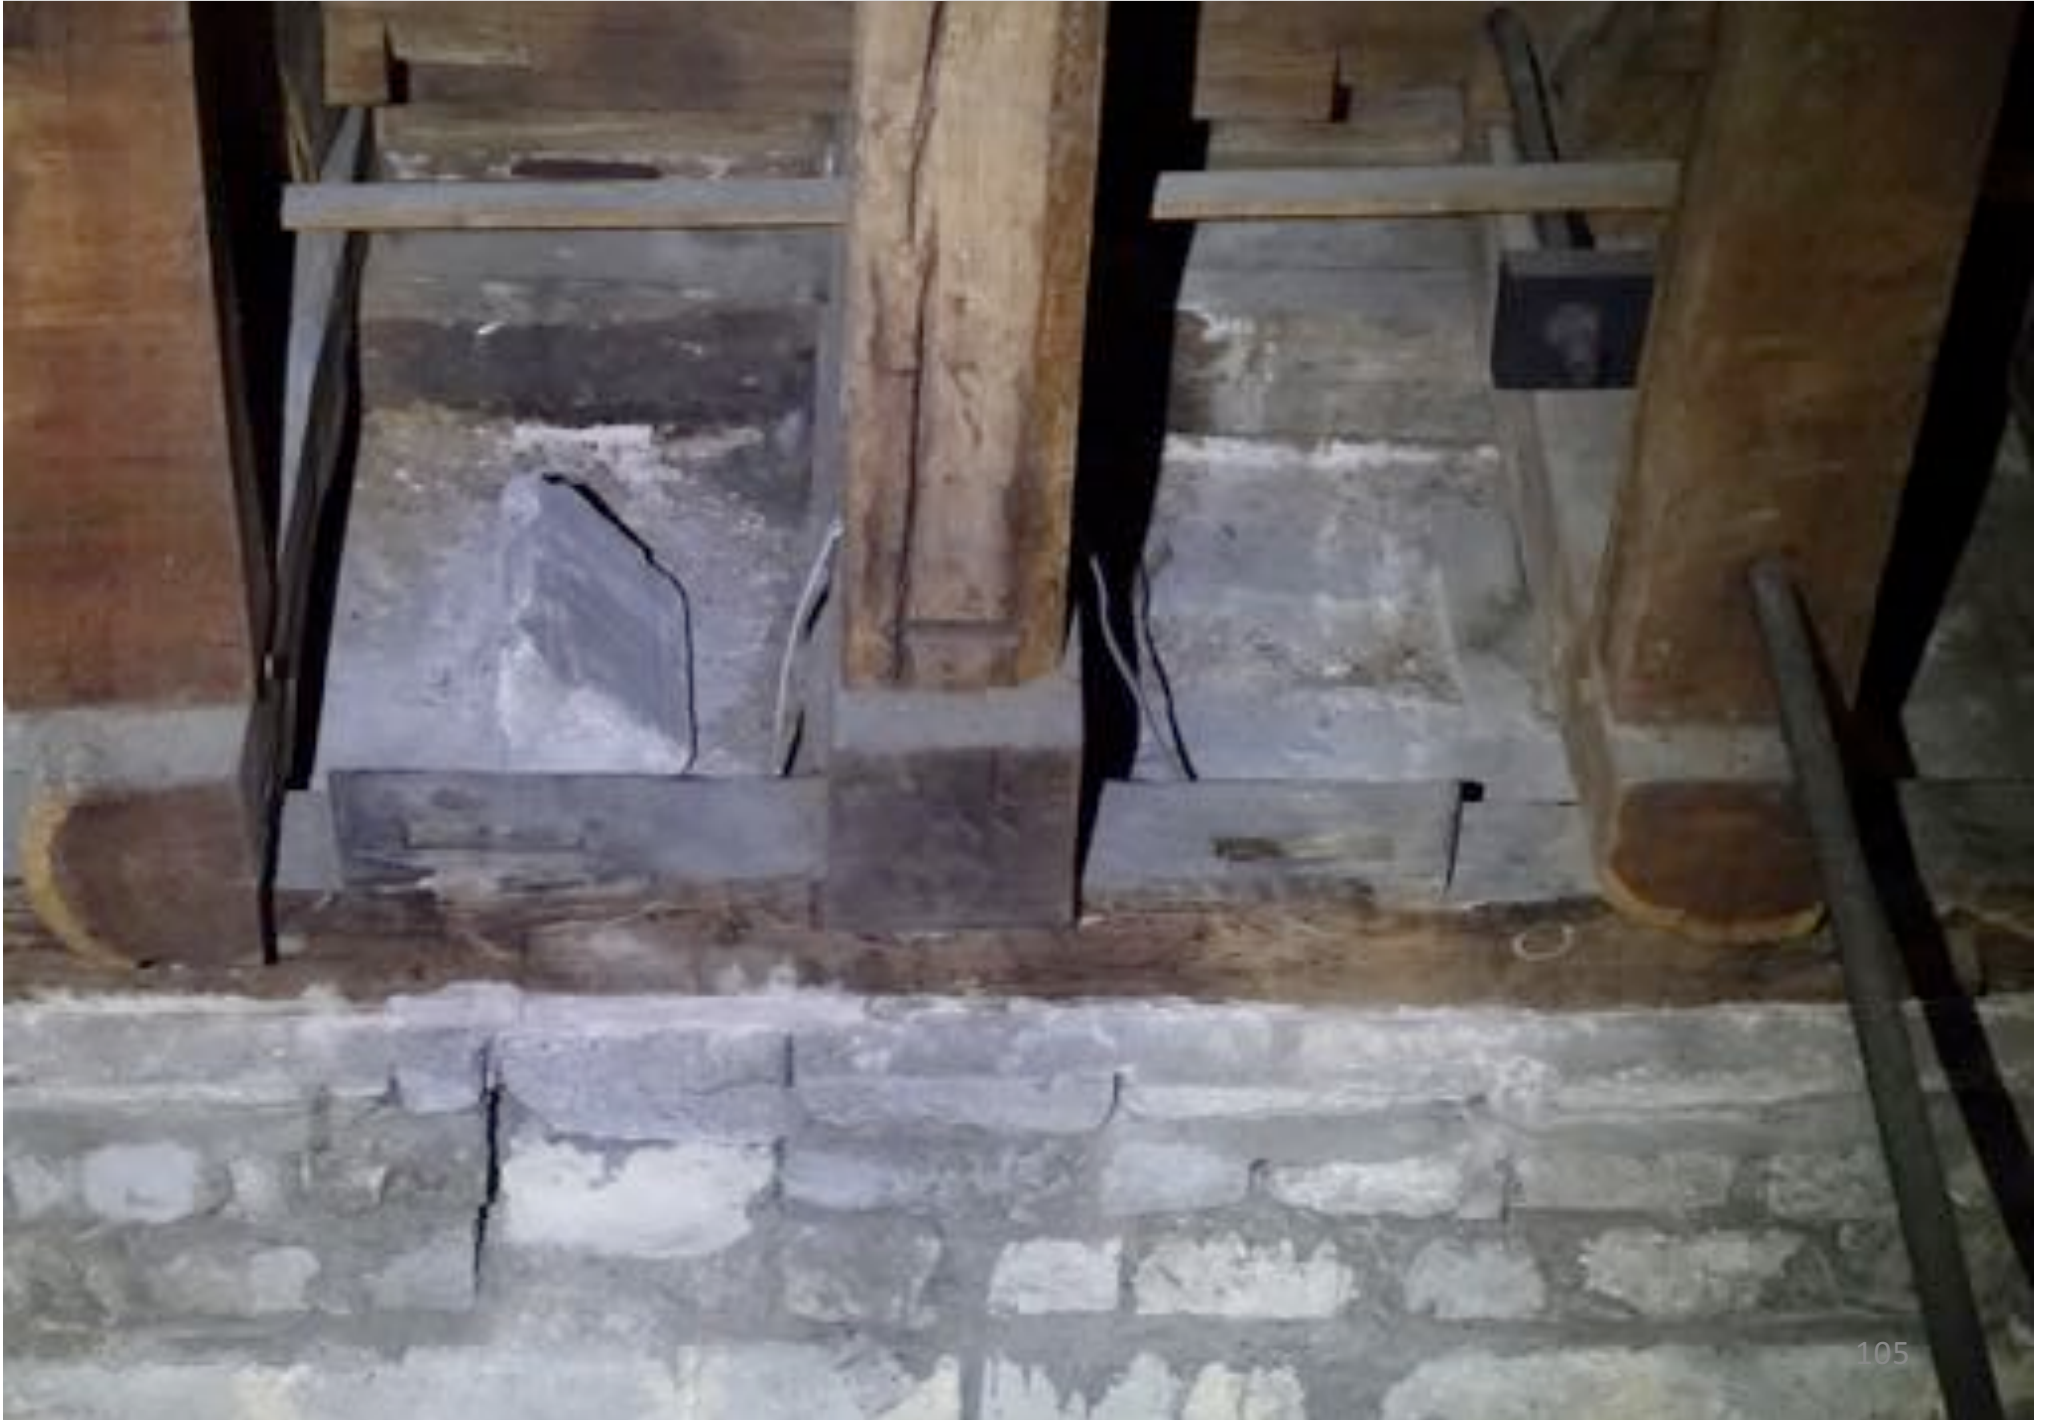
On the south side of the nave in Winchester cathedral the inner plate is reused and has both vertical mortices and horizontal dovetail joints. All elder pieces from the roof construction can tell about how it was made. A gigantic craftsmans puzzle.

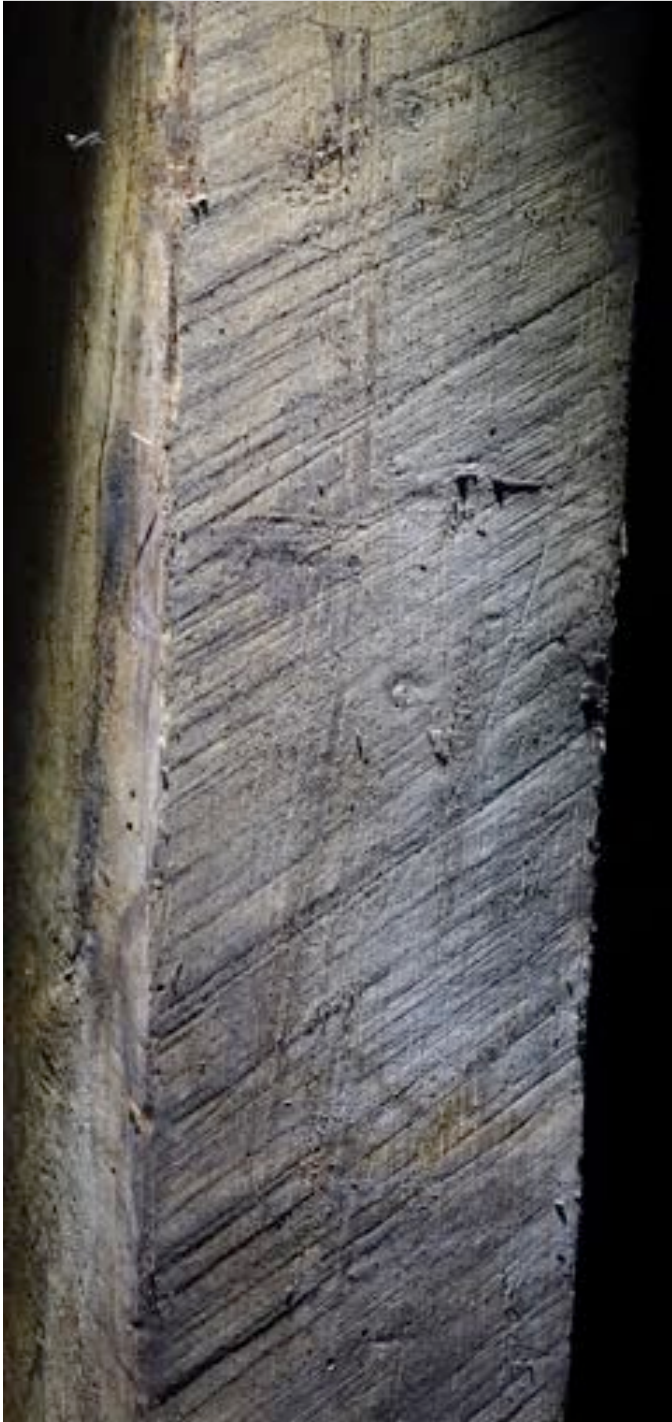
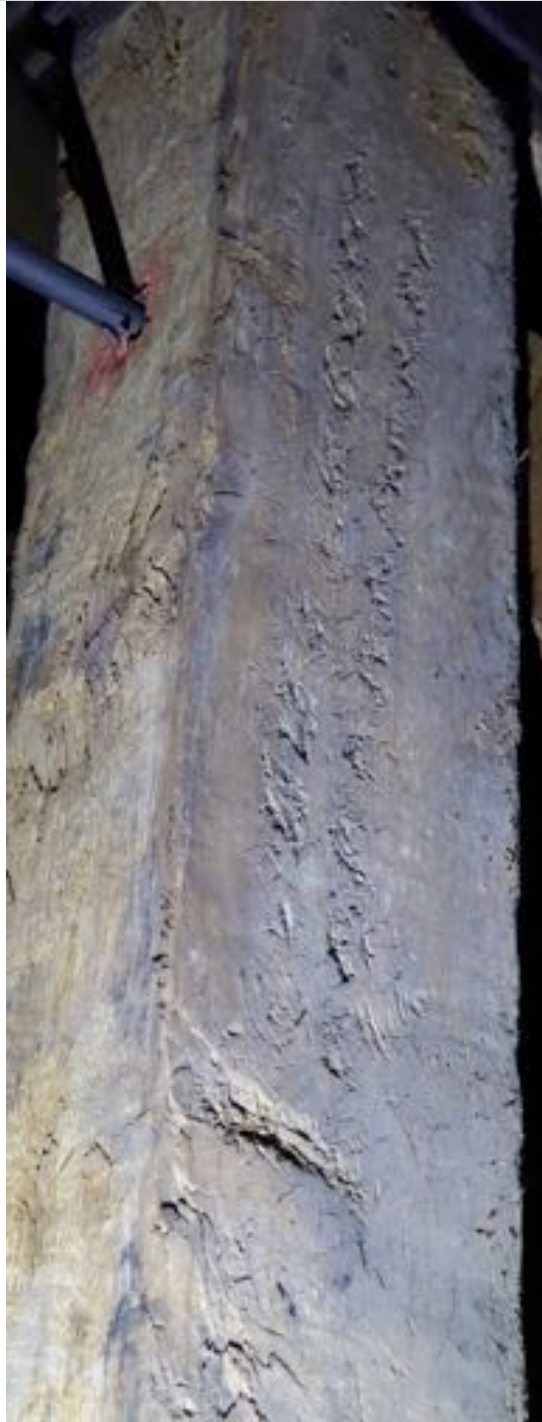
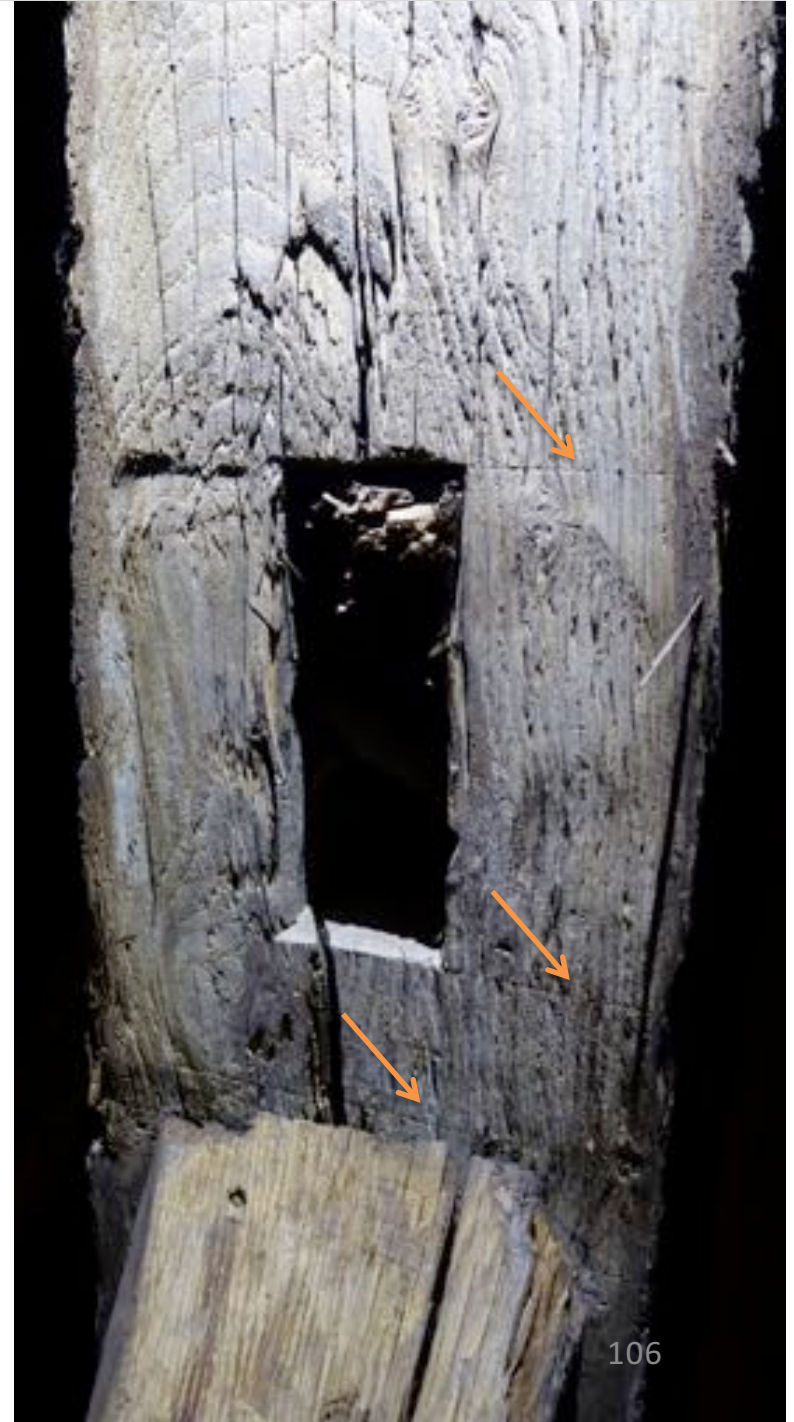
Far left, a timber that first has been hewn to a square beam, and then cleaved into two pieces with a pitsaw. Middle, a beam that has been used as a workbench before it was put up. Far right, an older mortice not in use, where **the scribing lines** for the layout can be seen.

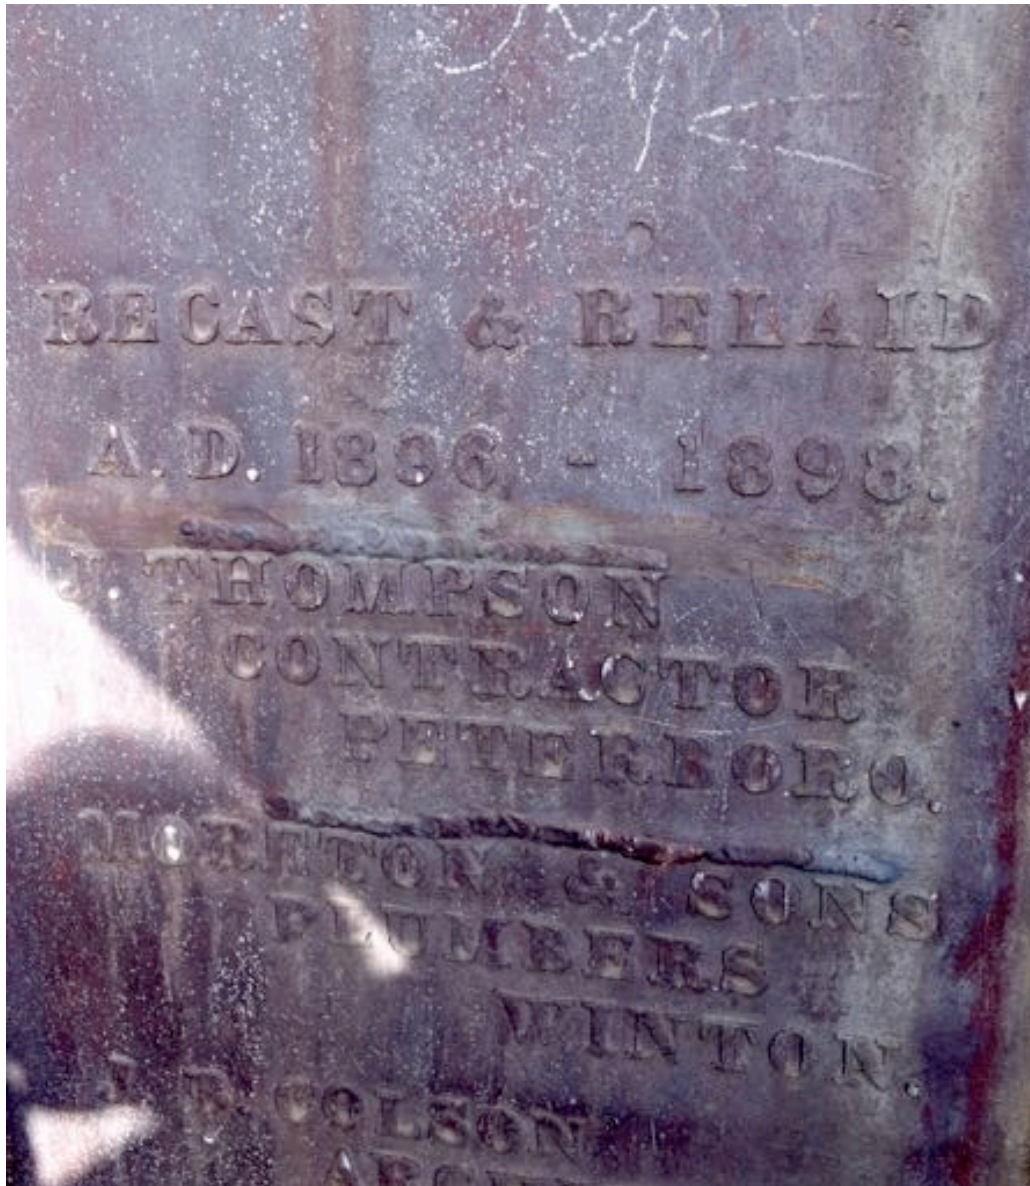
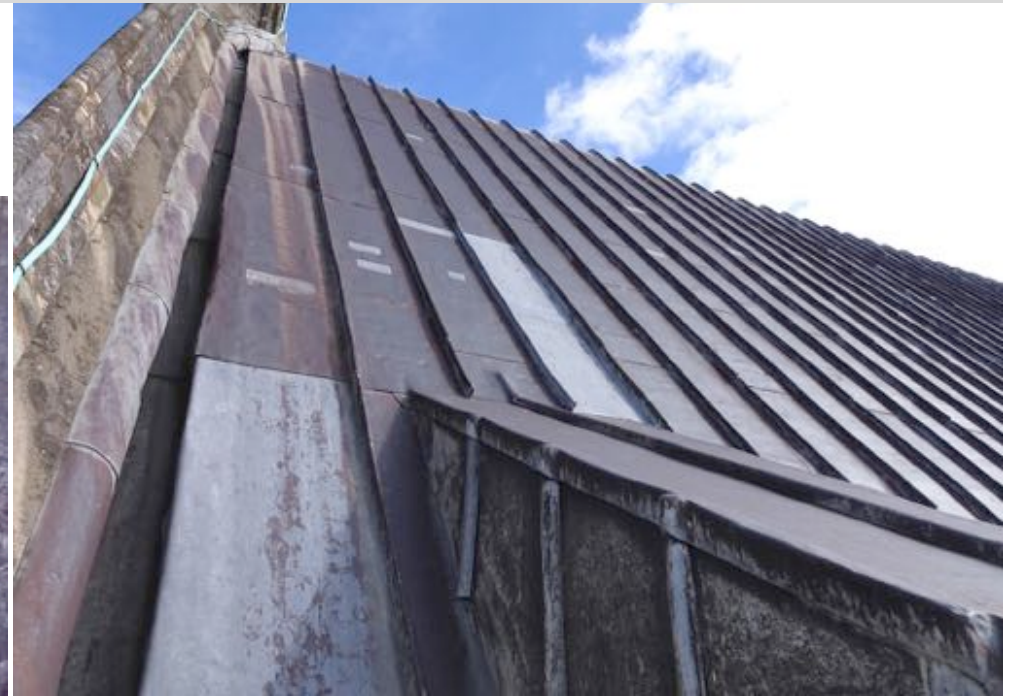
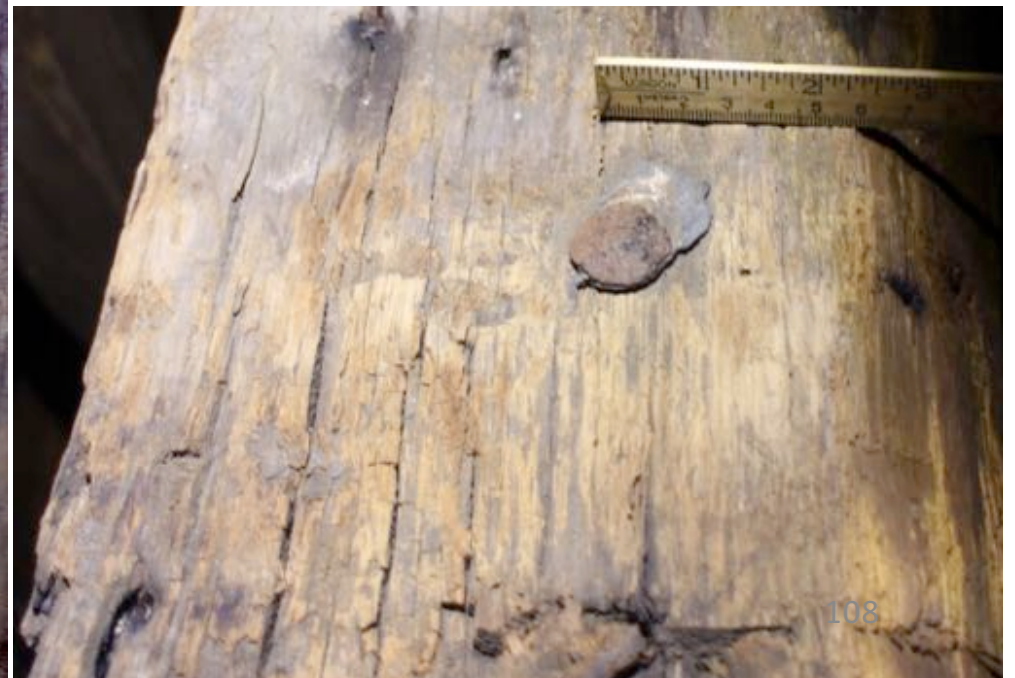
The Winchester cathedral's roof is covered with 3-4 mm lead plates. On one old roof board we found an old leadnail with a piece of lead still underneath. These leadnails sometimes have small "dots", under its head, to better grab the lead sheet, so the hole for the nail doesn't grow and cause leakage when temperature changes and the sheet expands/shrinks.
