Carpentry art, excursion to England

The search for comparison of Scandinavian craftsmanship in medieval English carpentry art

This PM is the result of a carpentry art excursion made by Karl-Magnus Melin and Mattias Hallgren in april 2017. Karl-Magnus works as a carpenter and craft researcher at Knadriks Kulturbbygg, is project leader for the diocese project Historic carpentry art in the diocese of Lund and is a doctoral student at the University of Gothenburg.

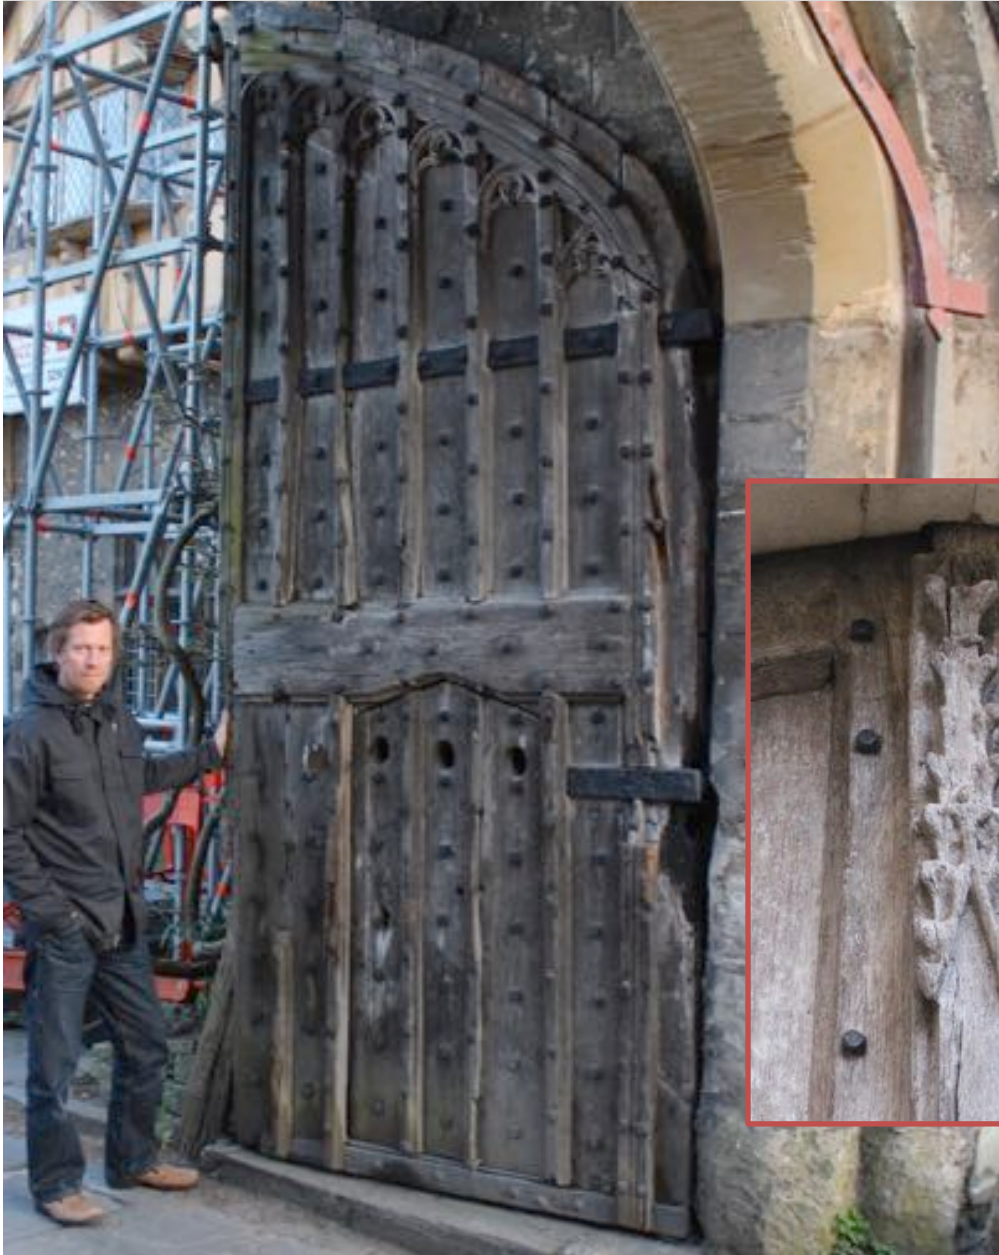
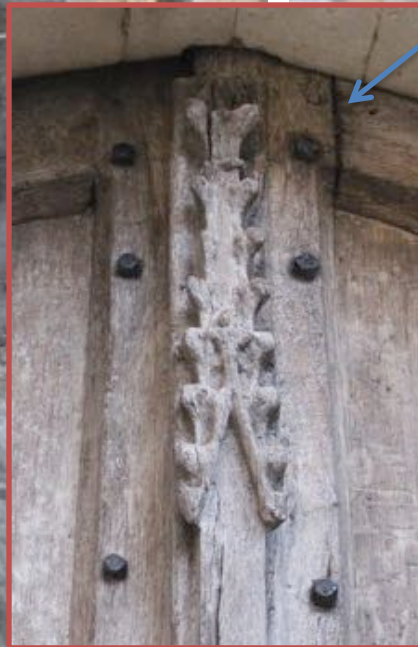
South of the cathedral in Winchester there are an old city port, and two more at Winchester College. They are still in good health and are definitely worth taking a closer look at. There is a lot of work behind building doors like these, with fine precision and advanced carpentry.
