PM St Maria Church in Sastamala, Finland 4 July 2023 - Mattias Hallgren, Traditionsbärarna

The visit to St Maria church in Sastamala, Finland, was part of the ongoing research about medieval wooden constructions. I, Mattias Hallgren, am a carpenter and craftresearcher, I participate in several projects contributing with my carpenter's perspective.

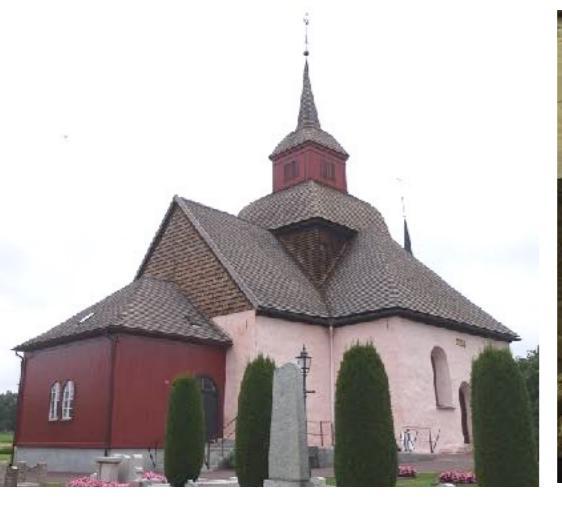
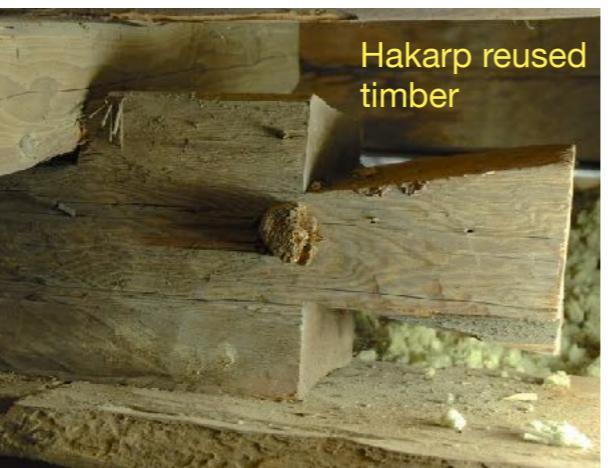
Hakarp church in Husqvarna, Sweden. Reused medieval wall timber in roof and tower built 1695.

Reusing timber from an older building is common in churches. A good example of this is in Hakarp church, Husqvarna, Sweden, where they used the old timber church as a scaffolding in 1694 when building a new stone church around the old one. Then the medieval timber was reused for the tower and the new roof construction.

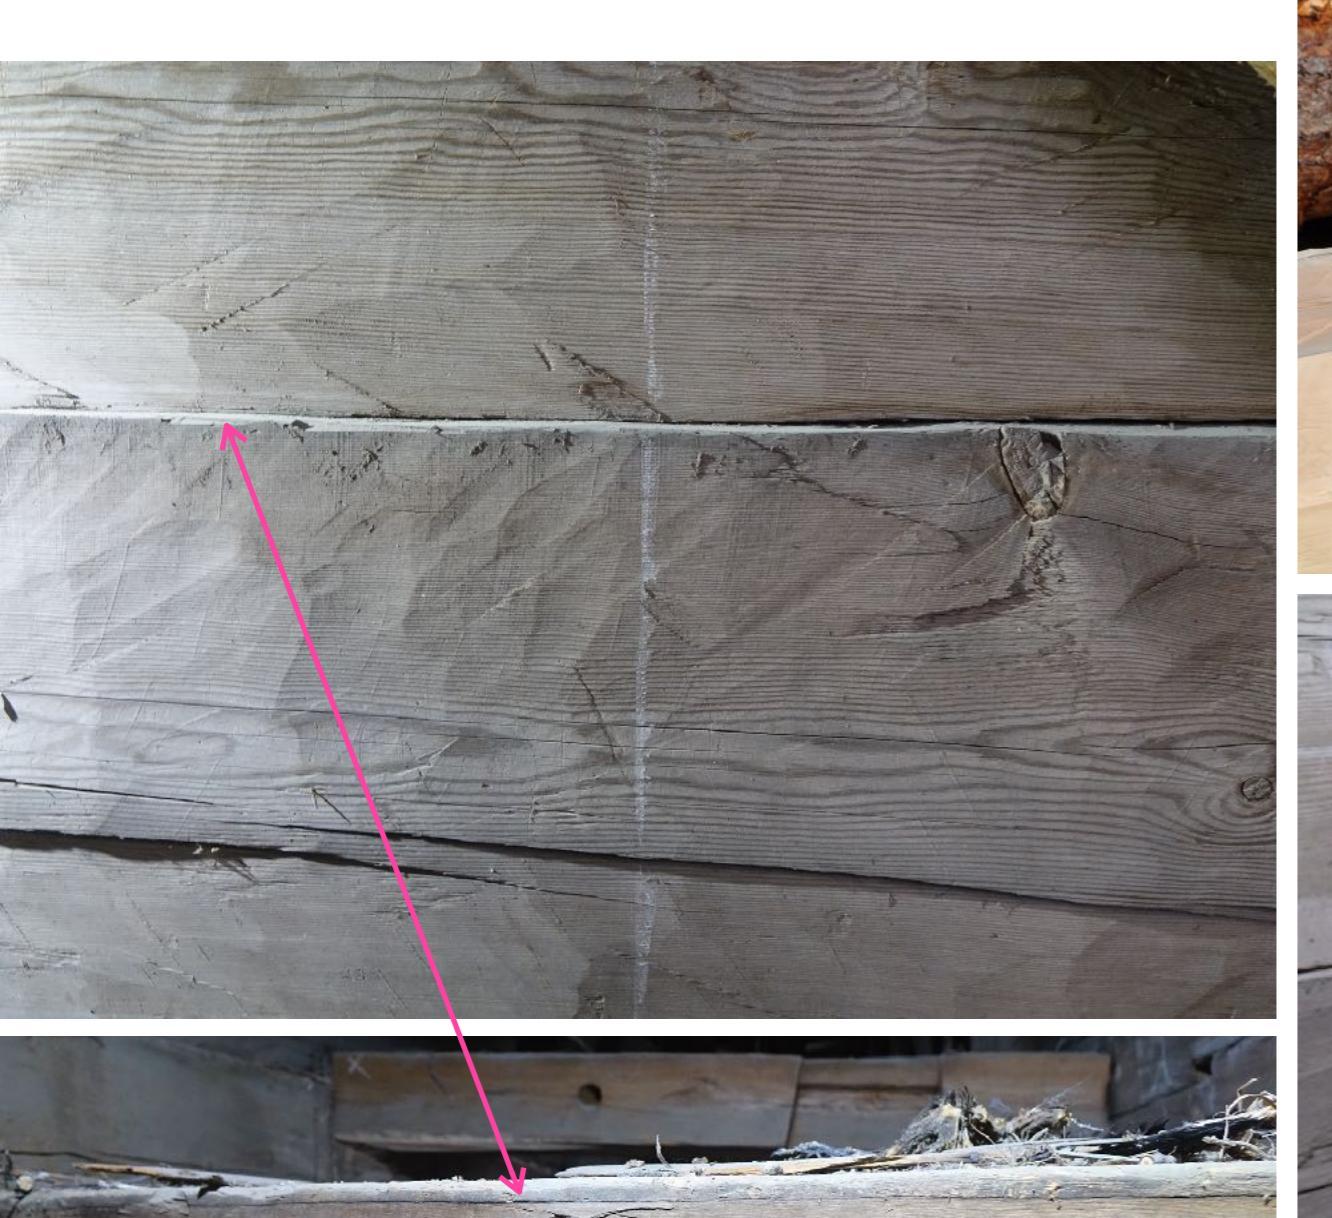
The wall timber is hewn to a box-shape, not like an ordinary timber building that is hewn on two sides only. Here, as in Swedish medieval churches, the timber is hewn flat on 4 sides, with slightly moss-groove on the bottom side. This is to get the pressure from the building out to the sides of the wall, tightening together for rain and wind. There are no traces from panel or shingles on the outside of the timber.

Trace from the upper log where the pressure has made a "line" in the upper side of this wall timber.
